Oconto County Lakes Project

ANDERSON LAKE STUDY SUMMARY REPORT 2019

*University of Wisconsin-Stevens Point and
Oconto County Staff and Citizens*

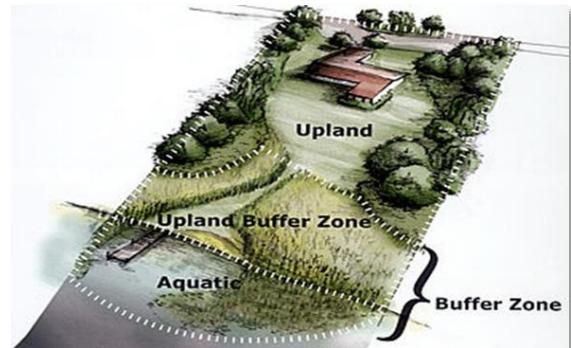
- Shorelands around Anderson Lake were surveyed in June 2017. Some of Anderson Lake's shoreland is healthy, but many stretches are in need of restoration.

Total lakefront footage	No. Riparian lots	Measured shoreland disturbance (feet)	Measured shoreland disturbance (%)
12,681	90	8,378	66%

- Leave natural shoreland vegetation in place or restore if it has been removed.
- Learn to identify and look for invasive plants and animals and know who to contact if found.
- Do not purchase prohibited and restricted species. Purchase native plants when possible.
- Never transplant water garden or aquarium plants into lakes, streams or wetlands. Properly dispose of them.
- Remove invasive exotic plants from your landscape and replace them with native plants or non-invasive exotics. Scout regularly for new invasive plants.
- Avoid using garden plants from other regions whose invasive potential is poorly understood.
