# Oconto County Lakes Project

## BEAR PAW LAKE STUDY

### SUMMARY REPORT

2021

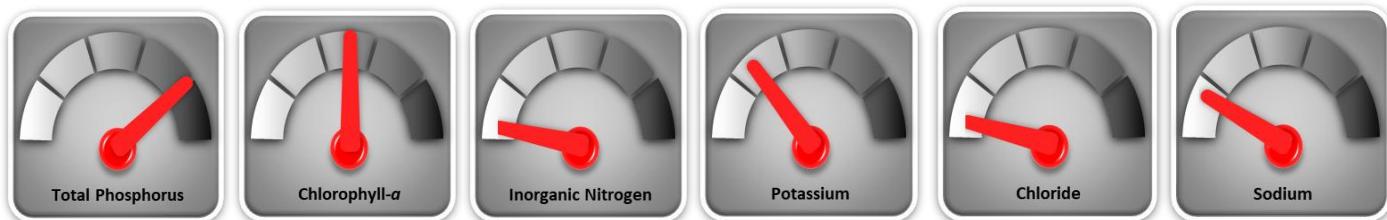
- Total Phosphorus was consistently below the Wisconsin state standard of 20 ug/L for deep seepage lakes during the two-year study. The long-term trend (based on summer samples) suggests a stable concentration.
- Inorganic nitrogen remained below the threshold of 0.3 mg/L when algal blooms increase.
- Chlorophyll-a, an indirect measure of algae, reached the threshold of 6 ug/L in one sample. The long-term trend is stable.

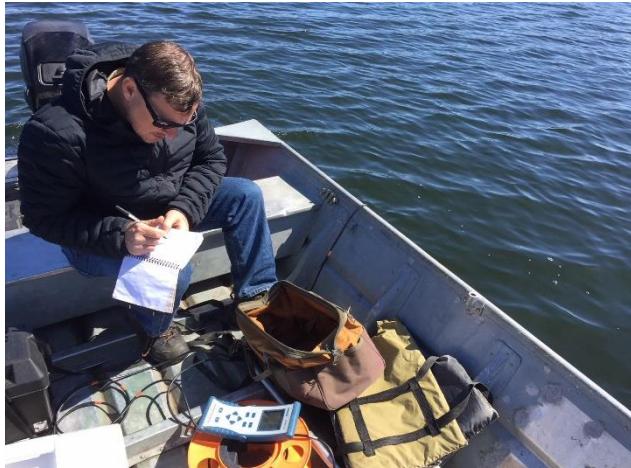
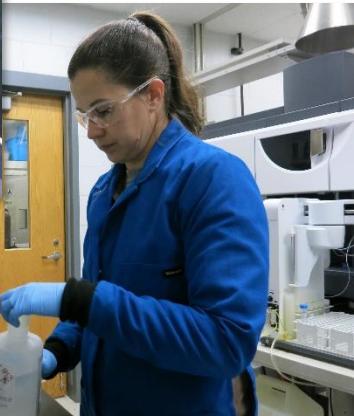
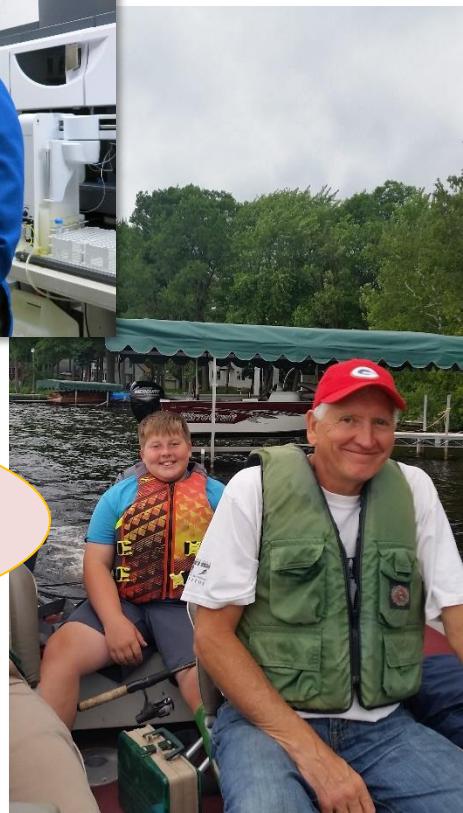
- Concentrations of potassium (0.57 mg/L), chloride (0.84 mg/L) and sodium (0.83 mg/L) were all low. This suggests minimal impact from septic systems, road salt, animal waste and fertilizers.
- DACT, a screening tool to determine if your lake is being impacted by pesticides, was not detected.
- Water in Bear Paw Lake is soft (24.5 mg/L CaCO<sub>3</sub>), having a low level of dissolved minerals. Soft lakes tend to have more biological activity.
