Oconto County Lakes Project

BOOT LAKE STUDY SUMMARY REPORT

2019

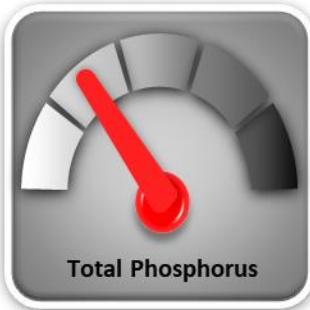
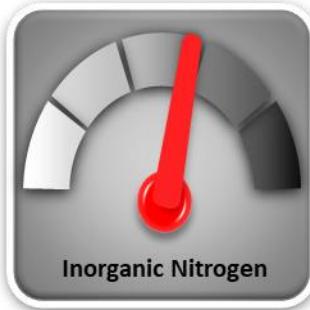
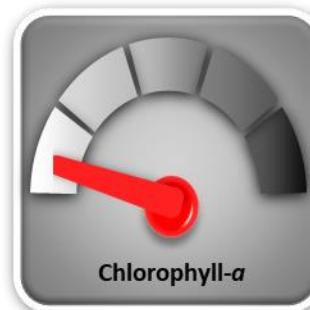
- Total Phosphorus was consistently below the standard of 20 ug/L for deep seepage lakes during the two-year study.
- Inorganic nitrogen remained below the threshold of 0.3 ug/L when algal blooms increase.
- Chlorophyll-a remained well below 6 ug/L and appears to be decreasing over the long term.

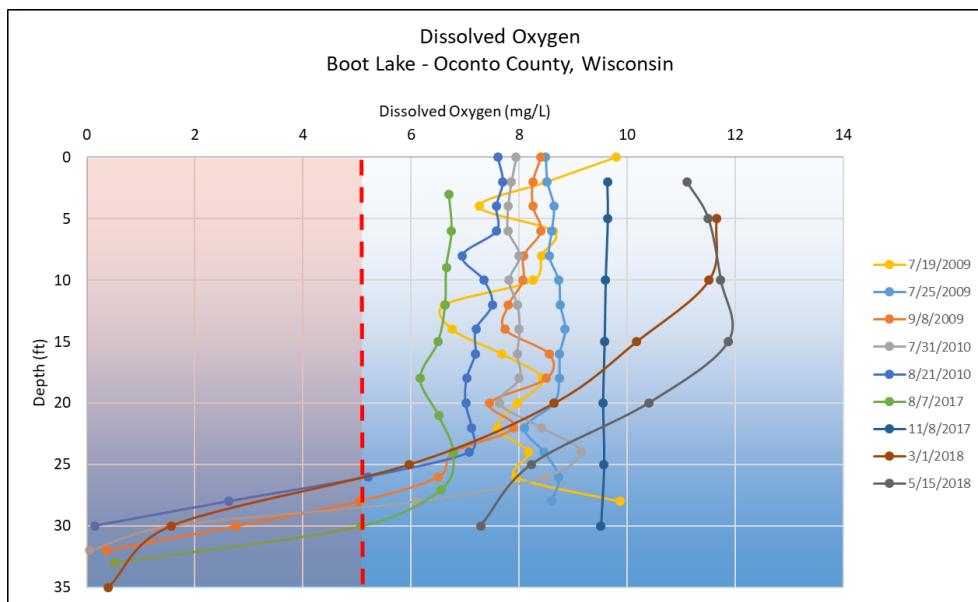
Sufficient **dissolved oxygen** in lake water is essential to the survival of aquatic organisms. The amount of dissolved oxygen present within a lake varies by season and depth. It is determined by the biological activity that consumes or produces oxygen, by water mixing through wind, changes in temperature, and inputs of surface and groundwater. Generally, at least 5 mg/L oxygen is required for fish.

- Sufficient oxygen is available in Boot Lake throughout the water column during all parts of the year. Oxygen concentrations remain low in the hypolimnion (below 25 feet) most of the year.

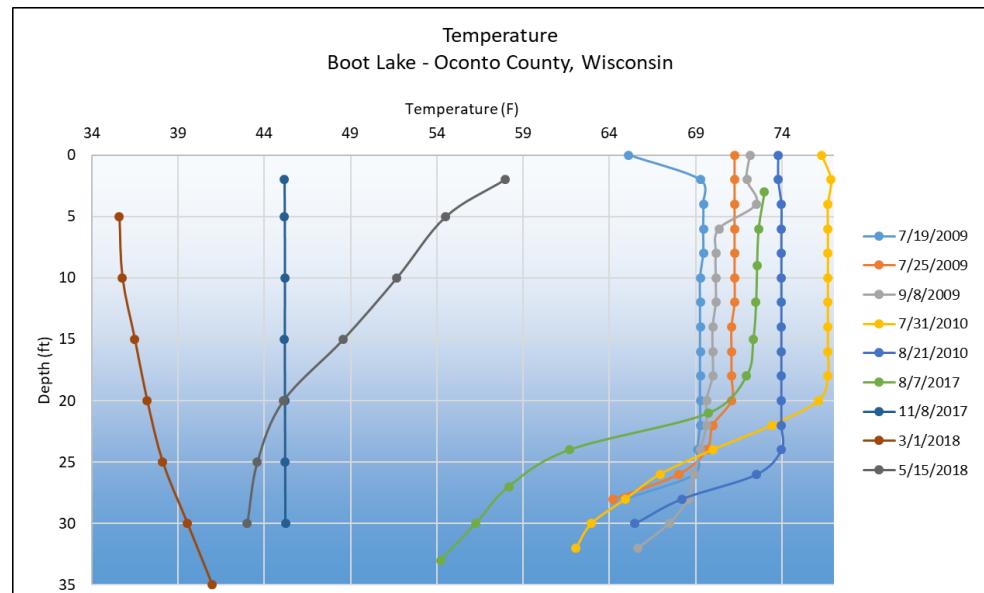
Lake water **temperature** has a significant impact on water chemistry, spatial distribution of fish, microbial growth and oxygen content.

- The temperature gradient in Boot Lake shows a clear thermocline between 20-30 feet during the growing season.

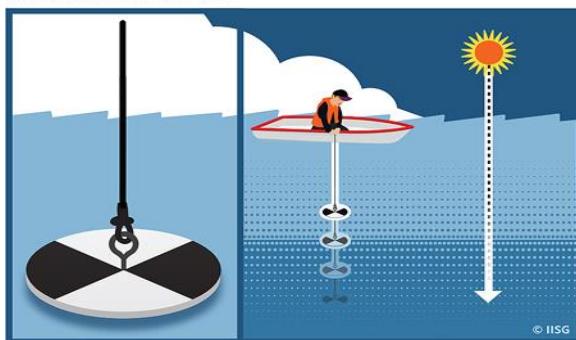
Secchi Disk

Water clarity is a measure of how deep light can penetrate (Secchi depth). Clarity is affected by water color, turbidity (suspended sediment), and algae. Water clarity helps determine where rooted aquatic plants can grow. It is typical for water clarity to vary throughout the year.

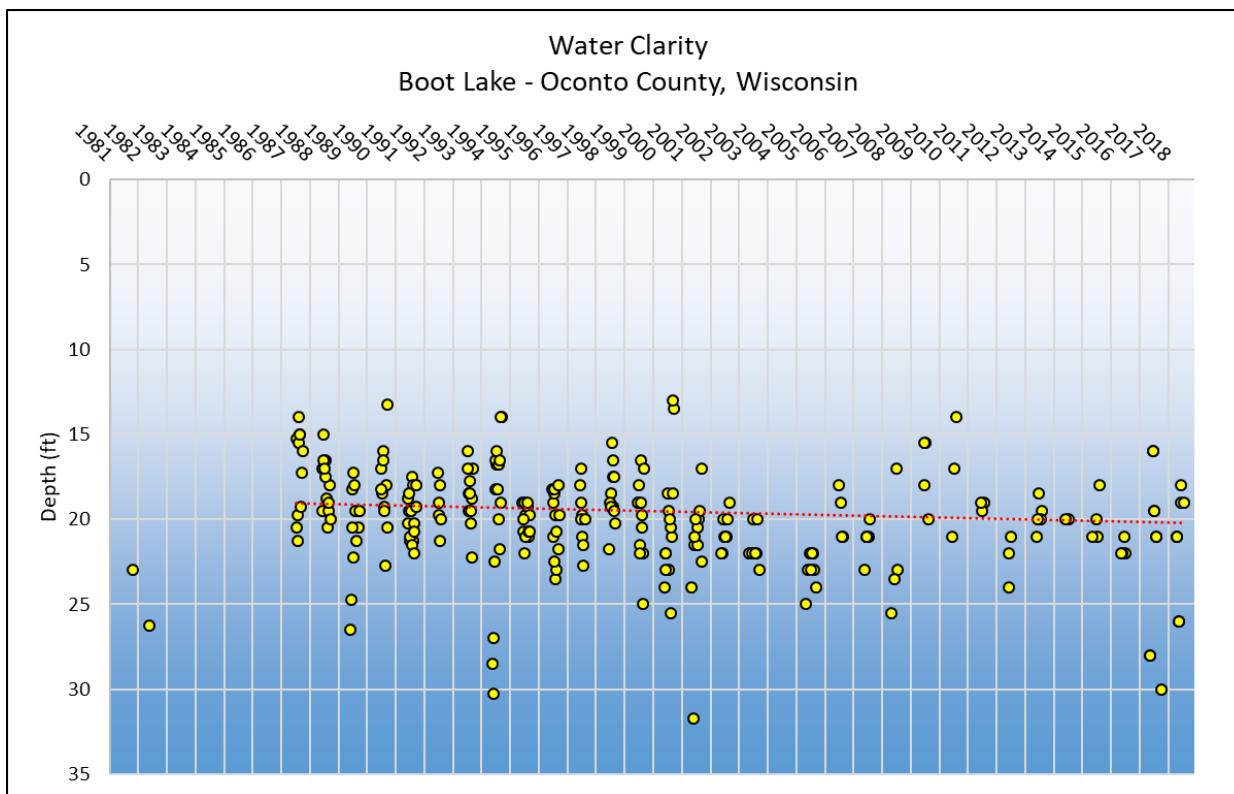
- The graph below shows water clarity measurements taken between April and November. It is typical for water clarity to vary throughout the year.
- During 2017-18, on average, the poorest water clarity in Boot Lake was in July and the best was in June and November. This is consistent with previous observations and demonstrates a slightly increasing trend over the past 30 years.

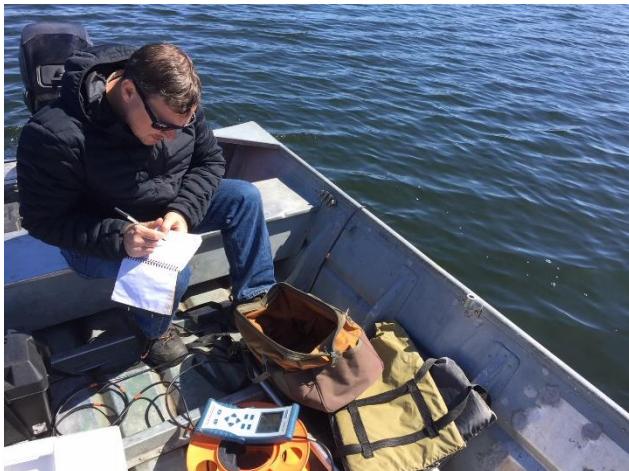
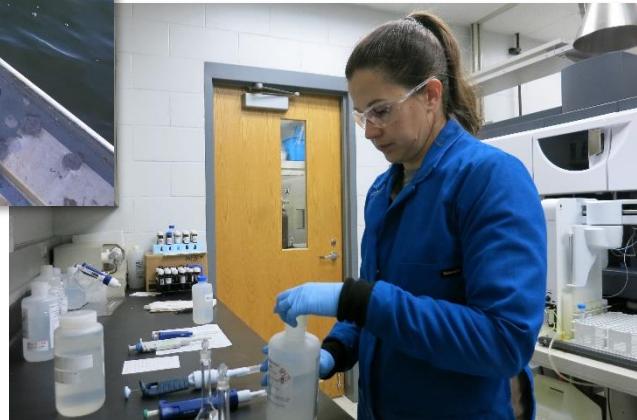
- Concentrations of potassium (0.623 mg/L), chloride (4.7 mg/L) and sodium (2.764 mg/L) were all low. This suggests minimal impact from septic systems, road salt, animal waste and fertilizers.
- DACT, a screening tool to determine if your lake is being impacted by pesticides, was not detected.
- Water in Boot Lake is moderately hard (79 mg/L CaCO₃), having an elevated level of dissolved minerals. Hard water lakes tend to produce more fish and aquatic plants than soft water lakes and have clearer water as the minerals tend to bind with phosphorus making it unavailable to algae blooms.

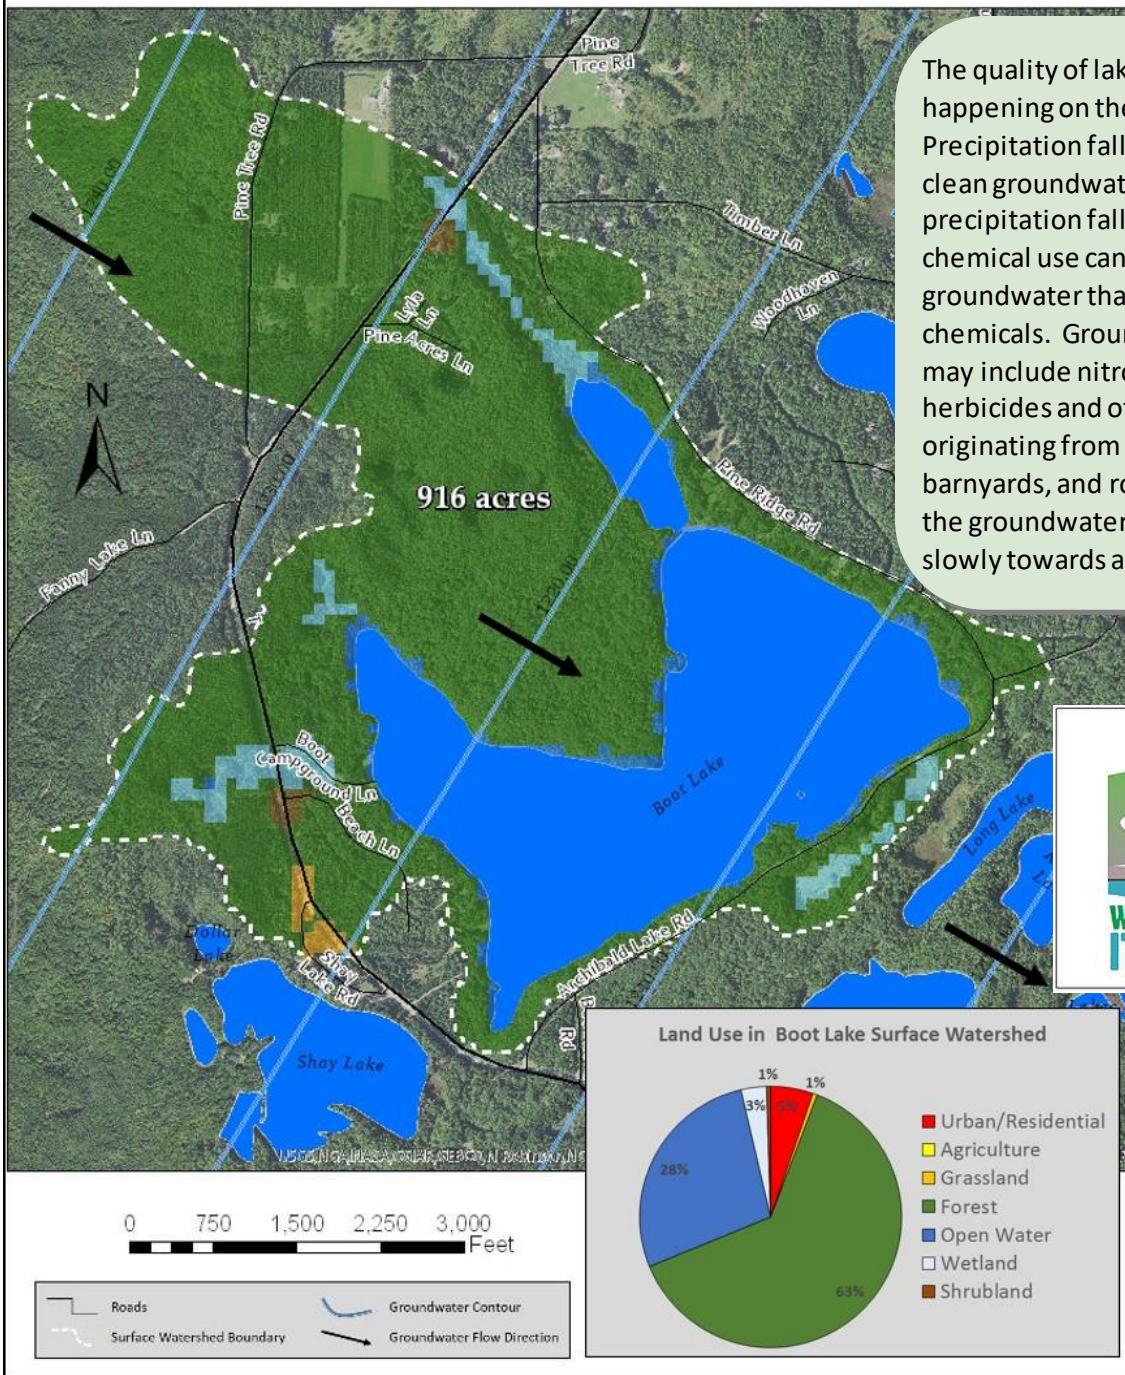
Boot Lake Surface Watershed & Groundwater Flow

Groundwater provides water to lakes in Oconto County throughout the entire year. Hard surfaces on the landscape prevent water from soaking into the ground and becoming groundwater. This results in less water flowing to the lake during snowmelt and rain events. Water that does not infiltrate to groundwater becomes **surface runoff** flowing across the surface of the landscape where it can move sediment and contaminants to the lake from within its watershed.

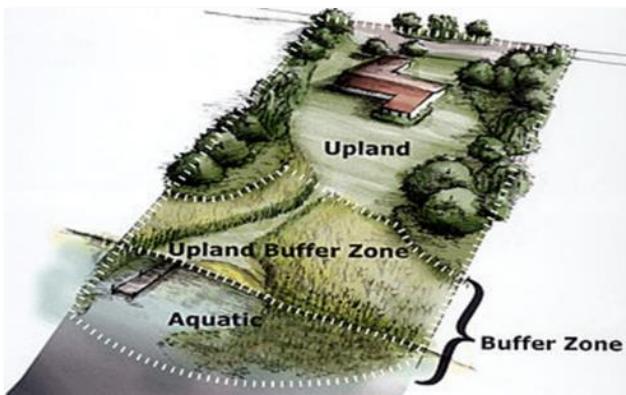
Shorelands around Boot Lake were surveyed in July 2017. Much of Boot Lake's shoreland is healthy, but some stretches are in need of restoration. Restoration would benefit the lake.

Total lakefront footage	No. Riparian lots	Total allowable (NR115) disturbed shoreland-feet	Total allowable (NR115) disturbed shoreland-%	Measured shoreland disturbance-feet	Measured shoreland disturbance-%
23,671	83	2,490	11%	4,302	18%

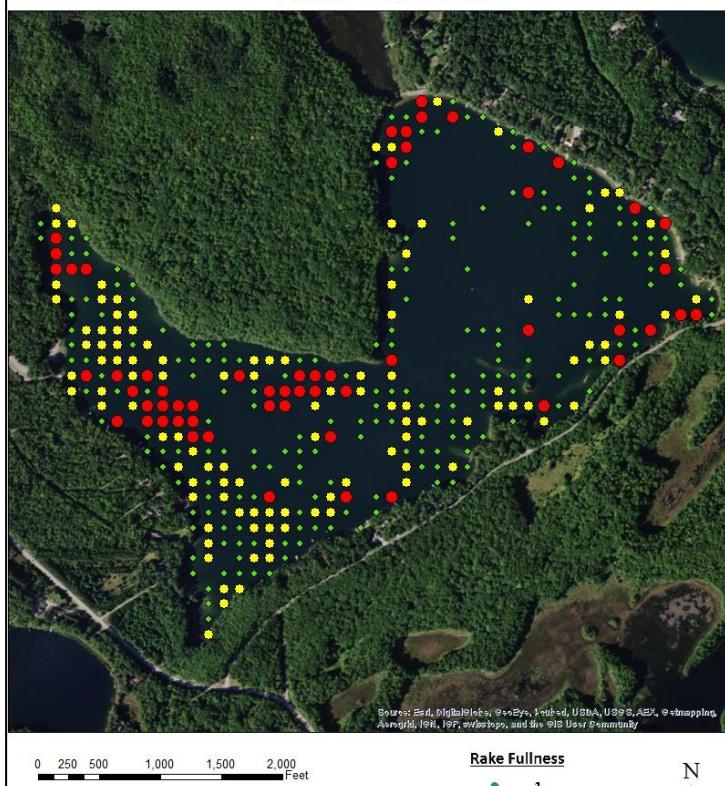
Boot Lake Aquatic Plant Survey 2017:
Rake Fullness

- The aquatic plant community in Boot Lake is characterized by above-average diversity of plant species when compared to other lakes in the Oconto County Lakes Project, with a total of 31 species in the 2017 survey.
- During the 2017 aquatic plant survey of Boot Lake, 57% of the sites had vegetative growth. The maximum depth of vegetation was 37 feet.
- The most frequently encountered plant species were nitella (40%), fern pondweed (29%), and chara (27%). All three species are native to Wisconsin.
- No invasive species were observed.

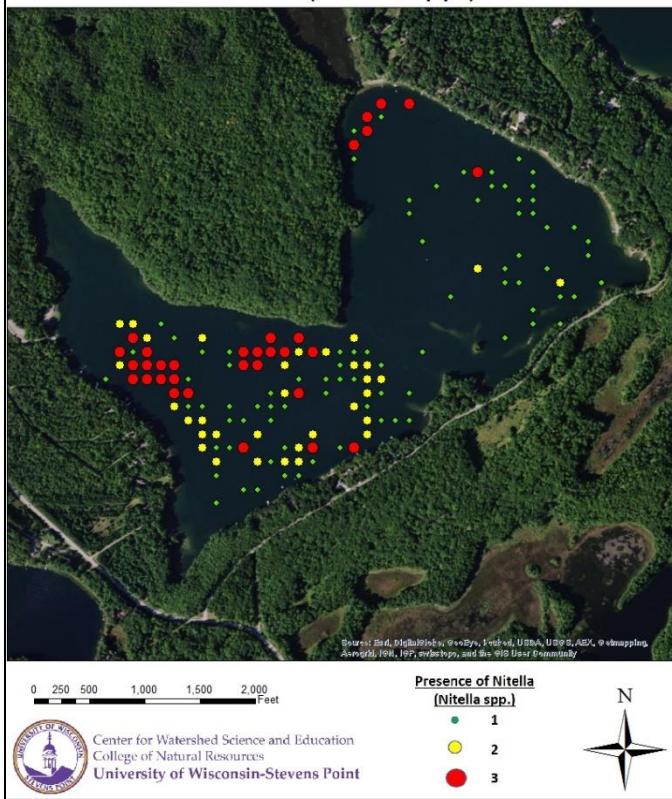
Boot Lake Aquatic Plant Survey 2017: Nitella (Nitella spp.)

Nitella is a macroalgae that similarly grows along lake bottoms and can benefit a lake by filtering nutrients from water and preventing establishment of invasive species.

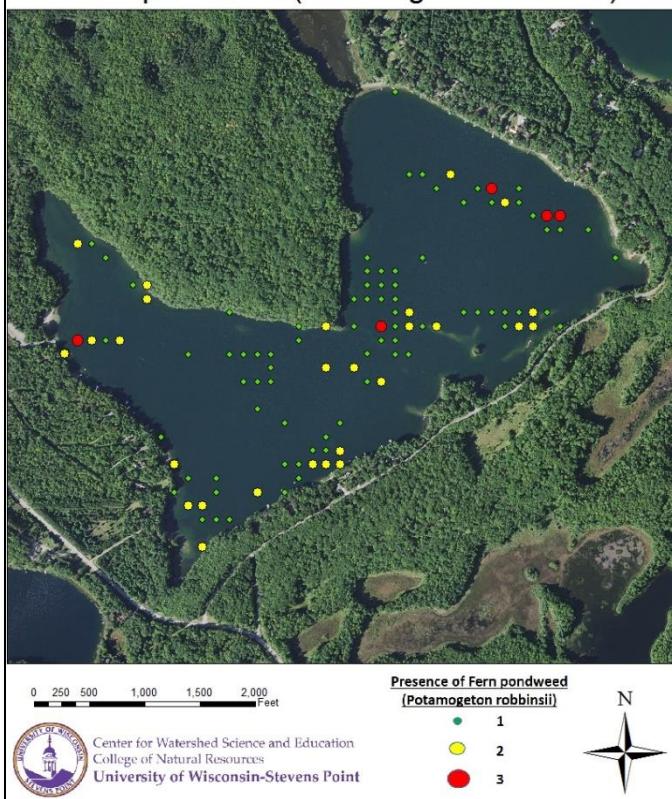
Boot Lake Aquatic Plant Survey 2017: Fern pondweed (Potamogeton robbinsii)

Fern pondweed, or Robbins pondweed, has glossy, finely toothed leaves appearing as whorls near the end of stems. Also known as the water-nymph, the whole plant is eaten by waterfowl and provides shelter for small fish and insects.

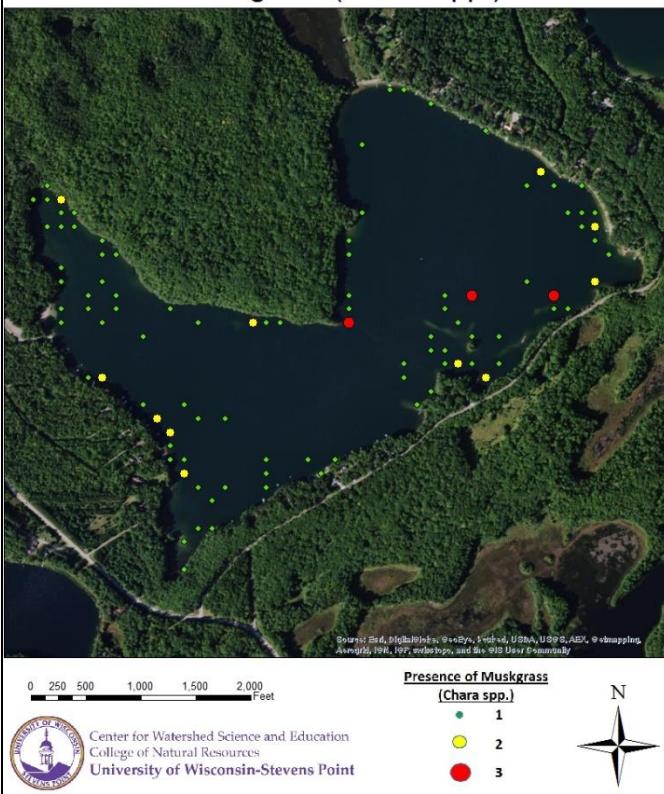
Boot Lake Aquatic Plant Survey 2017: Muskgass (Chara spp.)

Like nitella, **Chara** is a type of macro algae that grows attached to muddy lake bottoms and has a musky odor. Muskgass, as it is known, filters the lake water and is helpful in preventing the establishment of invasive species.
