Oconto County Lakes Project

GRINDLE LAKE STUDY SUMMARY REPORT 2019

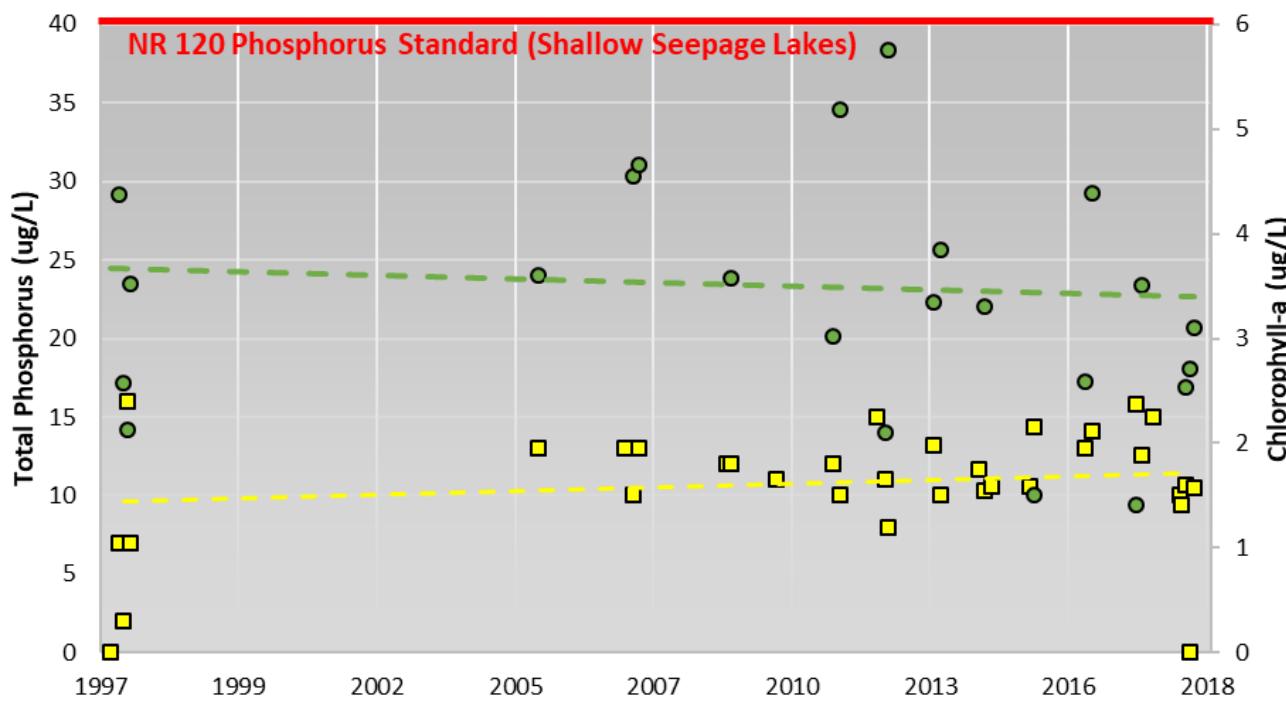
Total Phosphorus & Chlorophyll-a
Grindle Lake - Oconto County, Wisconsin

- Total Phosphorus was consistently below the standard of 40 ug/L for shallow seepage lakes during the two-year study. The 20-year trend is slightly increasing.
- Inorganic nitrogen remained below the threshold of 0.3 ug/L when algal blooms increase.
- Chlorophyll-a remained below 6 ug/L and appears stable over the long term.

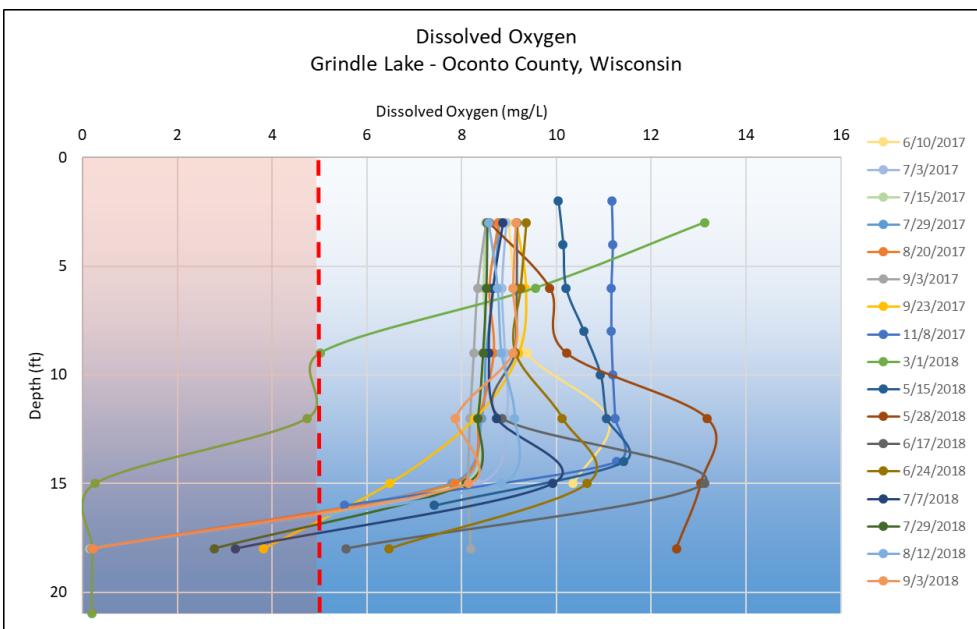
- During most of the year, sufficient oxygen is available in Grindle Lake throughout the water column. Oxygen is depleted during the winter while the lake is ice covered, however, with the only the upper 9 feet having enough to support fish.
- Bumps in dissolved oxygen concentrations at 10-15 feet suggest mild algal activity.

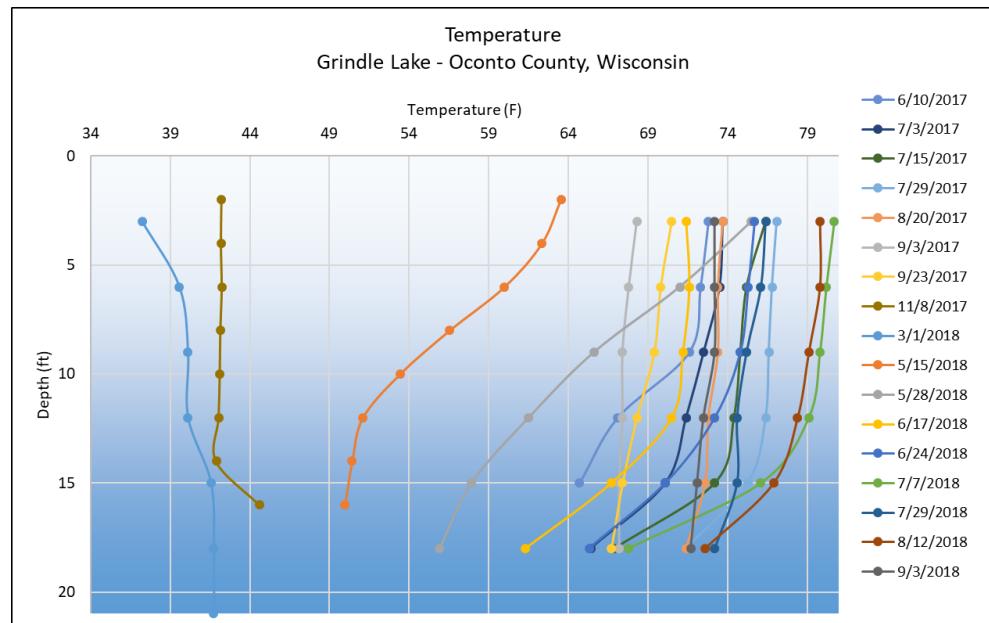
Lake water **temperature** has a significant impact on water chemistry, spatial distribution of fish, microbial growth and oxygen content.

- The temperature gradient in Grindle Lake is relatively uniform from top to bottom most of the year, typical of a shallow, mixed lake.

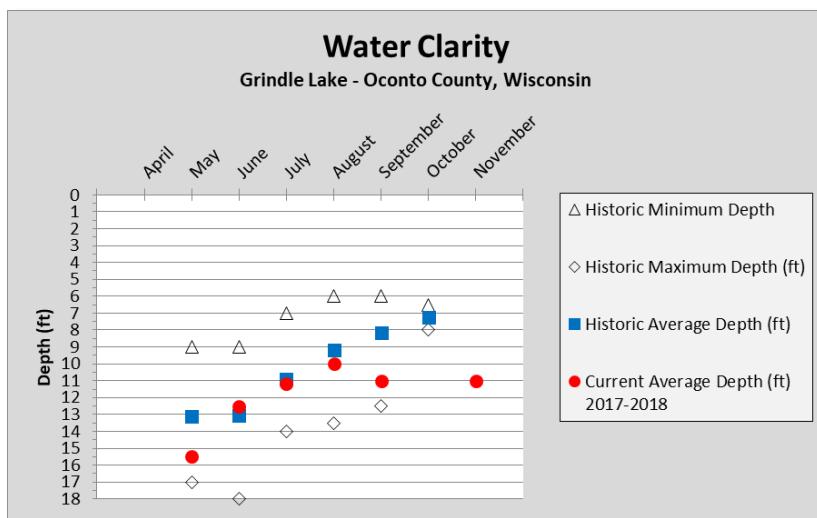
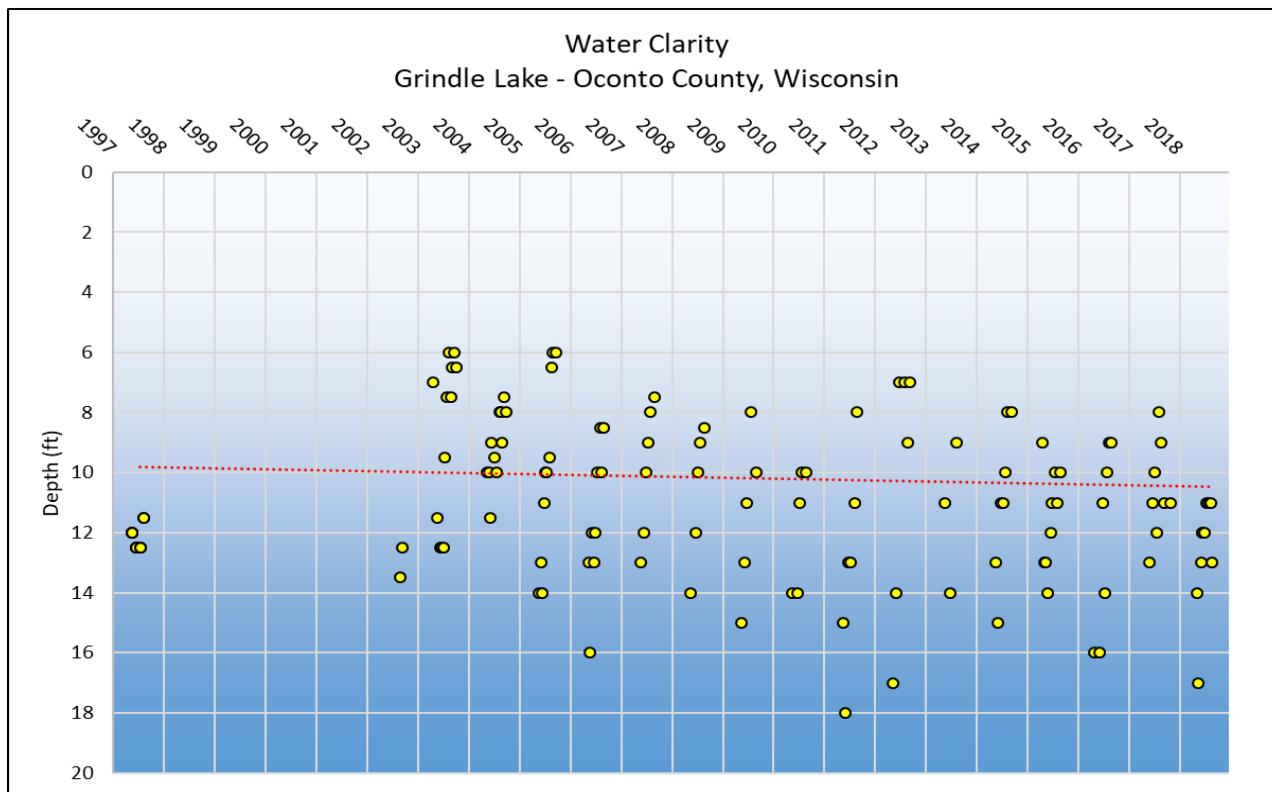
- The graph below shows water clarity measurements taken between April and November. It is typical for water clarity to vary throughout the year.
- During 2017-18, on average, the poorest water clarity in Grindle Lake was in August and the best was in May. This is consistent with previous observations and demonstrates a slightly increasing trend over the past 20 years.

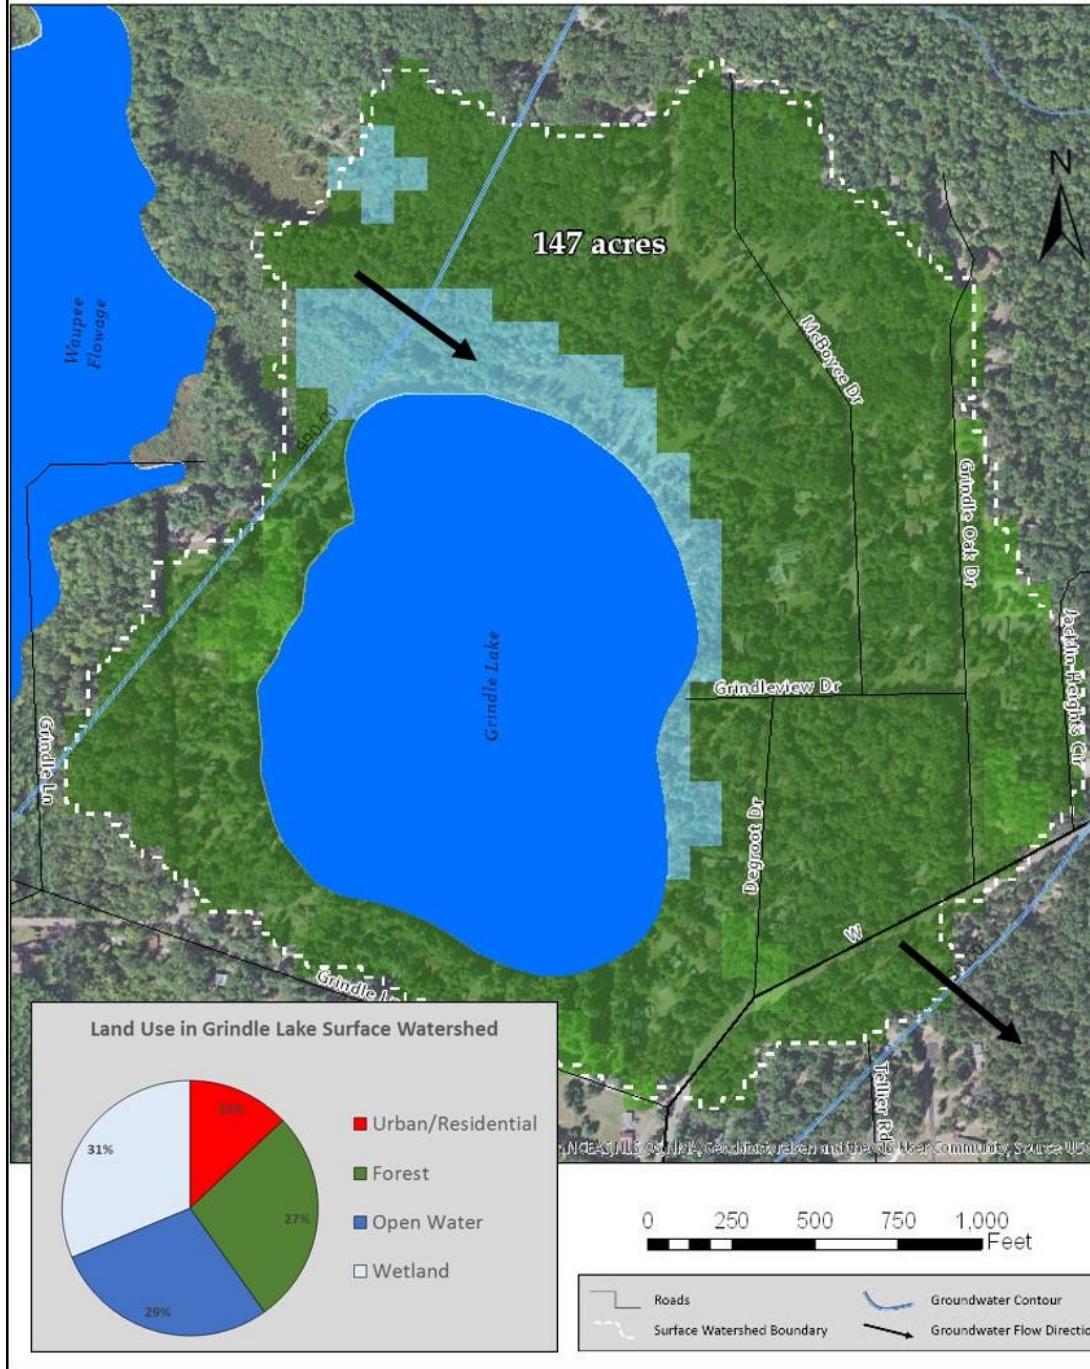
Grindle Lake Surface Watershed & Groundwater Flow

Groundwater provides water to lakes in Oconto County throughout the entire year. Hard surfaces on the landscape prevent water from soaking into the ground and becoming groundwater. This results in less water flowing to the lake during snowmelt and rain events. Water that does not infiltrate to groundwater becomes **surface runoff** flowing across the surface of the landscape where it can move sediment and contaminants to the lake from within its watershed.

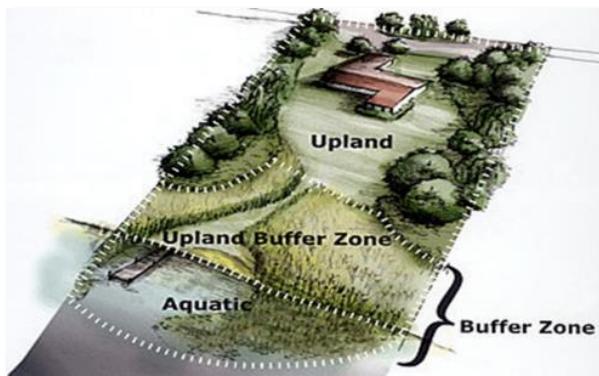
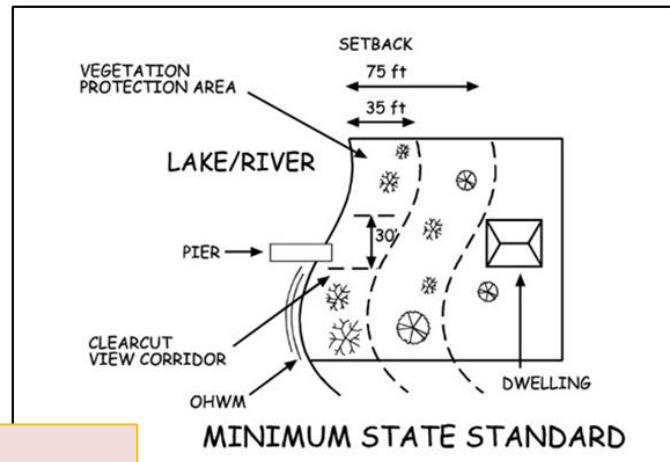
Shorelands around Grindle Lake were surveyed in August 2017. Much of Grindle Lake's shoreland is healthy, but some stretches are in need of restoration. Restoration would benefit the lake.

Total lakefront footage	No. Riparian lots	Total allowable (NR115) disturbed shoreland-feet	Total allowable (NR115) disturbed shoreland-%	Measured shoreland disturbance-feet	Measured shoreland disturbance-%
5,197	50	1,500	29%	2,870	55%

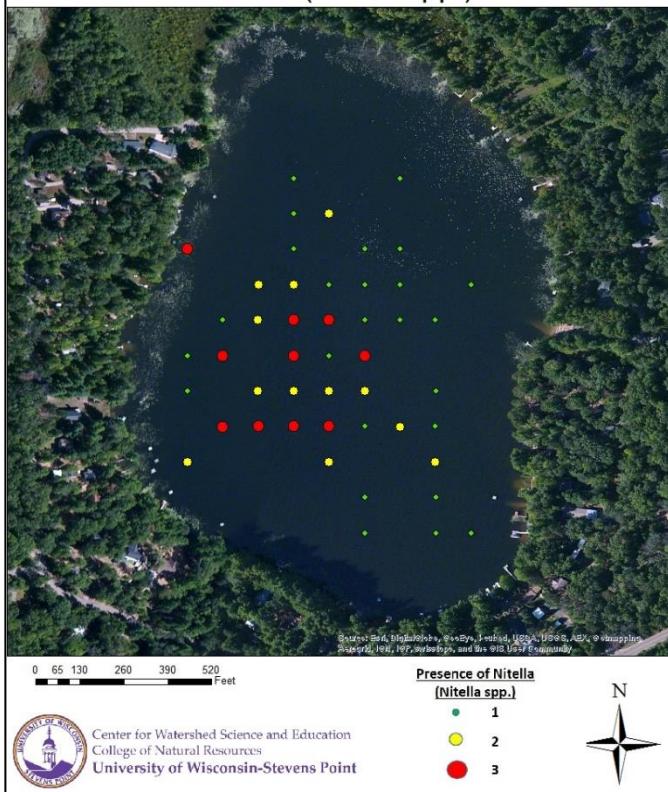
Grindle Lake Aquatic Plant Survey 2017: Nitella (Nitella spp.)

Nitella is a macroalgae that similarly grows along lake bottoms and can benefit a lake by filtering nutrients from water and preventing establishment of invasive species.

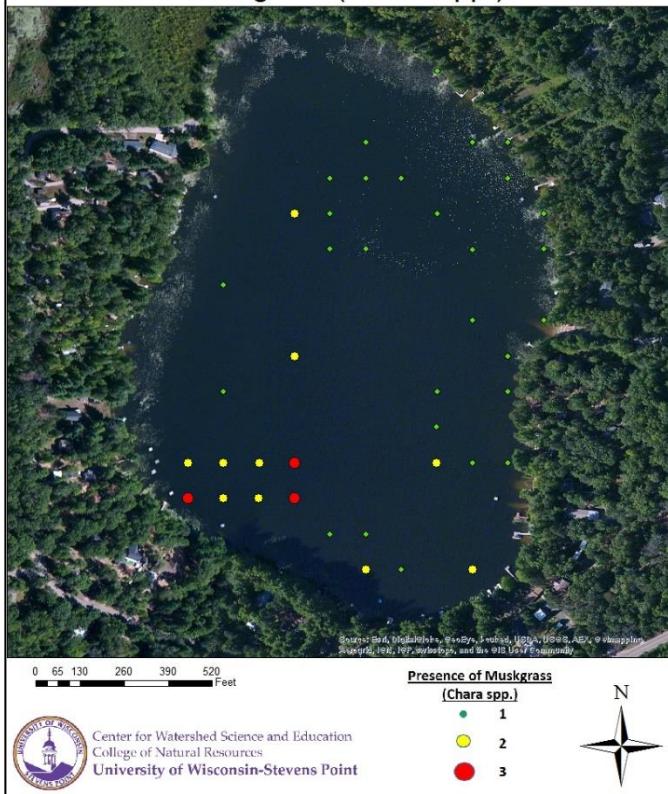
Grindle Lake Aquatic Plant Survey 2017: Muskgass (Chara spp.)

Like nitella, **Chara** is a type of macro algae that grows attached to muddy lake bottoms and has a musky odor. Muskgass, as it is known, filters the lake water and is helpful in preventing the establishment of invasive species.

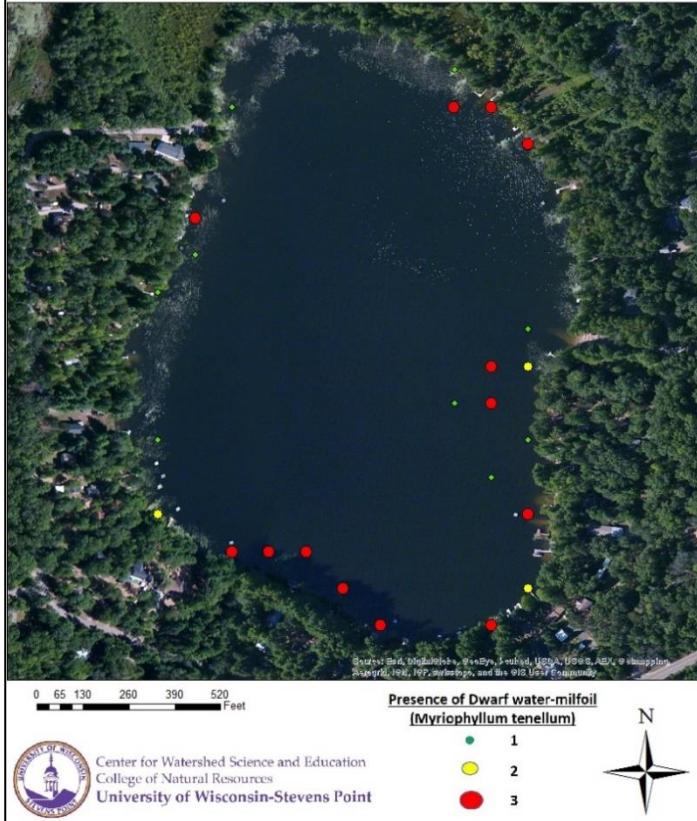
Grindle Lake Aquatic Plant Survey 2017: Dwarf water-milfoil (*Myriophyllum tenellum*)

Dwarf water-milfoil is a very sensitive species with little tolerance for disturbance and, thus, is an indicator of a high-quality, natural environment. It grows in dense clusters of thin, unbranched stems from rhizomes in sandy soil. The fruit is eaten by waterfowl that often rises above the water surface in shallow areas.
