Oconto County Lakes Project

LAKE JOHN STUDY

SUMMARY REPORT

2019

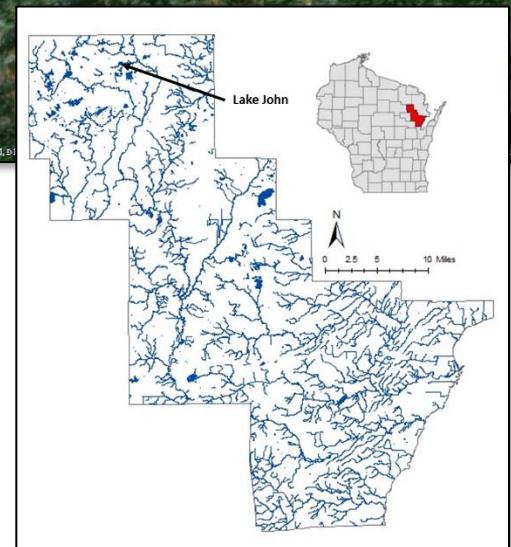
Township of Lakewood

East of Highway 32

Surface Area: 99 acres

Maximum Depth: 23 feet

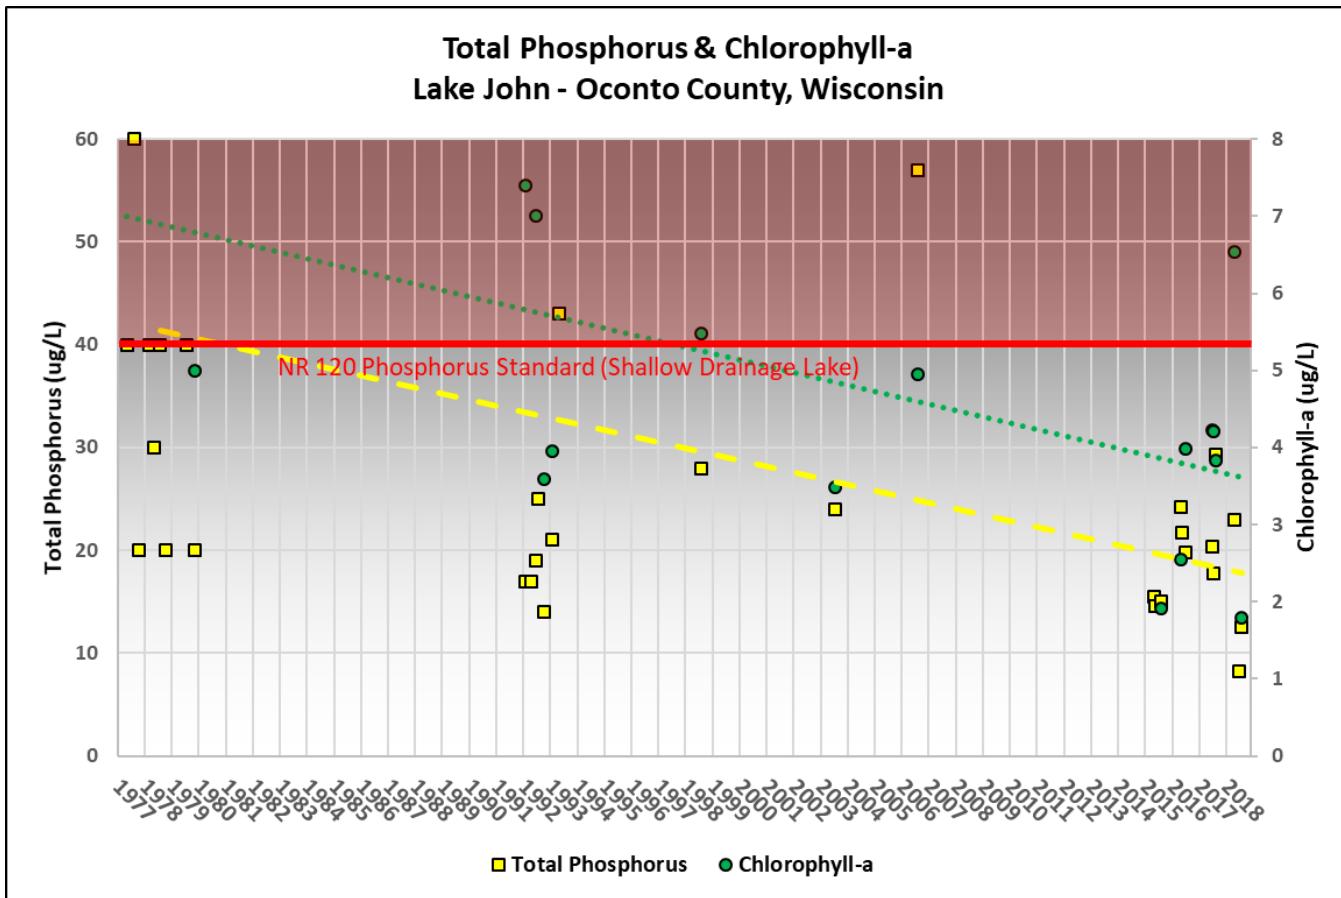
- Total phosphorus was consistently below the Wisconsin State phosphorus standard of 40 ug/L for shallow drainage lakes during the two-year study. The 14-year trend is decreasing (based on July data).
- Inorganic nitrogen was very low (0.03 mg/L), well below the threshold of 0.3 mg/L when algal blooms increase.
- Chlorophyll-a, an indirect measure of algae, remained consistently below the threshold of 6 ug/L and appears stable over the long term.

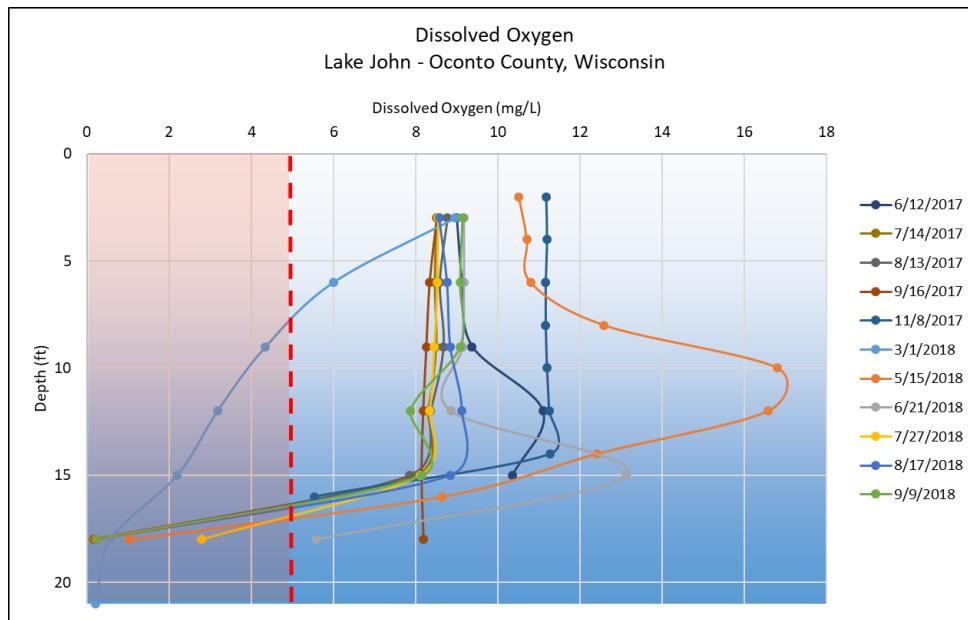
- During most of the year, sufficient oxygen is available in Lake John throughout the water column. Oxygen is depleted during the winter while the lake is ice covered, however, with the only the upper 7 feet having enough to support fish.
- Bumps in dissolved oxygen concentrations at 9-15 feet suggest mild algal activity.

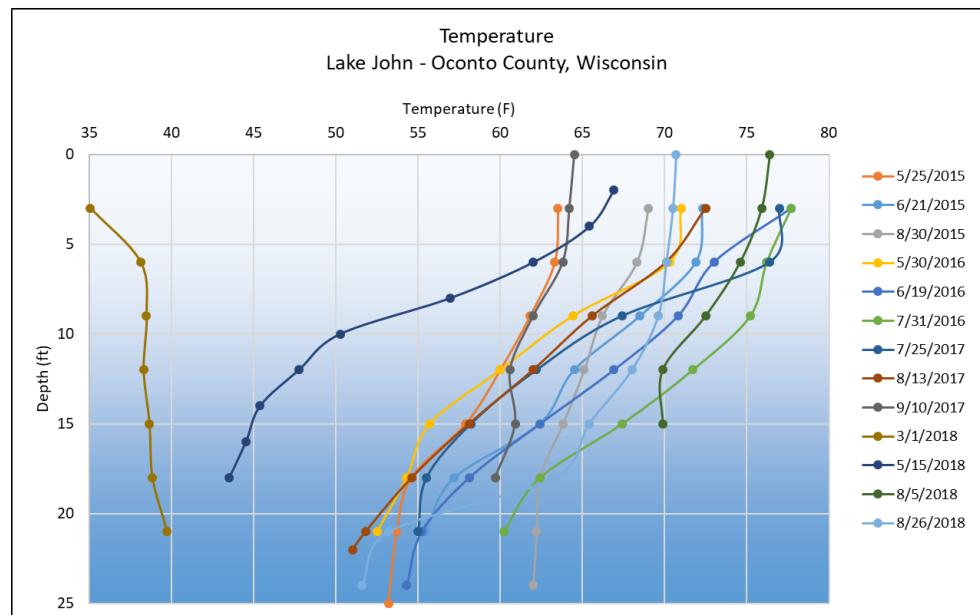
- The temperature gradient in Lake John is relatively straight most of the year, typical of a shallow, mixed lake.

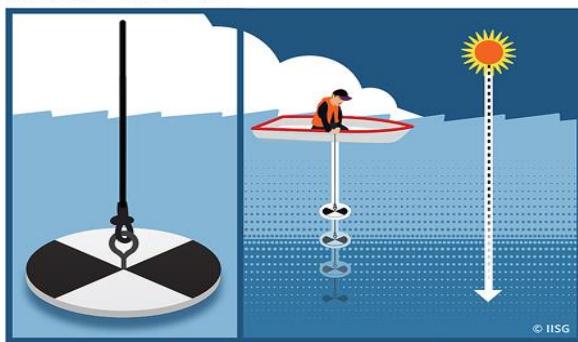
Secchi Disk

Water clarity is a measure of how deep light can penetrate (Secchi depth). Clarity is affected by water color, turbidity (suspended sediment), and algae. Water clarity helps determine where rooted aquatic plants can grow. It is typical for water clarity to vary throughout the year.

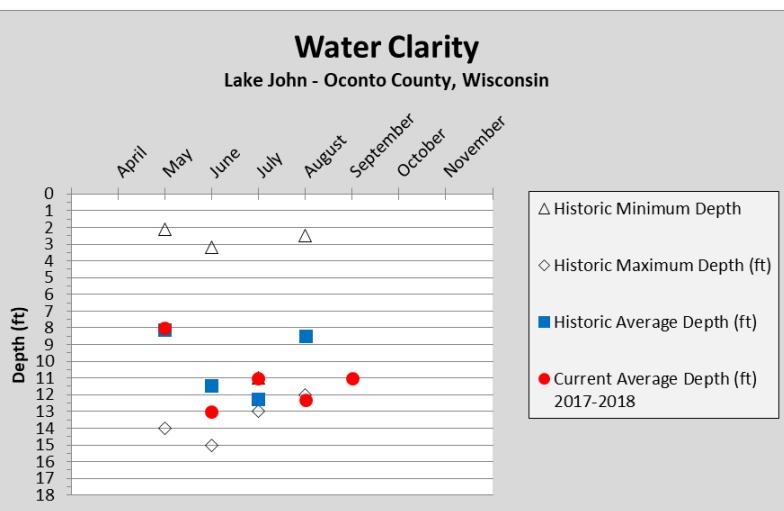
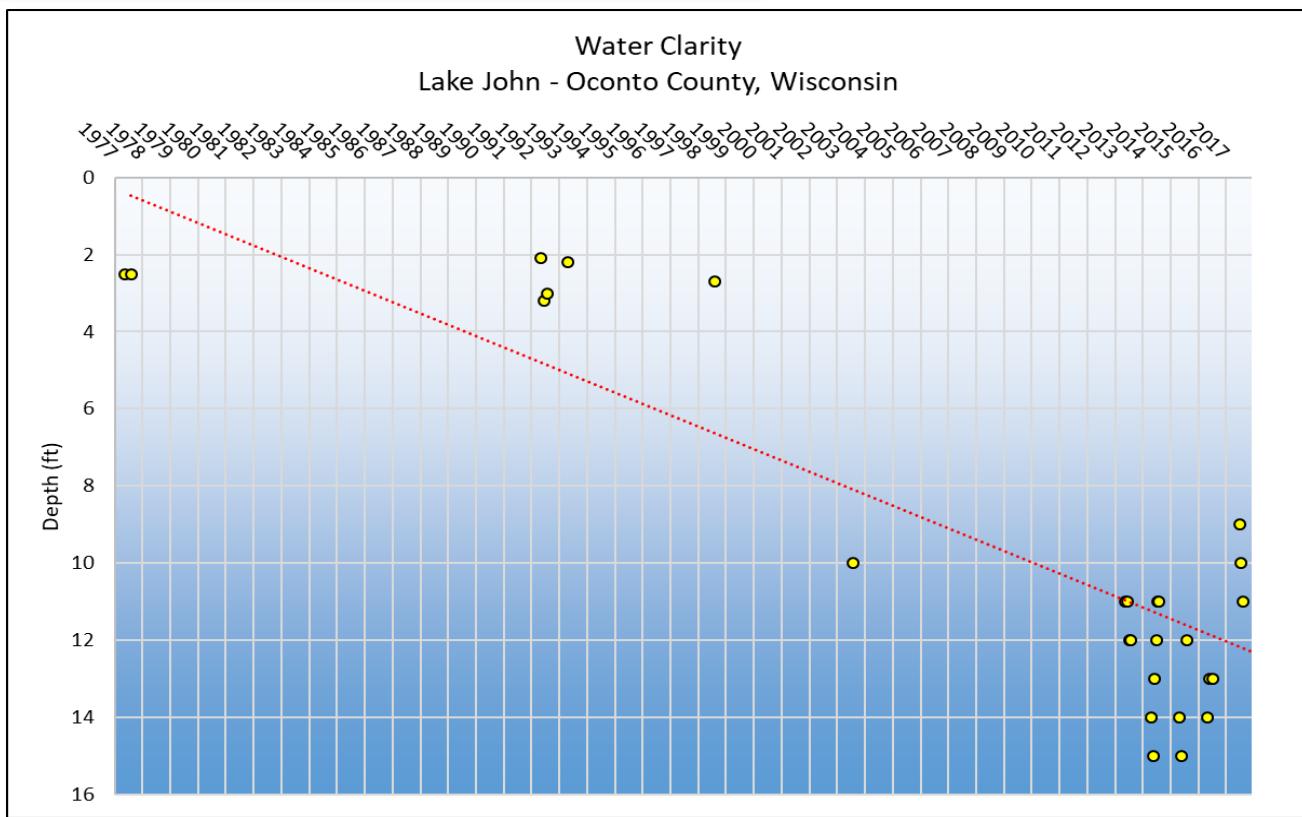
- The graph below shows water clarity measurements taken between May and September. It is typical for water clarity to vary throughout the year.
- During 2017-18, on average, the poorest water clarity in Lake John was in June and the best was in September. This is consistent with previous observations and demonstrates a slightly increasing trend over the past 14 years.

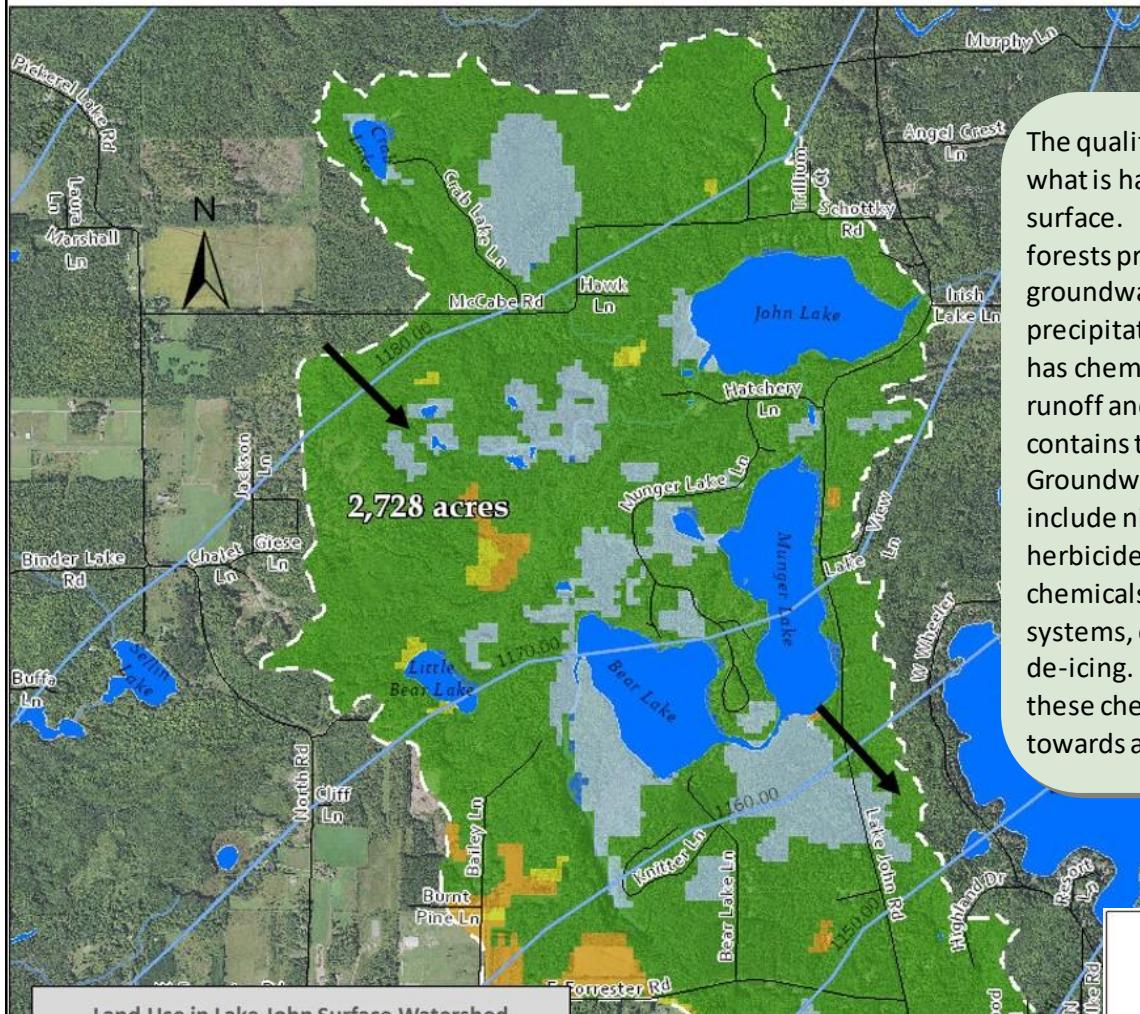
Lake John Surface Watershed & Groundwater Flow

Groundwater provides water to lakes in Oconto County throughout the entire year. Hard surfaces on the landscape prevent water from soaking into the ground and becoming groundwater. This results in less water flowing to the lake during snowmelt and rain events. Water that does not infiltrate to groundwater becomes **surface runoff** flowing across the surface of the landscape where it can move sediment and contaminants to the lake from within its watershed.

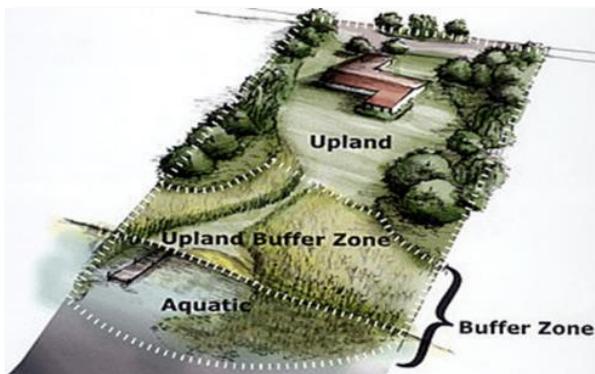
Shorelands around Lake John were surveyed in July 2017. Much of Lake John's shoreland is healthy, but some stretches are in need of restoration. Restoration would benefit the lake.

Total lakefront footage	No. Riparian lots	Total allowable (NR115) disturbed shoreland-feet	Total allowable (NR115) disturbed shoreland-%	Measured shoreland disturbance-feet	Measured shoreland disturbance-%
10,295	58	1,740	17%	2,049	20%

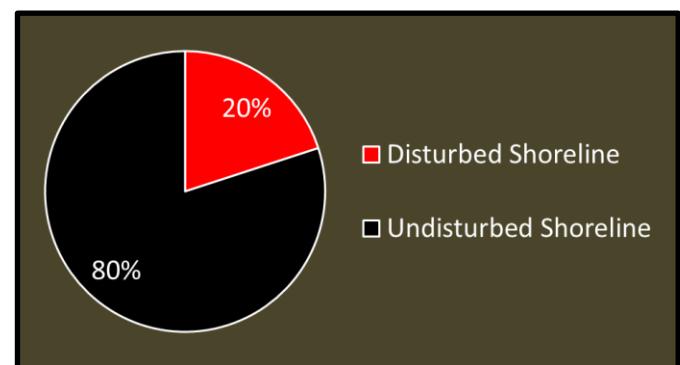
Modifications, Structures, Erosion	Measured Occurrence
Artificial Beach	15 ft
Rip Rap	867 ft
Sea Wall	65 ft
Impervious Surface	0 ft
Mowed Lawn	2,033 ft
Erosion	0 ft
Nonconforming Buildings	
Piers	44
Coarse Woody Habitat	82 logs/mile

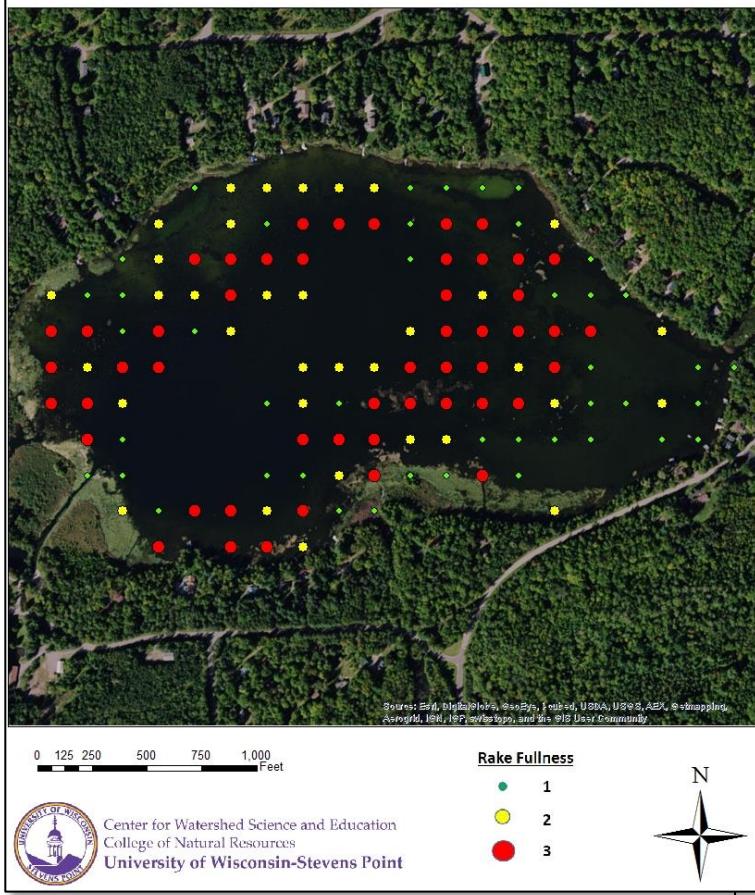
Lake John Aquatic Plant Survey 2015:
Rake Fullness

- The aquatic plant community in Lake John is characterized by an average diversity of plant species when compared to other lakes in the Oconto County Lakes Project, with a total of 21 species in the 2015 survey.
- During the 2015 aquatic plant survey of Lake John, 82% of the sites had vegetative growth. The maximum depth of vegetation was 18 feet.
- The most frequently encountered plant species were chara (65%), northern water-milfoil (54%), coontail (30%), and flat-stem pondweed (30%). All four species are native to Wisconsin.
- No invasive species were observed.

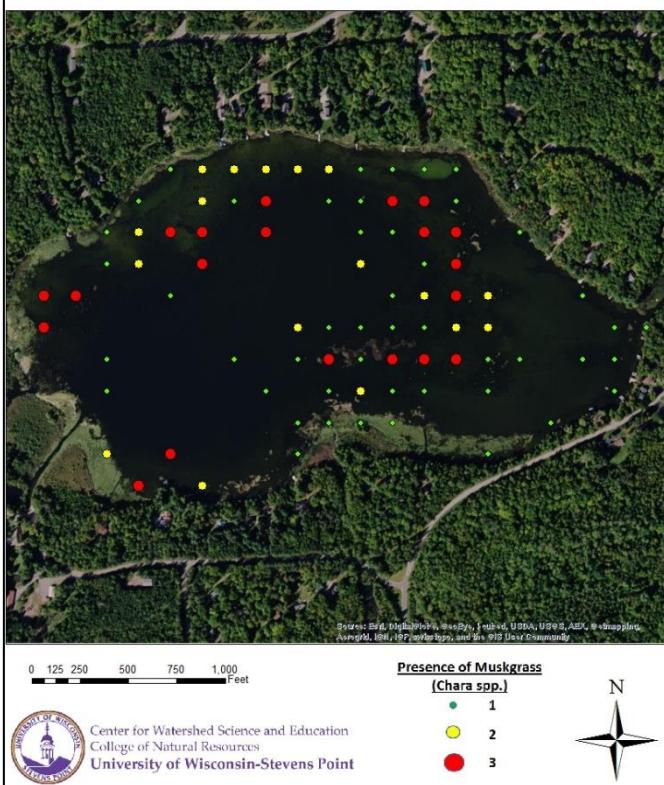
Lake John Aquatic Plant Survey 2015: Muskgass (Chara spp.)

Chara is a type of macro algae that grows attached to muddy lake bottoms and has a musky odor. Muskgass, as it is known, filters the lake water and is helpful in preventing the establishment of invasive species.

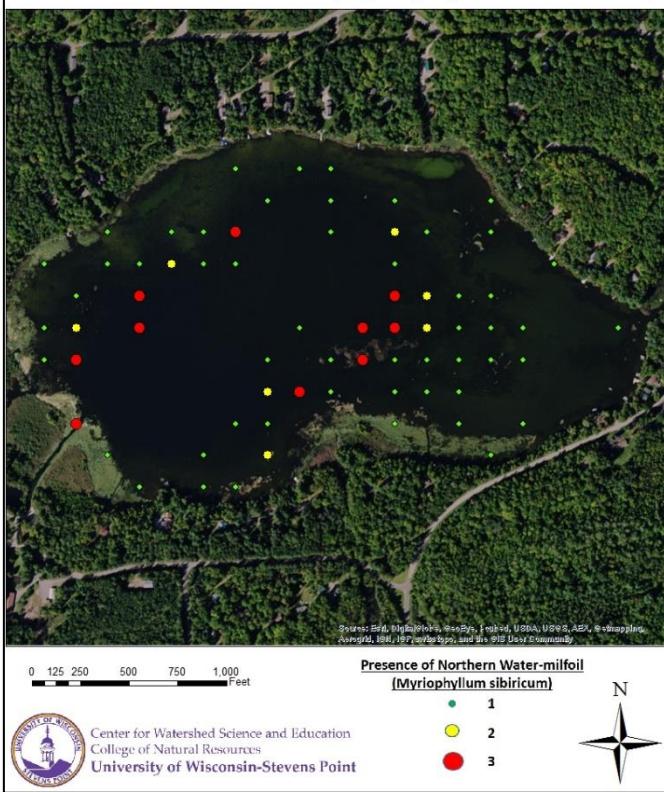
Lake John Aquatic Plant Survey 2015: Northern Water-milfoil (Myriophyllum sibiricum)

Northern water-milfoil is important forage and cover for aquatic animals and an important food source for waterfowl.
