Oconto County Lakes Project

NELLIGAN LAKE STUDY SUMMARY REPORT

2021

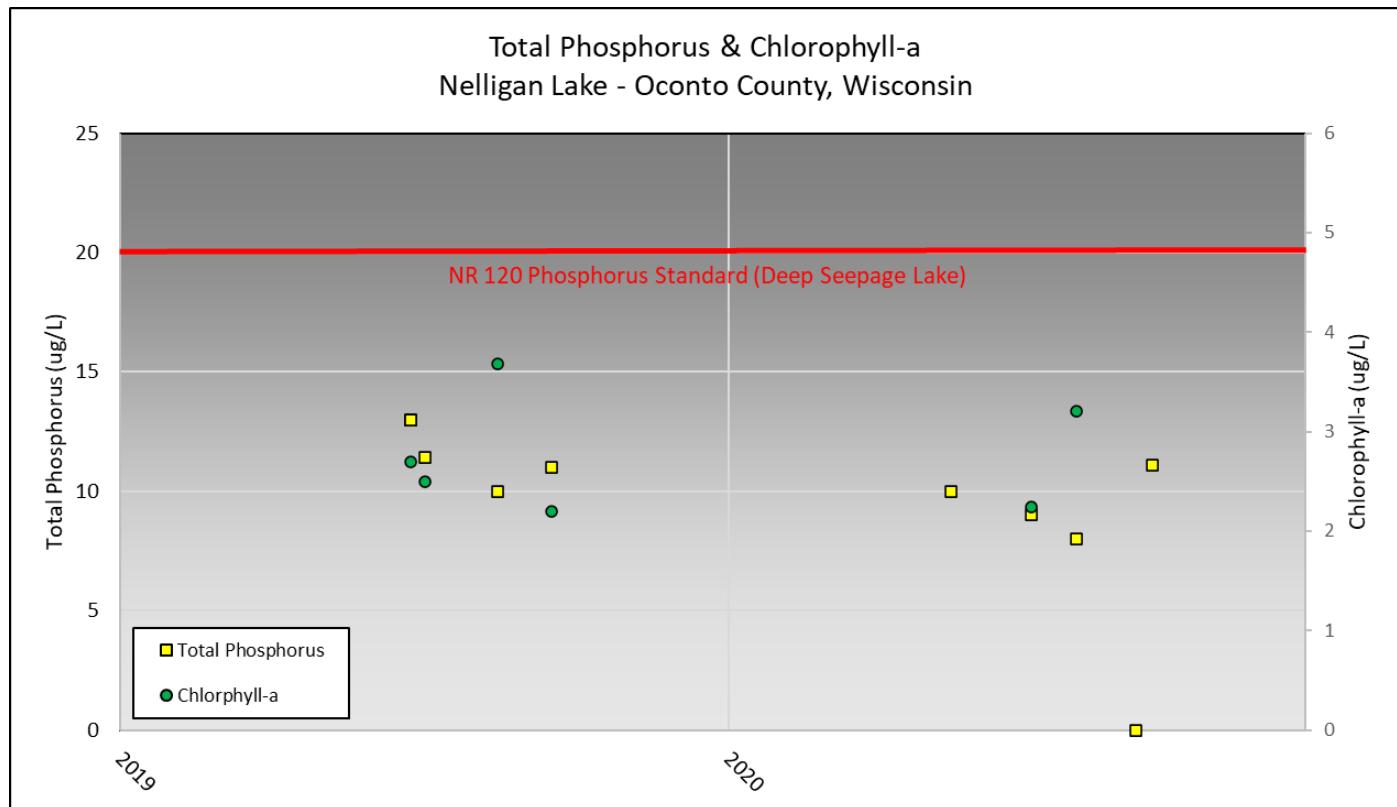
- Total Phosphorus was consistently below the Wisconsin state standard of 20 ug/L for deep seepage lakes during the two-year study. The long-term trend (based on summer samples) suggests a slightly decreasing average concentration.
- Inorganic nitrogen remained below the threshold of 0.3 mg/L when algal blooms increase.
- Chlorophyll-a, an indirect measure of algae, remained below the threshold of 6 ug/L and when nuisance algae blooms become more frequent.

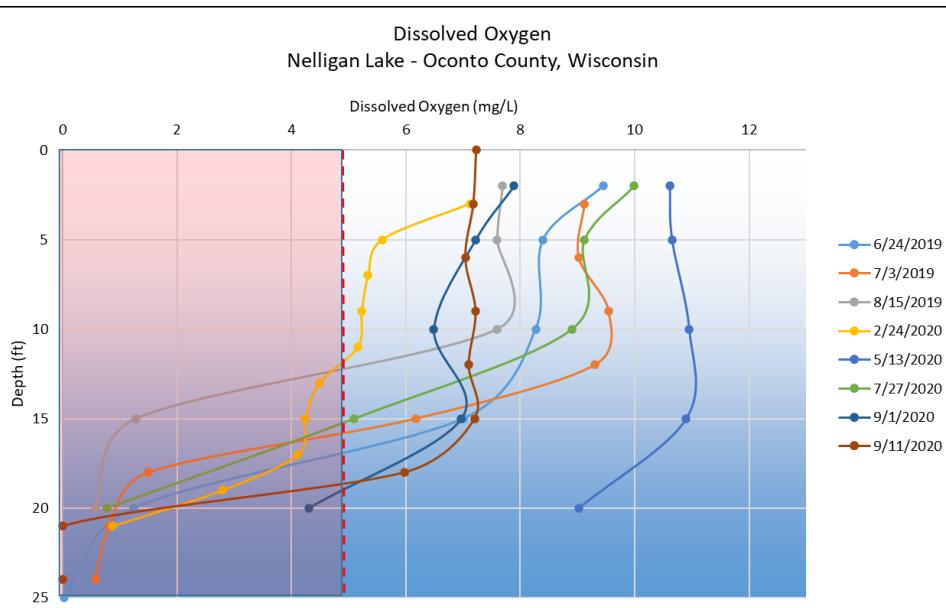
- Sufficient oxygen is available in the water column of Nelligan Lake throughout the year. The lowest concentrations were observed in late winter when only the top 11 feet has enough oxygen to support most fish species.
- Slight increases in dissolved oxygen at depth (~10 feet) are indicative of algae blooms.

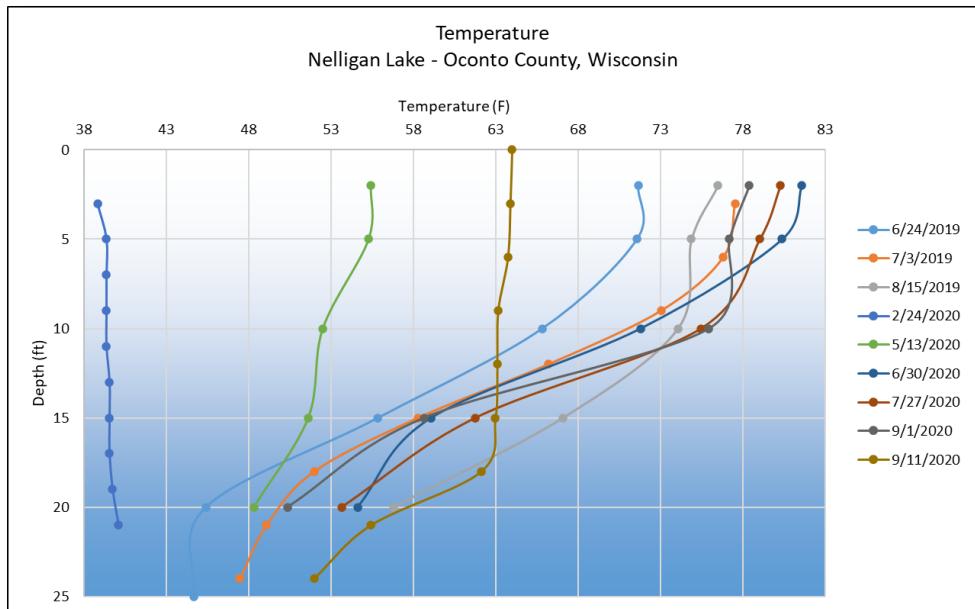
- The temperature gradient in Nelligan Lake weak stratification between 5 and 15 feet during the growing season that separates warmer oxygen-rich water at the top from colder oxygen-poor water below.

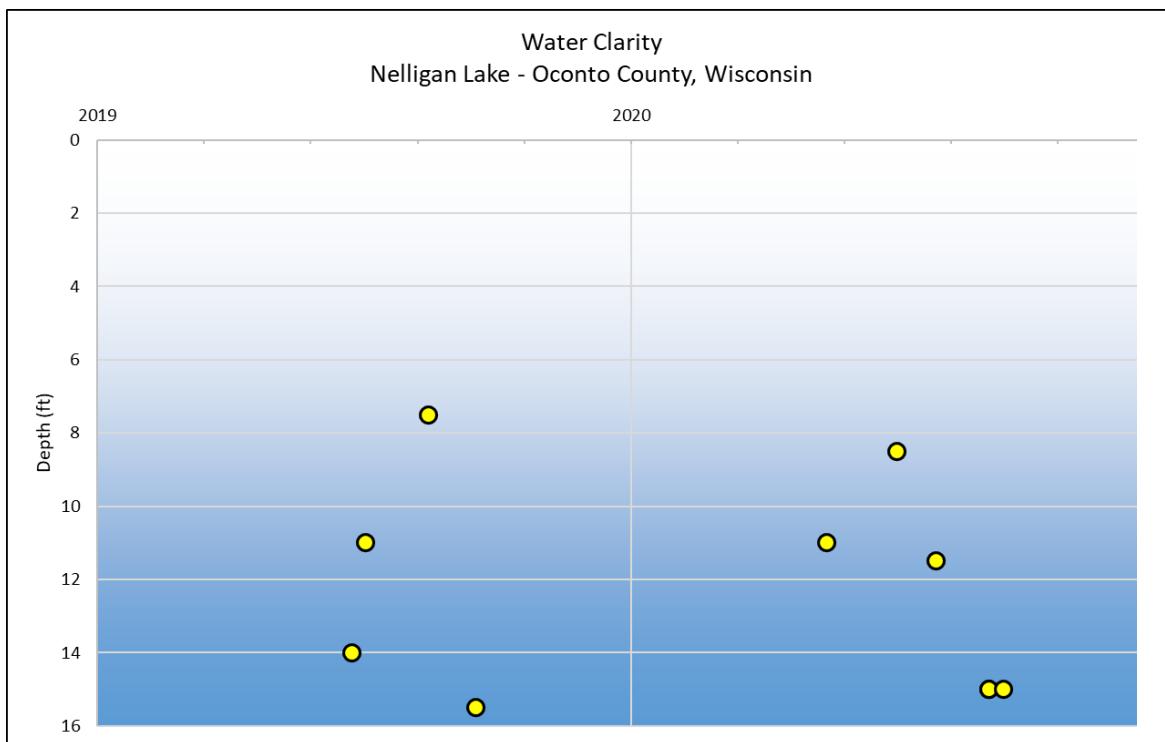
- No data is available for Nelligan Lake beyond the samples collected for this study. Additional monitoring is recommended.
- The graph below shows water clarity measurements taken between April and November.
- During 2019-20, on average, the poorest water clarity in Nelligan Lake was in August and the best

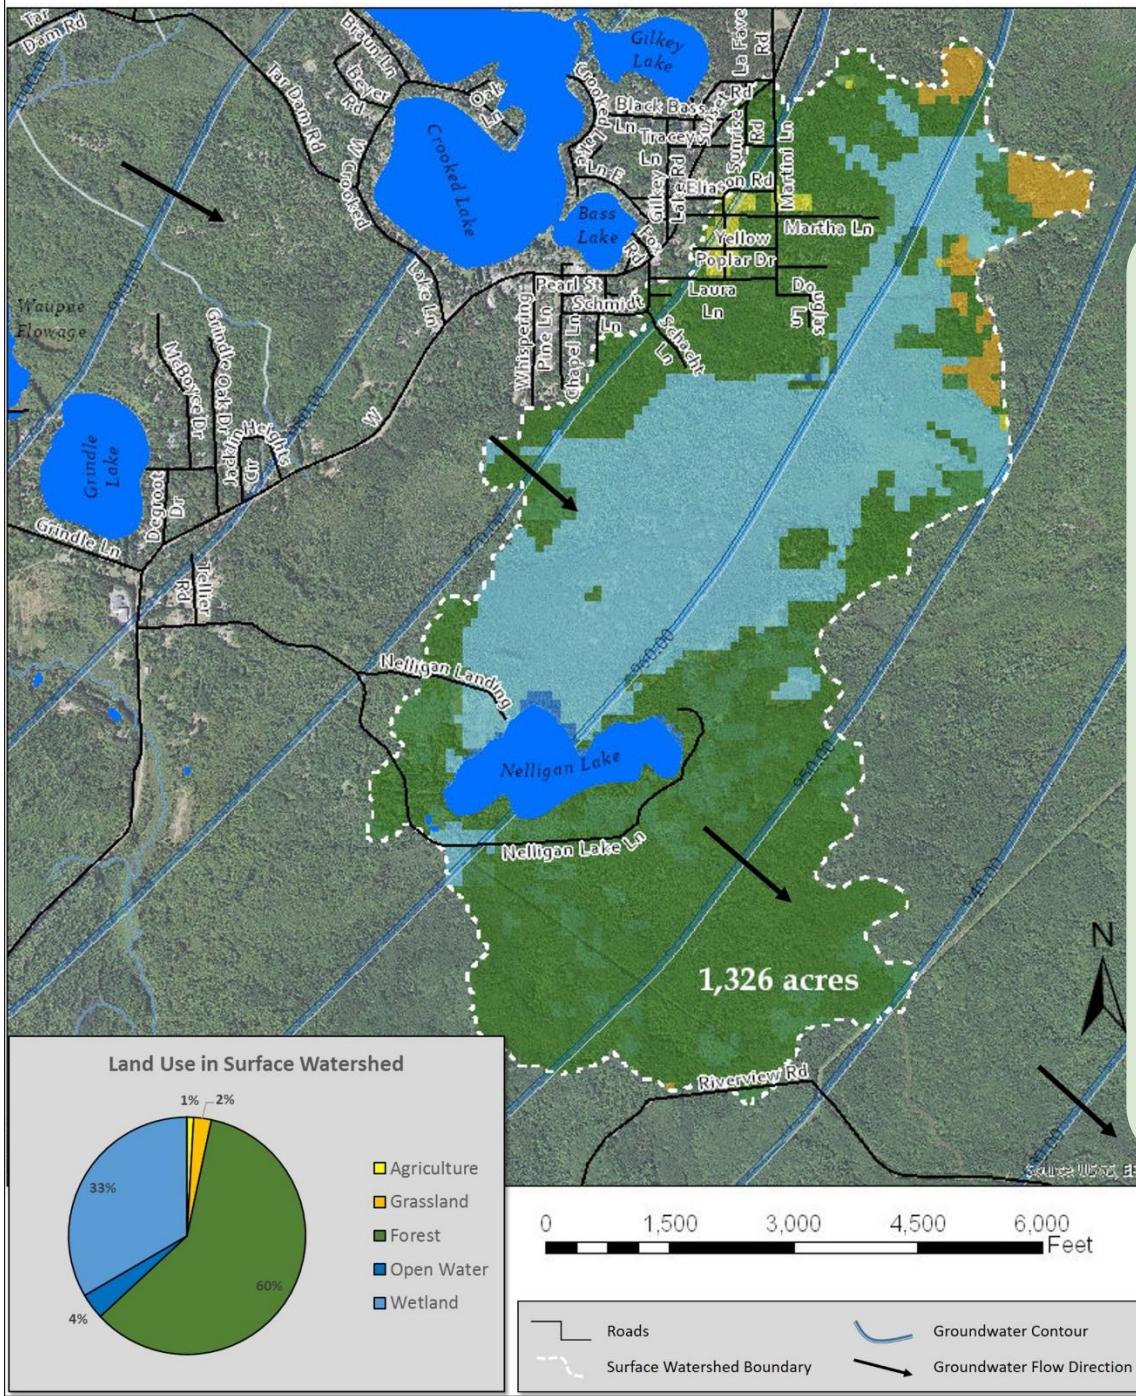
Nelligen Lake Surface Watershed & Groundwater Flow

Groundwater provides water to lakes in Oconto County throughout the entire year. Hard surfaces on the landscape prevent water from soaking into the ground and becoming groundwater. This results in less water flowing to the lake during snowmelt and rain events. Water that does not infiltrate to groundwater becomes **surface runoff** flowing across the surface of the landscape where it can move sediment and contaminants to the lake from within its watershed.

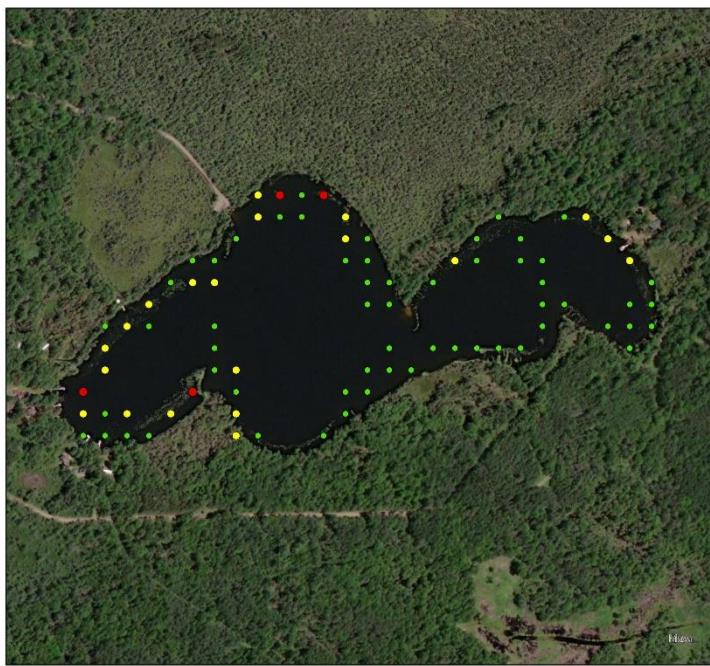
Nelligan Lake Aquatic Plant Survey 2019:
Rake Fullness

- The aquatic plant community in Nelligan Lake is characterized by below average diversity of plant species when compared to other lakes in the Oconto County Lakes Project, with a total of 10 species in the 2019 survey.
- During the 2019 aquatic plant survey of Nelligan Lake, 44% of visited sites had vegetative growth. The maximum depth of vegetation was 18 feet.
- The most frequently encountered plant species were Dwarf watermilfoil (76%), watershield (30%) and small purple bladderwort (23%). All three species are native to Wisconsin.
- No invasive species were observed.

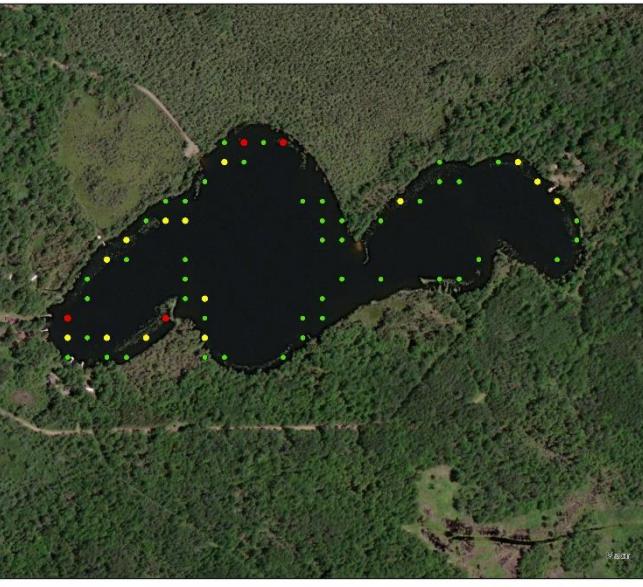
Nelligan Lake Aquatic Plant Survey: 2019 Dwarf water-milfoil (Myriophyllum tenellum)

Presence of Dwarf water-milfoil
(*Myriophyllum tenellum*)

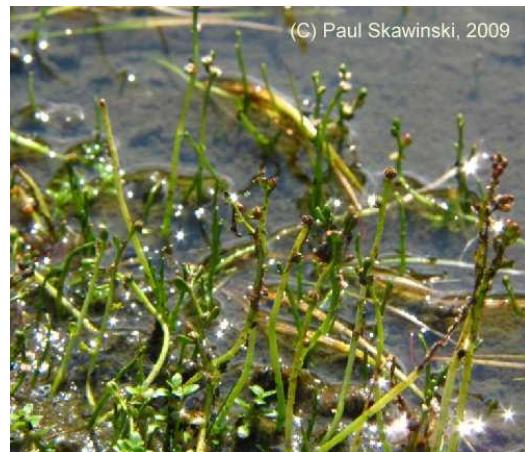
Dwarf water-milfoil is a very sensitive species with little tolerance for disturbance and, thus, is an indicator of a high-quality, natural environment. It grows in dense clusters of thin, unbranched stems from rhizomes in sandy soil. The fruit is eaten by waterfowl that often rises above the water surface in shallow areas.

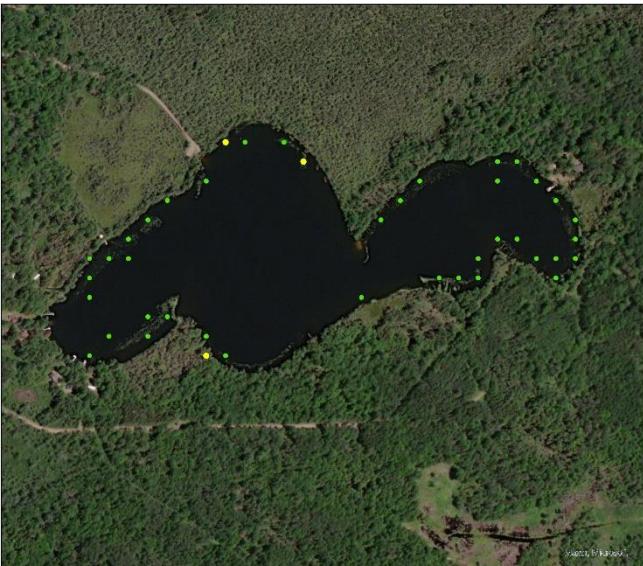
Nelligan Lake Aquatic Plant Survey: 2019 Watershield (Brasenia schreberi)

Presence of Watershield
(*Brasenia schreberi*)

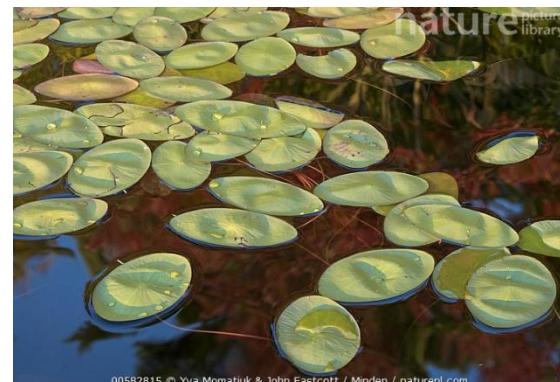
Watershield has floating leaves with their distinctive jelly-like slime on the undersides and stems. While providing shade and shelter for aquatic animals and food for waterfowl, the plants secrete a number of chemicals that kill or inhibit growth of bacteria, algae, and other plants. Native Americans reportedly ate its tuberous roots.

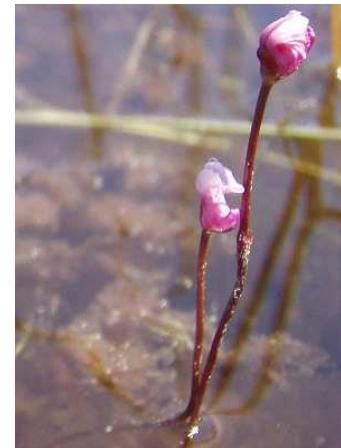
Small purple bladderwort is a sensitive species considered Threatened in Minnesota and of Special Concern in Wisconsin, so it should not be disturbed. A carnivorous plant, it has tiny bladders that capture small invertebrates to be broken down and digested.
