# Oconto County Lakes Project

## PINE RIDGE LAKE STUDY

### SUMMARY REPORT

2022

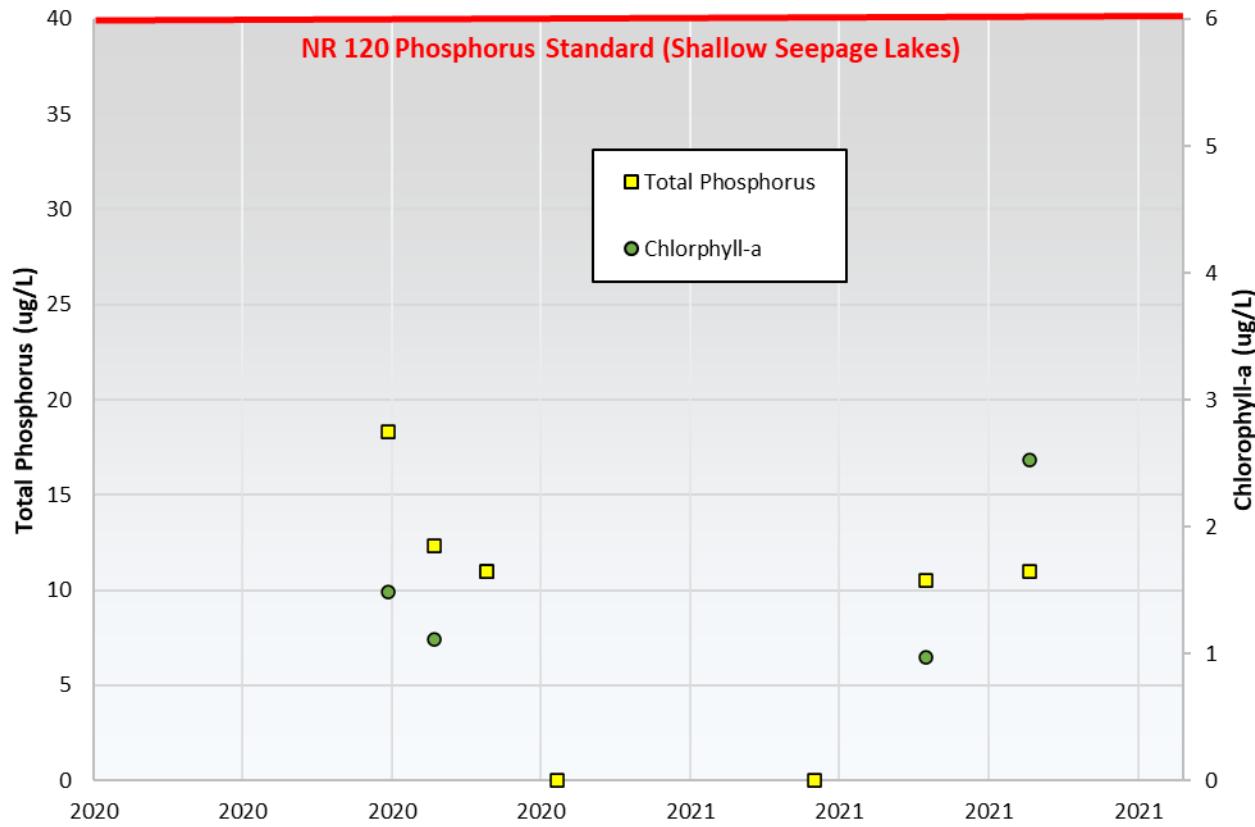
**Total Phosphorus & Chlorophyll-a**  
**Pine Ridge Lake - Oconto County, Wisconsin**

- Total Phosphorus was consistently below the Wisconsin state standard of 40 ug/L for shallow seepage lakes during the two-year study. A trend cannot be established from limited data. Continued monitoring is recommended.
- Inorganic nitrogen remained below the threshold of 0.3 mg/L when algal blooms increase.
- Chlorophyll-a, an indirect measure of algae, remained below the threshold of 6 ug/L.

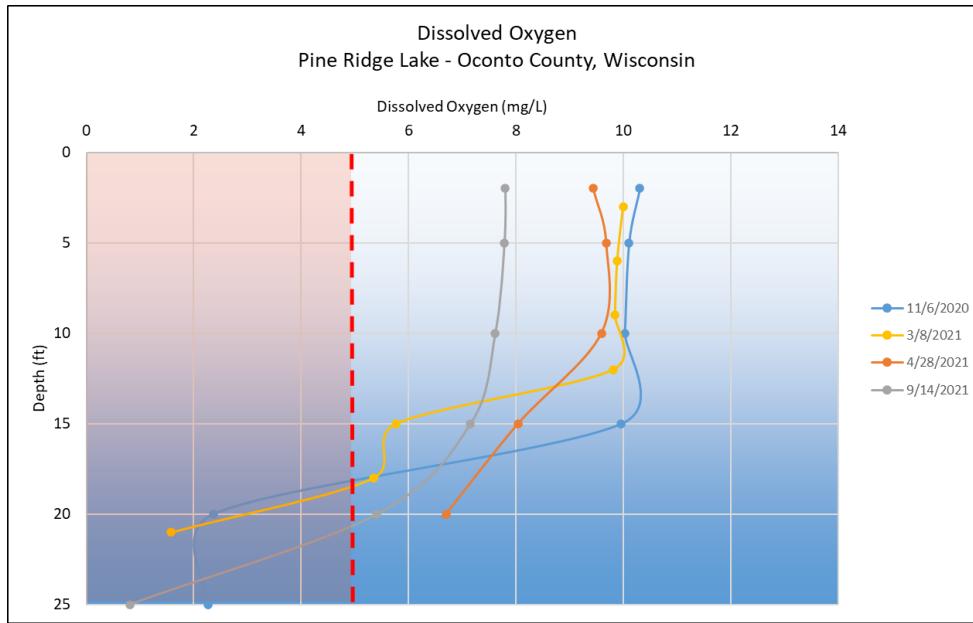
Sufficient **dissolved oxygen** in lake water is essential to the survival of aquatic organisms. The amount of dissolved oxygen present within a lake varies by season and depth. It is determined by the biological activity that consumes or produces oxygen, by water mixing through wind, changes in temperature, and inputs of surface and groundwater. Generally, at least 5 mg/L oxygen is required for fish.

➤ Sufficient oxygen is available in the water column of Pine Ridge Lake throughout the year. The lowest concentrations were observed in late winter when only the top 17 feet has enough oxygen to support most fish species.

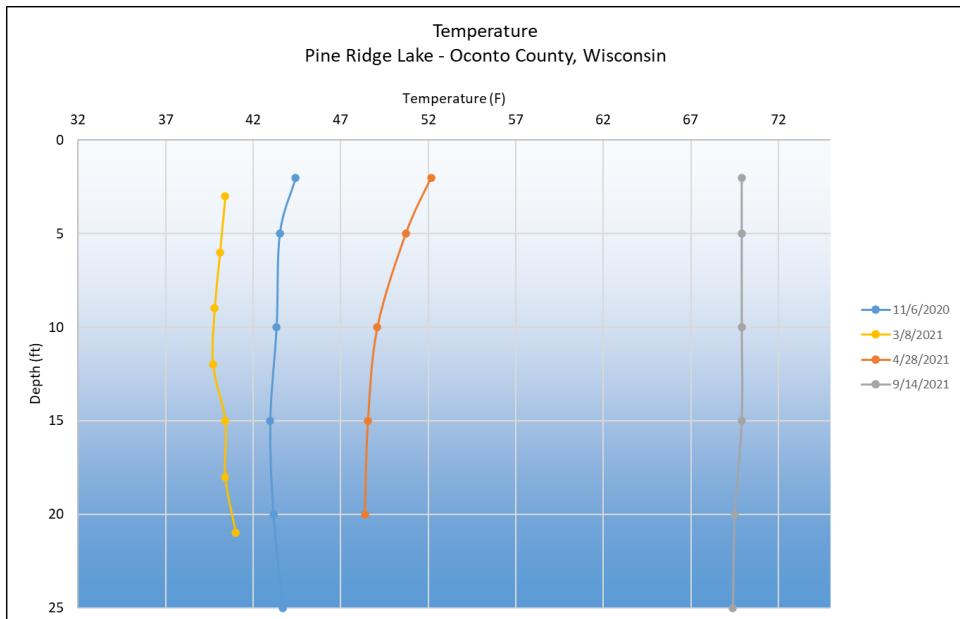
Lake water **temperature** has a significant impact on water chemistry, spatial distribution of fish, microbial growth and oxygen content.

➤ The temperature gradient in Pine Ridge Lake shows consistent temperatures with depth throughout the season, typical of a shallow lake.

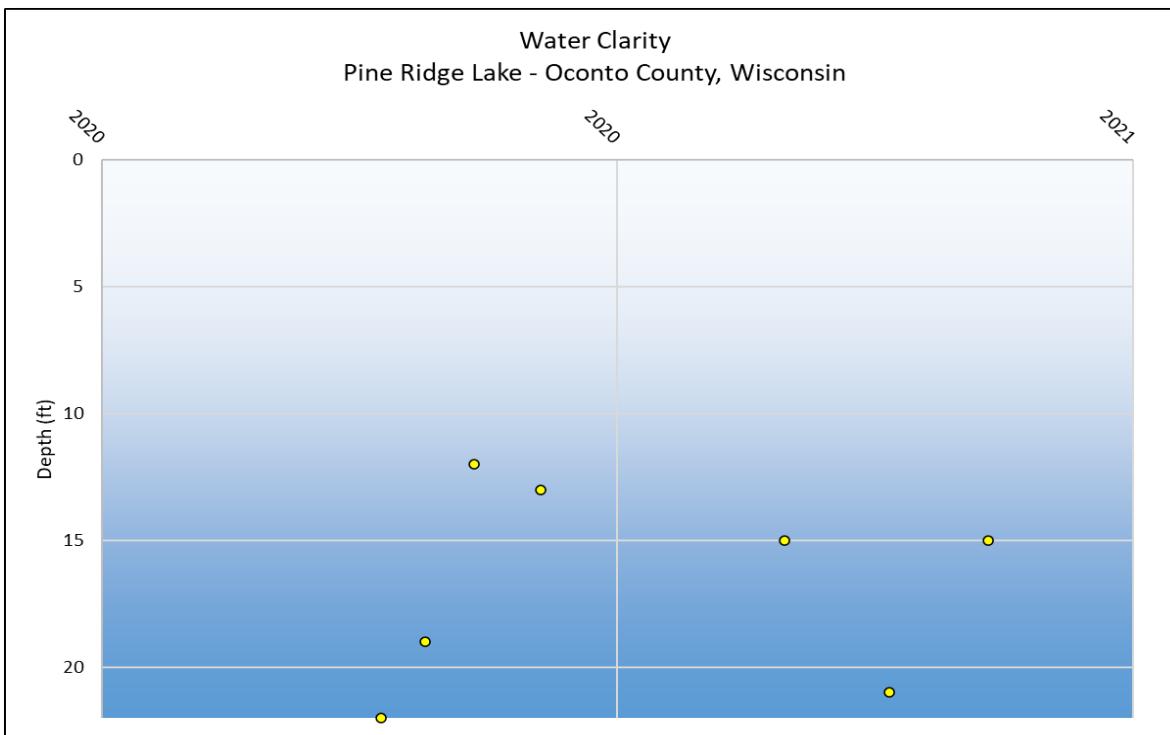
**Water clarity** is a measure of how deep light can penetrate (Secchi depth). Clarity is affected by water color, turbidity (suspended sediment), and algae. Water clarity helps determine where rooted aquatic plants can grow. It is typical for water clarity to vary throughout the year.

- The graph below shows water clarity measurements taken between May and November.
- During 2019-20, the poorest average water clarity was in May and best was in August. Limited historic data suggests a decreasing trend.

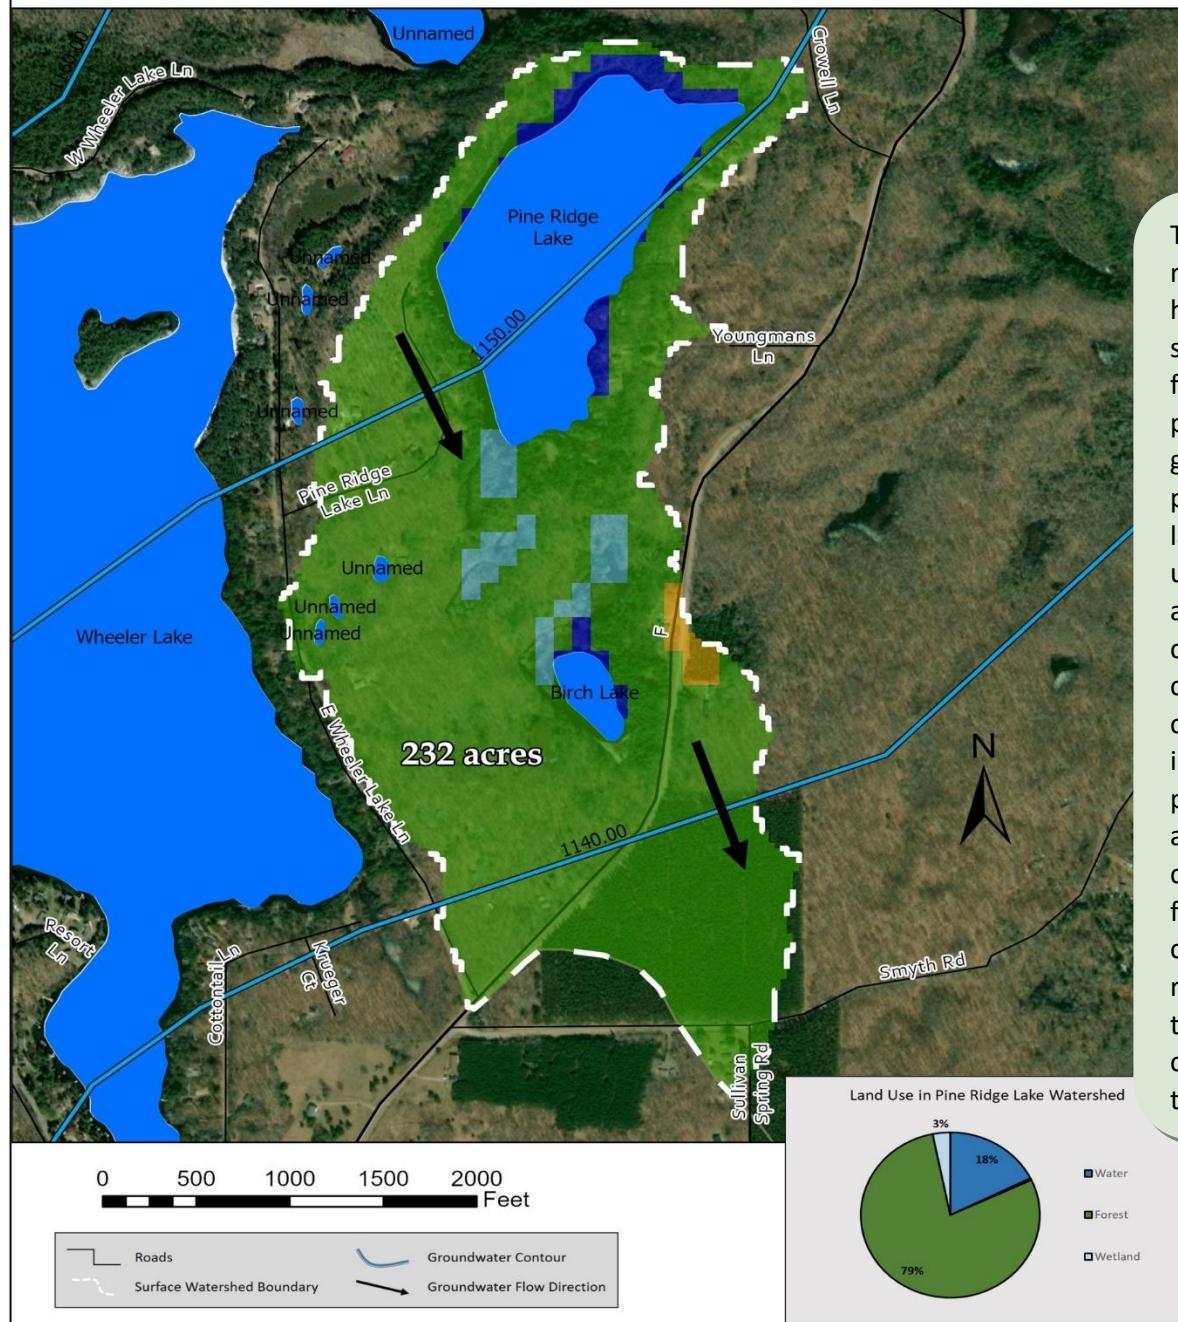
## Pine Ridge Lake Surface Watershed & Groundwater Flow

**Groundwater** provides water to lakes in Oconto County throughout the entire year. Hard surfaces on the landscape prevent water from soaking into the ground and becoming groundwater. This results in less water flowing to the lake during snowmelt and rain events. Water that does not infiltrate to groundwater becomes **surface runoff** flowing across the surface of the landscape where it can move sediment and contaminants to the lake from within its watershed.

The quality of lake water reflects what is happening on the land surface. Precipitation falling on forests produces clean groundwater, whereas precipitation falling on land that has chemical use can produce runoff and groundwater that contains these chemicals. Groundwater contamination may include nitrogen, pesticides, herbicides and other soluble chemicals originating from septic systems, crops, barnyards, and road de-icing. Once in the groundwater, these chemicals move slowly towards a lake or river.

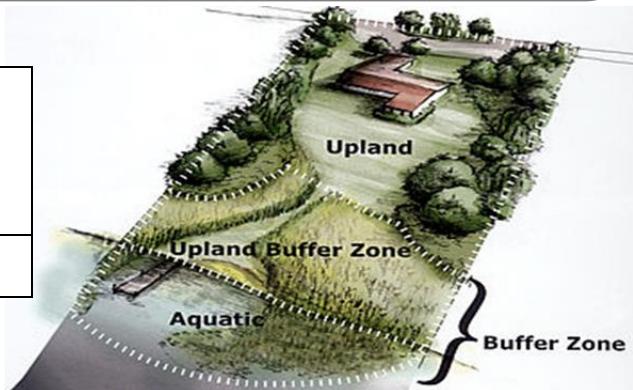
- Shorelands around Pine Ridge Lake were surveyed in July 2020. Though very little was considered disturbed, the lack of ground vegetation can lead to erosion issues. Where appropriate, strategies to reduce/divert runoff should be used.

Total lakefront footage	No. Riparian lots	Measured shoreland disturbance (feet)	Measured shoreland disturbance (%)
6,333	13	30	0.5%

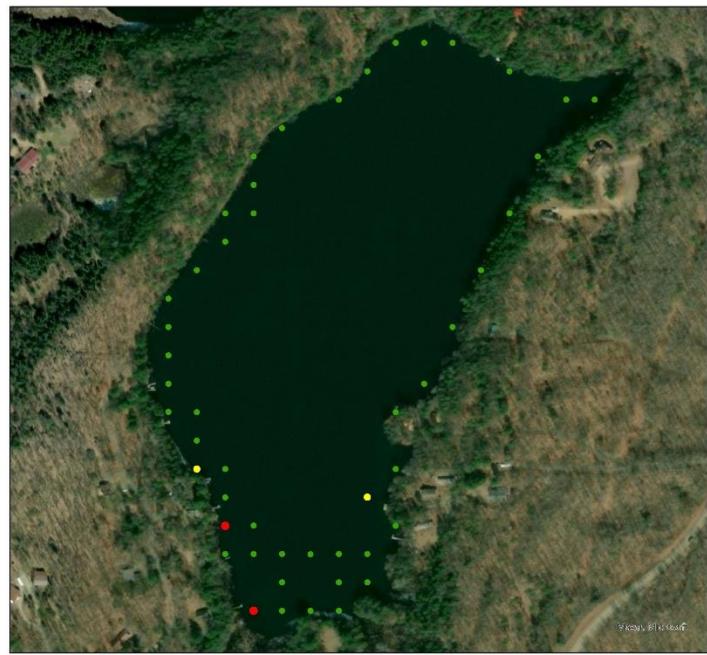
Pine Ridge Lake Aquatic Plant Survey 2020:  
Rake Fullness

- The aquatic plant community in Pine Ridge Lake is characterized by below average diversity of plant species when compared to other lakes in the Oconto County Lakes Project, with a total of 13 species in the 2020 survey.
- During the 2020 aquatic plant survey of Pine Ridge Lake, 28% of visited sites had vegetative growth. The maximum depth of vegetation was 16 feet and the Floristic Quality Assessment (FQI) was 22.
- The most frequently encountered plant species were variable pondweed (43%), chara (36%) and slender naiad (30%). All three species are native to Wisconsin.
- The invasive species Eurasian watermilfoil was observed at one location.

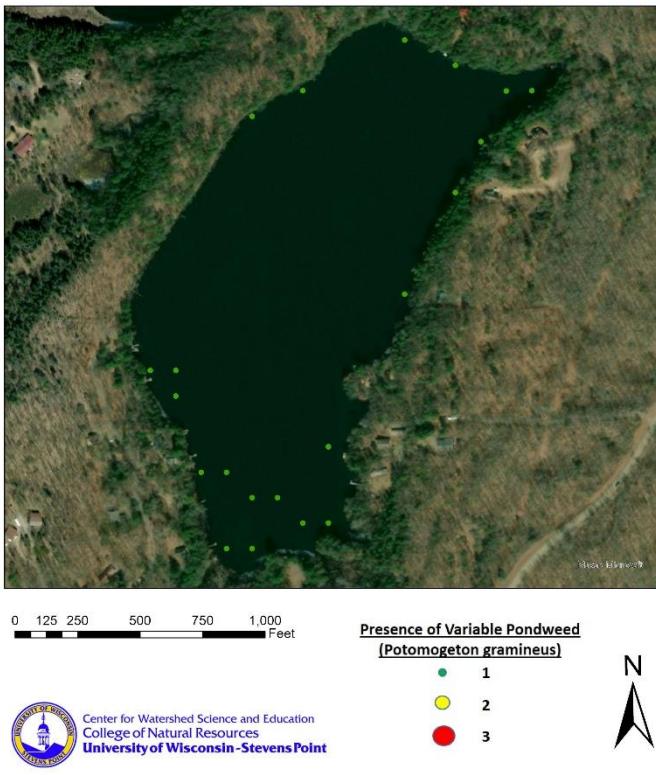
## Pine Ridge Lake Aquatic Plant Survey 2020: Variable pondweed (Potamogeton gramineus)

**Variable pondweed** has both floating and submersed leaves which provide food and habitat for fish.

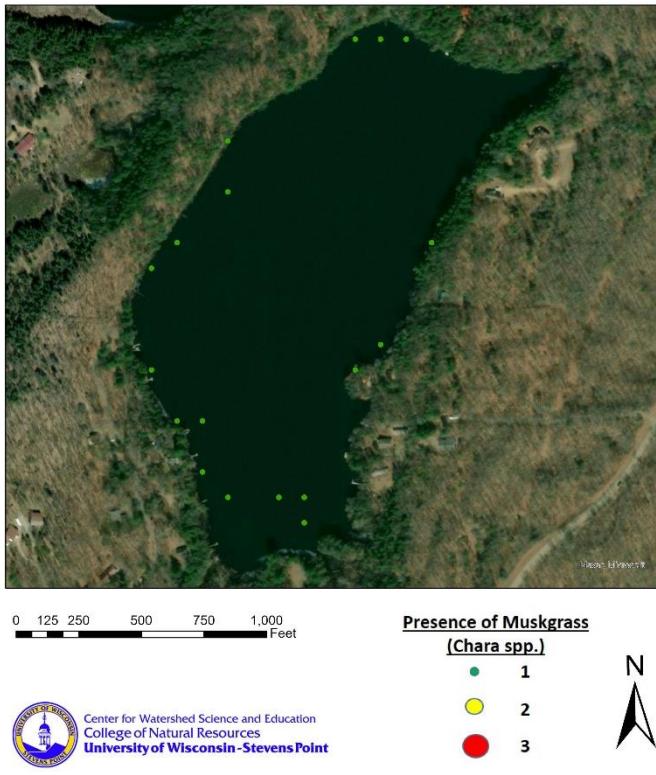
## Pine Ridge Lake Aquatic Plant Survey 2020: Muskgass (Chara sp.)

**Chara** is a type of macro algae that grows attached to muddy lake bottoms and has a musky odor. Muskgass, as it is known, filters the lake water and is helpful in preventing the establishment of invasive species.

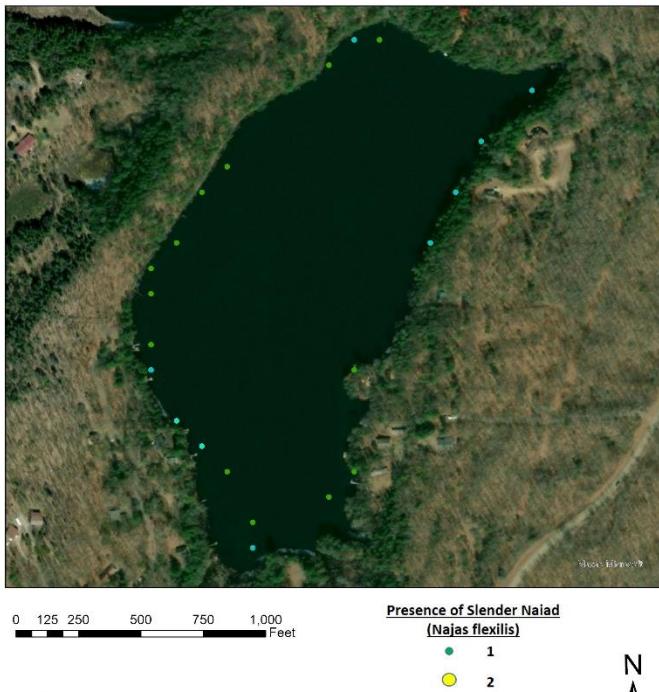
## Pine Ridge Lake Aquatic Plant Survey 2020: Slender naiad (*Najas flexilis*)

**Slender naiad**, also called nodding water-nymph, is a primary food source for waterfowl and provides habitat for many invertebrates.

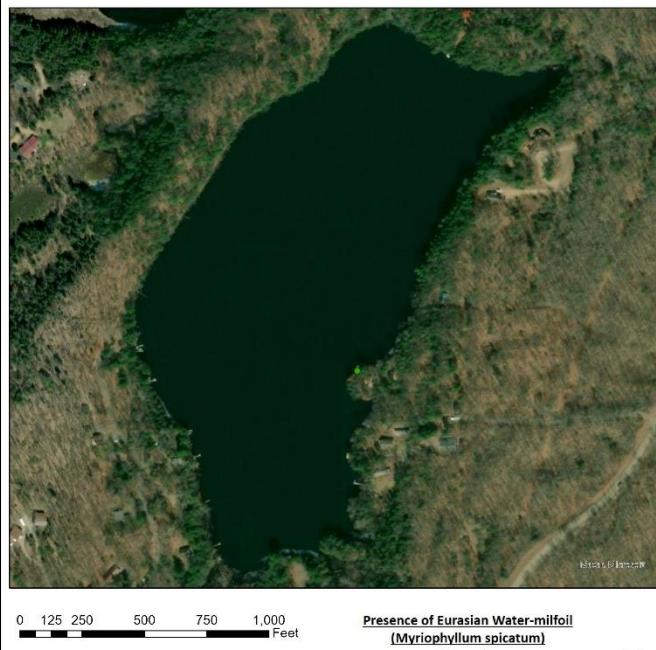
## Pine Ridge Lake Aquatic Plant Survey 2020: Eurasian watermilfoil (*Myriophyllum spicatum*)

- Eurasian watermilfoil was observed in one location during the 2020 aquatic plant survey.
