Round Oconto County Lakes Project

ROUND LAKE STUDY

SUMMARY REPORT

2023

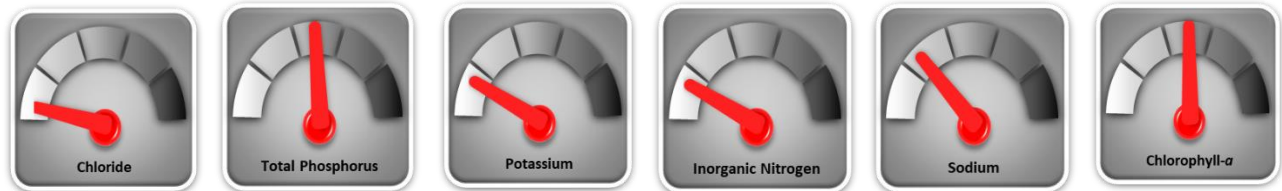
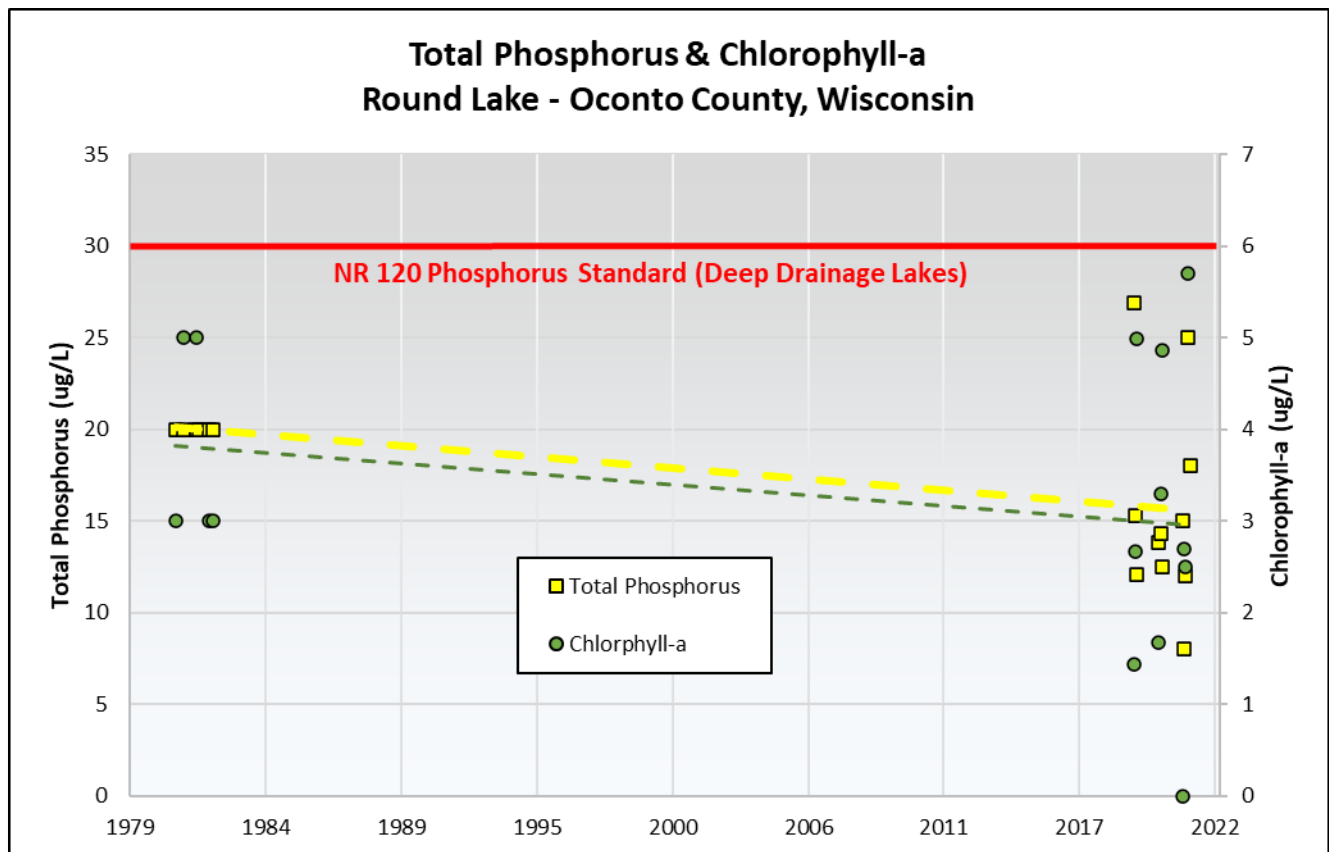
- Total Phosphorus was consistently below the Wisconsin state standard of 30 $\mu\text{g/L}$ for deep drainage lakes during the two-year study. The limited dataset does not indicate a clear trend.
- Inorganic nitrogen remained below the threshold of 0.3 mg/L when algal blooms increase.
- Chlorophyll-a, an indirect measure of algae, remained below the threshold of 6 $\mu\text{g/L}$ throughout the study.

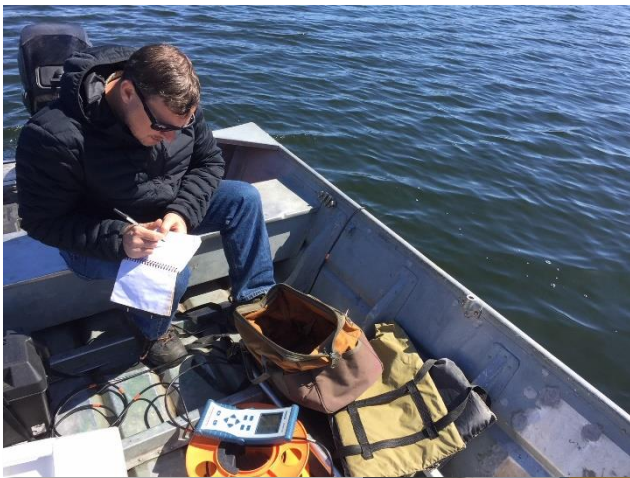
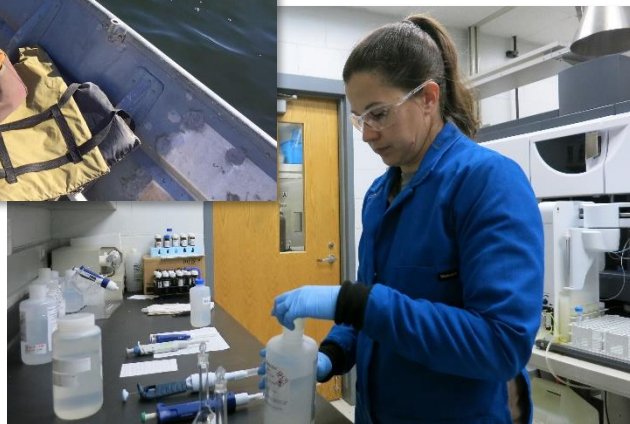
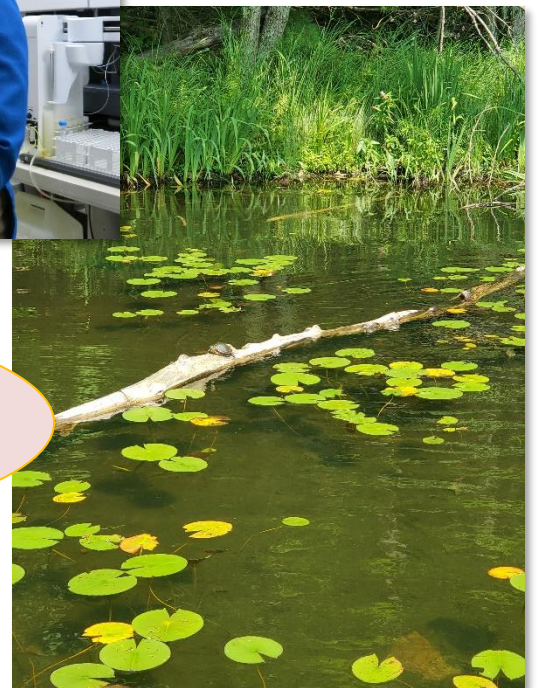
- Concentrations of potassium (0.69 mg/L), chloride (0.9 mg/L) and sodium (1.2 mg/L) were all low. This suggests minimal impact from septic systems, road salt, animal waste and fertilizers.
- DACT, a screening tool to determine if your lake is being impacted by pesticides, was not detected.
- Water in Round Lake is moderately hard (114 mg/L CaCO_3), having a slightly elevated level of dissolved minerals. These minerals tend to bind with phosphorus making it unavailable to algae blooms.

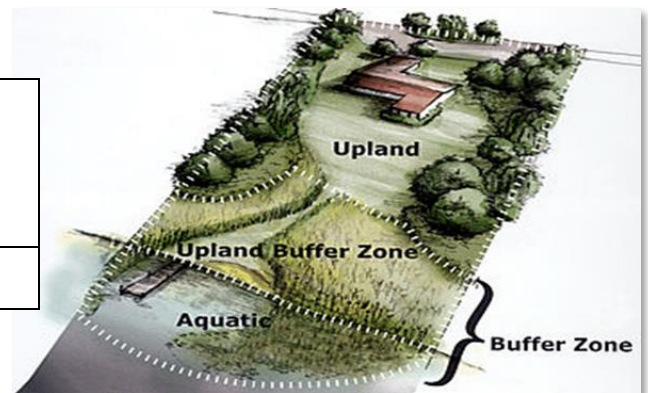
- Shorelands around Round Lake were surveyed in July 2021. Many shoreland areas are healthy, but some stretches are in need of restoration.

Total lakefront footage	No. Riparian lots	Measured shoreland disturbance (feet)	Measured shoreland disturbance (%)
4,246	39	1,538	36%

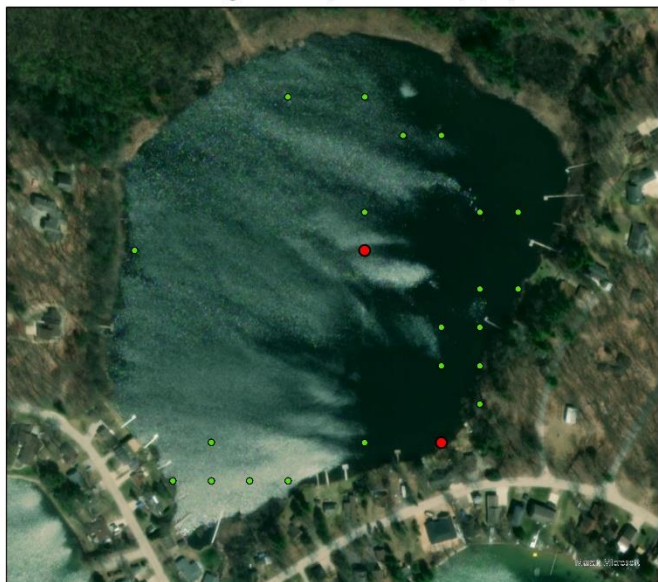
Round Lake Aquatic Plant Survey 2021: Muskgrass (*Chara* spp.)

Chara is a type of macro algae that grows attached to muddy lake bottoms and has a musky odor. Muskgrass, as it is known, filters the lake water and is helpful in preventing the establishment of invasive species.
