# Oconto County Lakes Project

## SHAY LAKE STUDY

### SUMMARY REPORT

**2020**

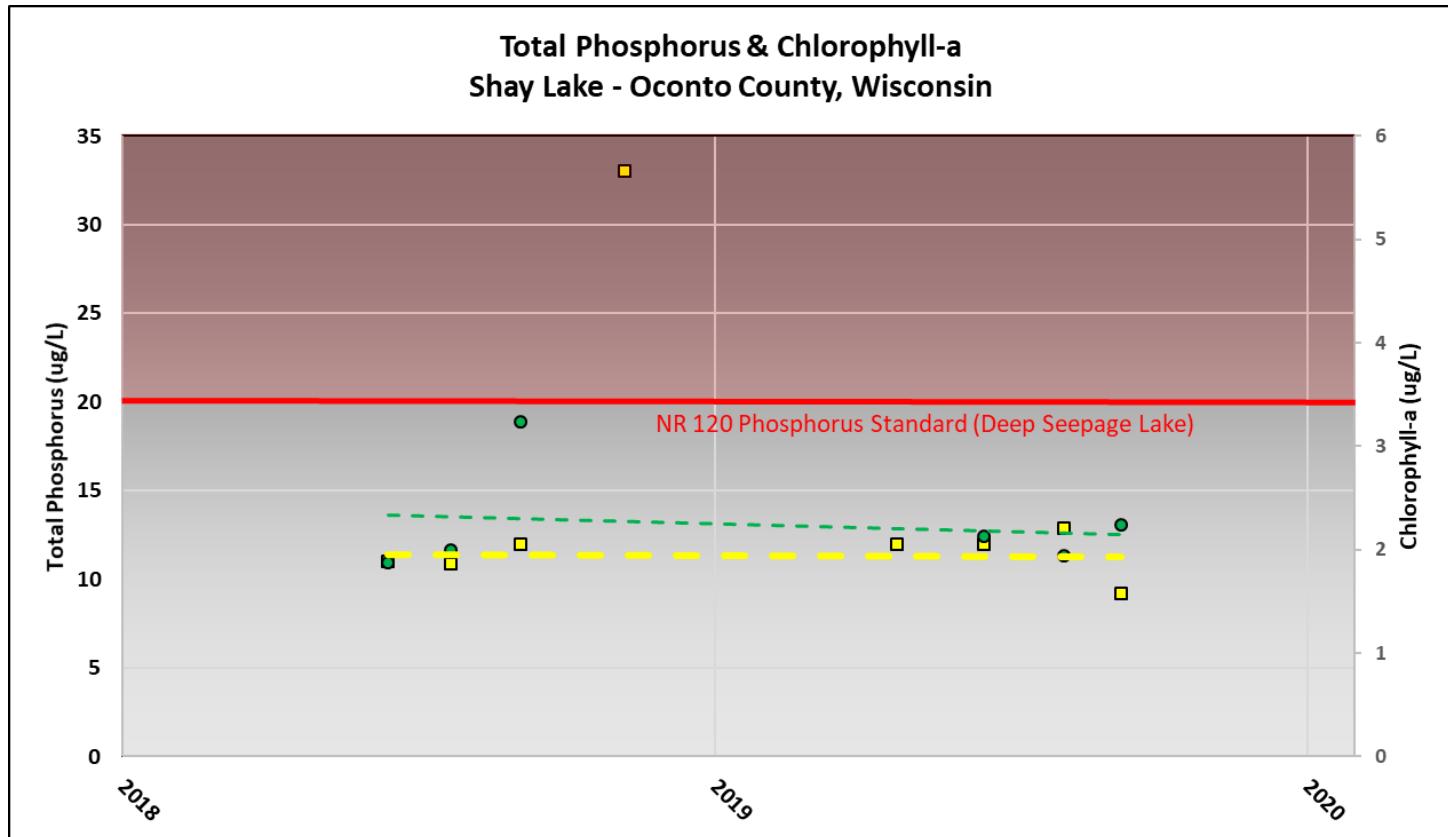
- Total Phosphorus was primarily below the Wisconsin state standard of 20 ug/L for deep seepage lakes during the two-year study. The two-year trend (based on summer samples) suggests a very stable concentration.
- Inorganic nitrogen remained below the threshold of 0.3 mg/L when algal blooms increase.
- Chlorophyll-a, an indirect measure of algae, remained well below the threshold of 6 ug/L and appears stable over the study period.

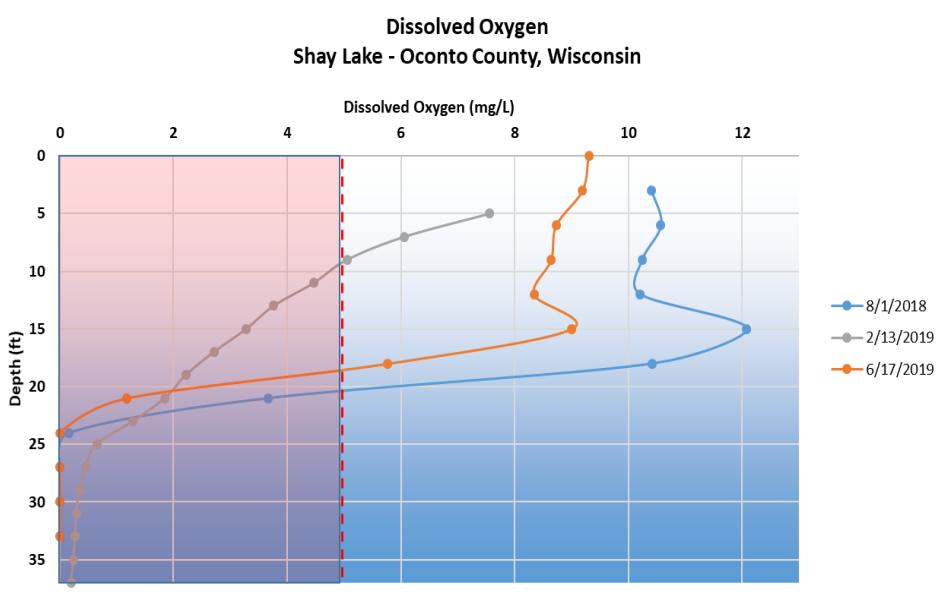
- Sufficient oxygen is available in the water column of Shay Lake throughout the year. The lowest concentrations were observed in late winter when only the top ~8 feet has enough oxygen to support most fish species.
- Elevated dissolved oxygen concentrations between 12 and 18 feet in the summer profiles is indicative of an algae bloom at depth.

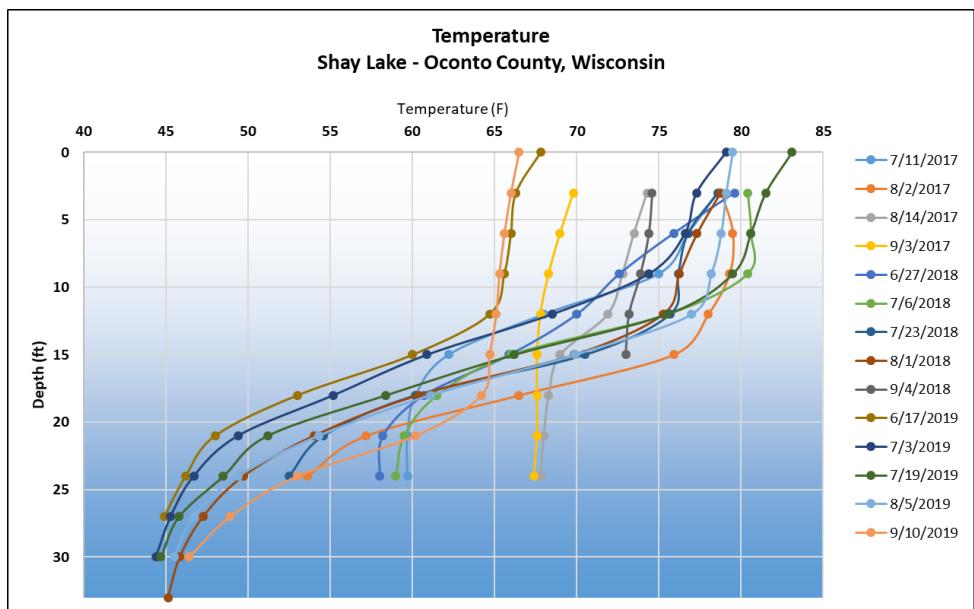
- The temperature gradient in Shay Lake exhibits a clear thermocline between 10 and 20 feet during the growing season that separates warmer oxygen-rich water at the top from colder oxygen-poor water below.

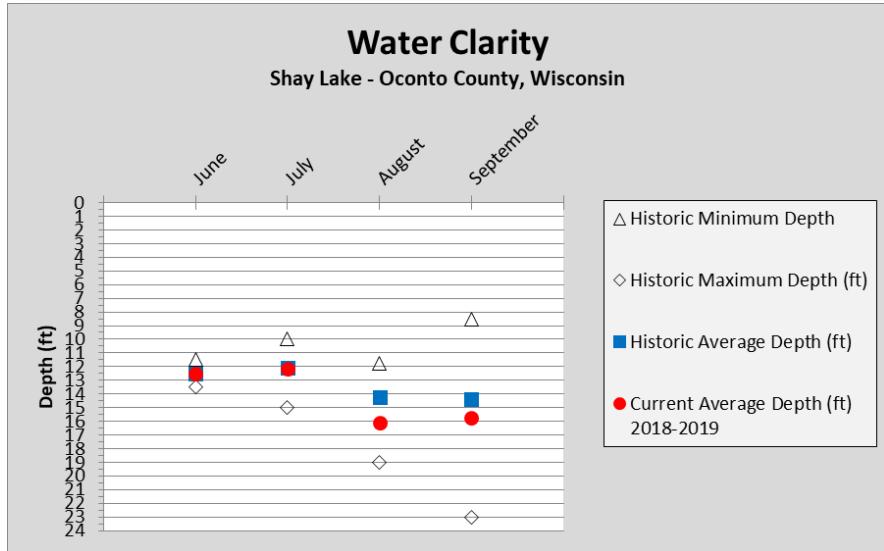
- The graph below shows water clarity measurements taken between June and September.
- During 2018-19, on average, the poorest water clarity in Shay Lake was in July and the best was in August. This is consistent with previous observations and demonstrates a slightly increasing trend over the long term.

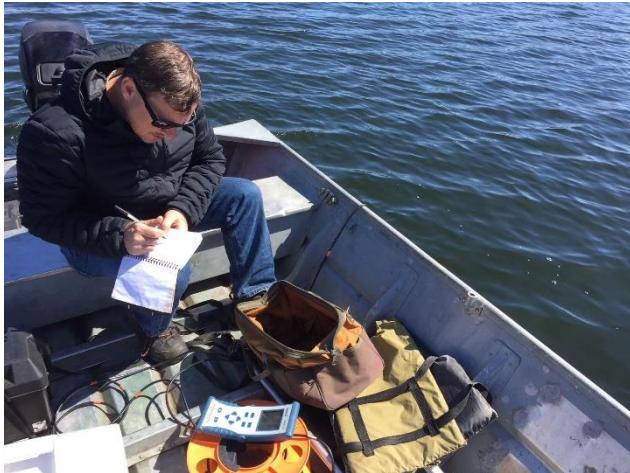
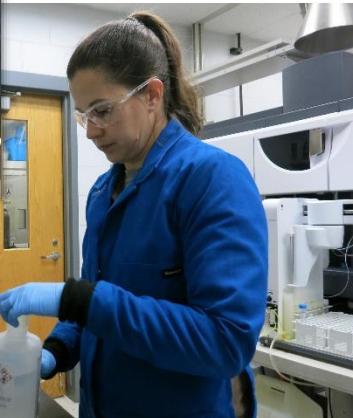
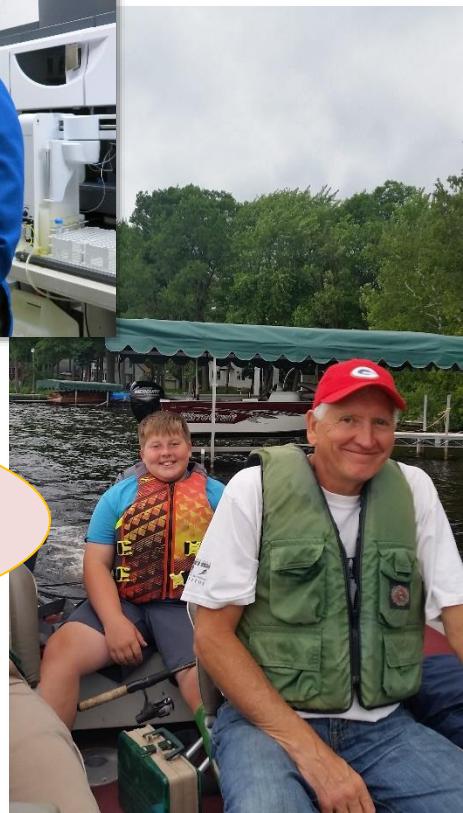
- Concentrations of potassium (0.822 mg/L), chloride (6.1 mg/L) and sodium (3.4 mg/L) were all low. This suggests minimal impact from septic systems, road salt, animal waste and fertilizers.
- DACT, a screening tool to determine if your lake is being impacted by pesticides, was not detected.
- Water in Shay Lake is hard (122 mg/L CaCO<sub>3</sub>), having an elevated level of dissolved minerals. These minerals tend to bind with phosphorus making it unavailable to algae blooms.

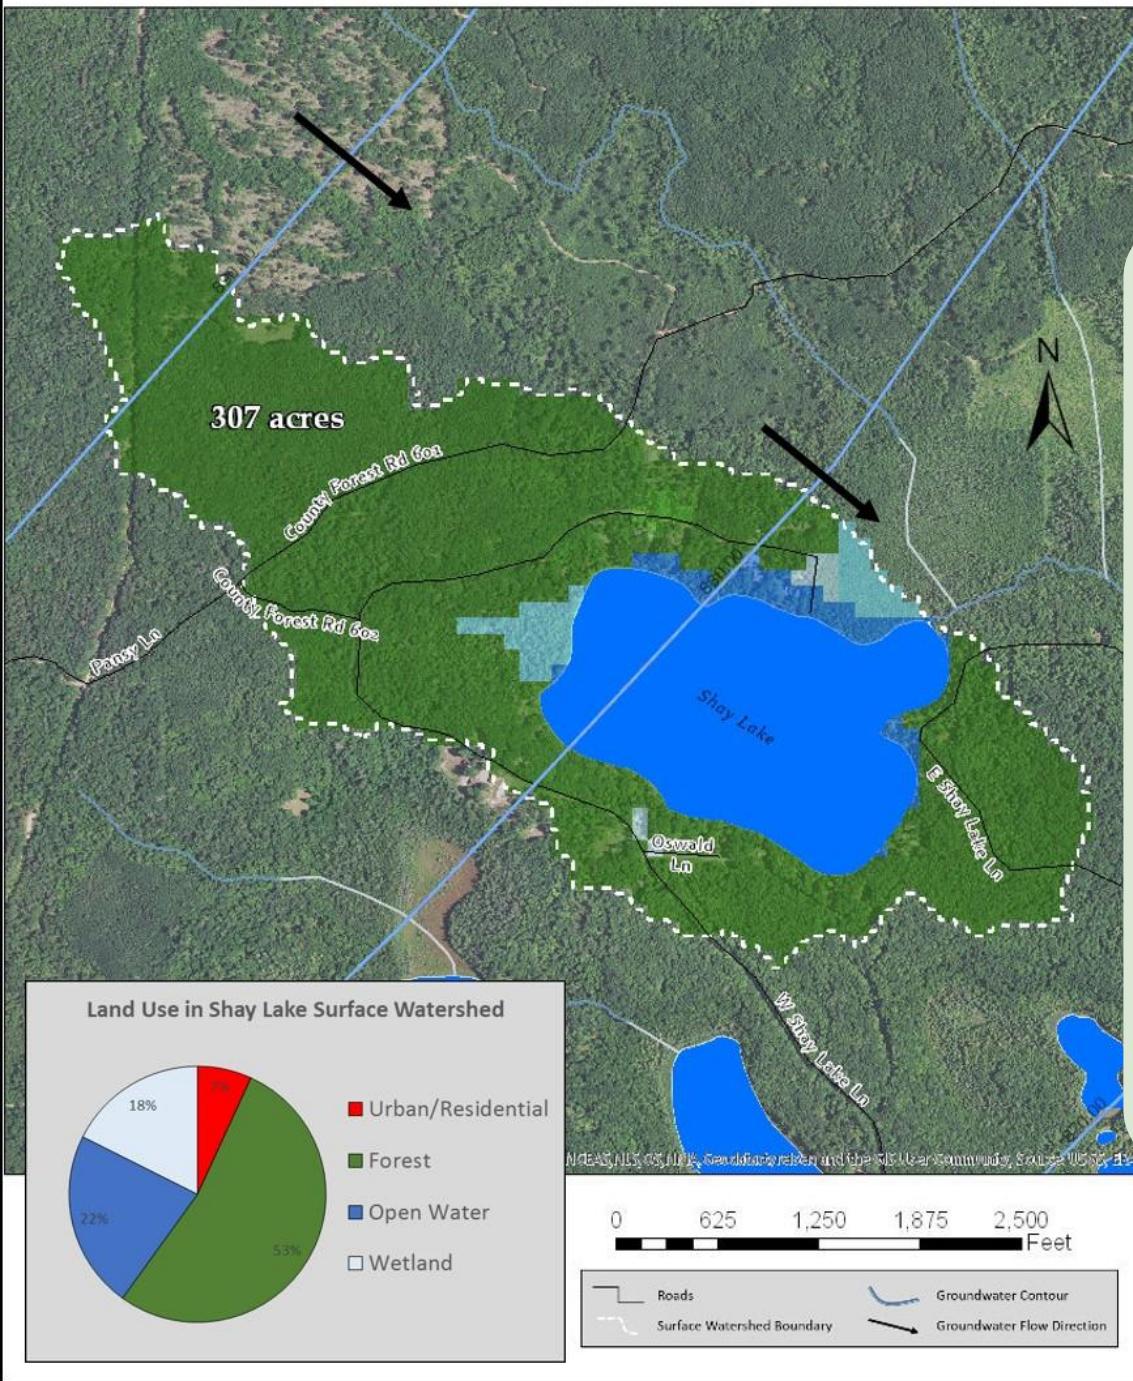
## Shay Lake Surface Watershed & Groundwater Flow

**Groundwater** provides water to lakes in Oconto County throughout the entire year. Hard surfaces on the landscape prevent water from soaking into the ground and becoming groundwater. This results in less water flowing to the lake during snowmelt and rain events. Water that does not infiltrate to groundwater becomes **surface runoff** flowing across the surface of the landscape where it can move sediment and contaminants to the lake from within its watershed.

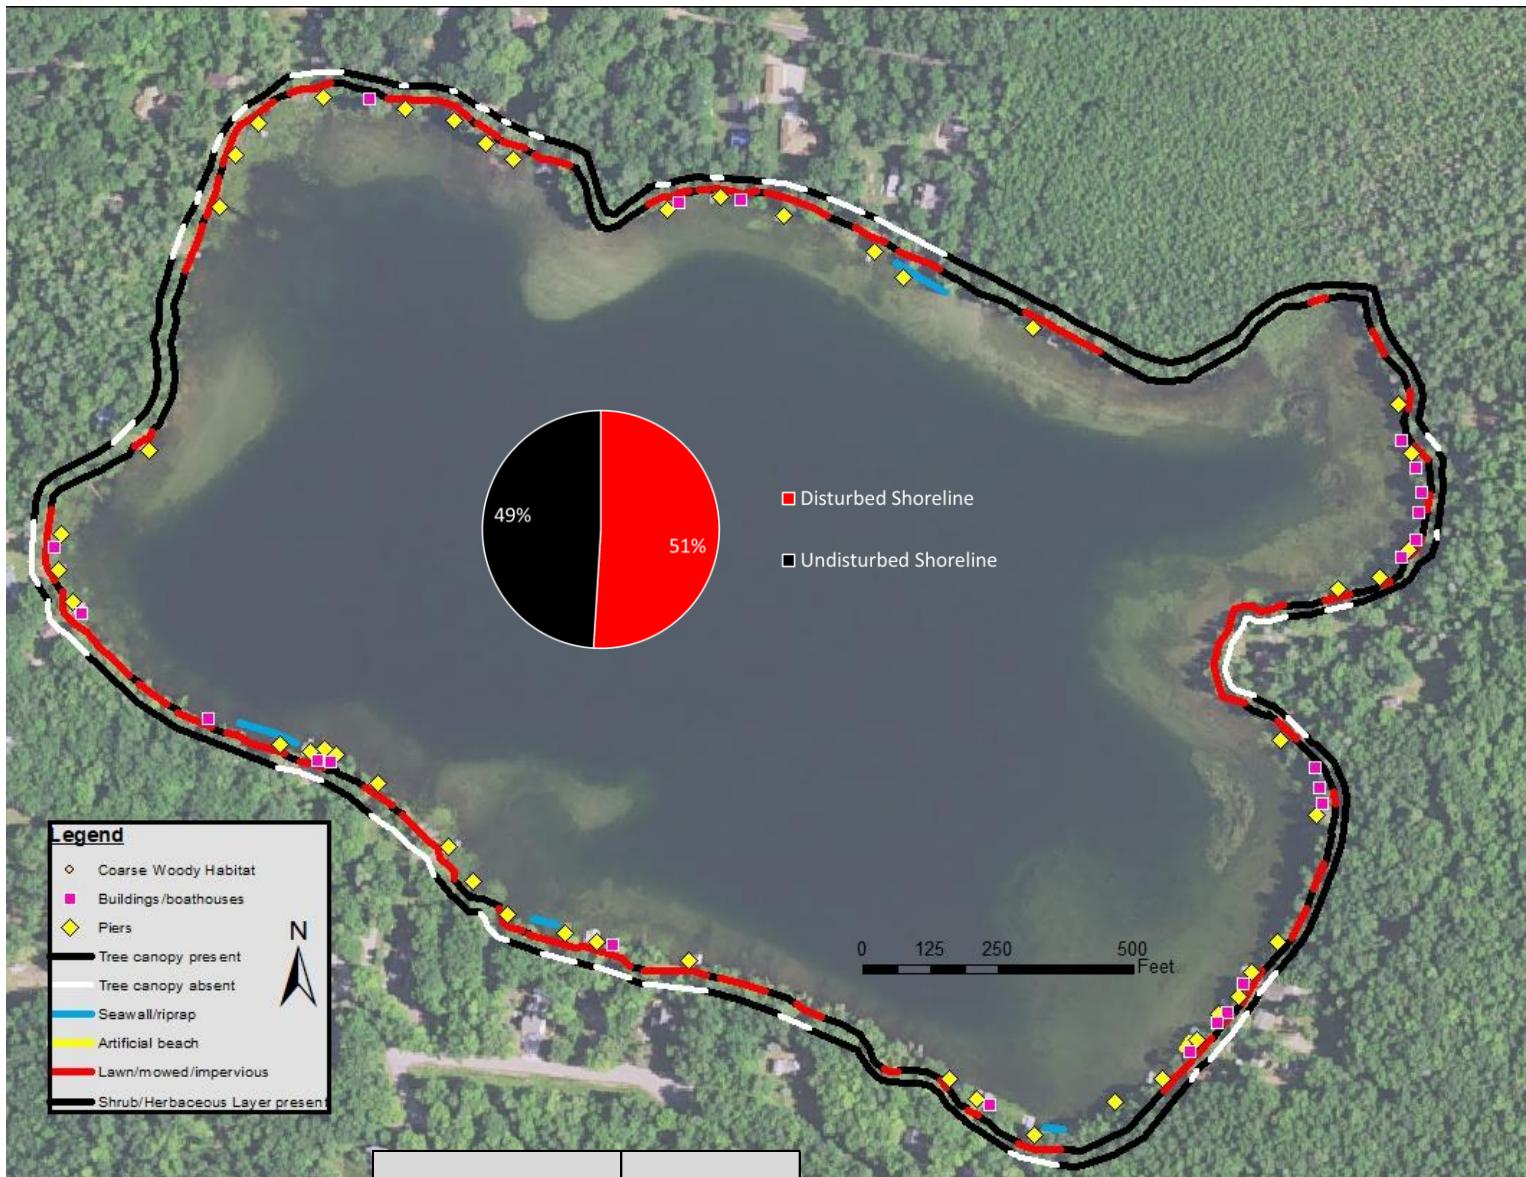
Modifications, Structures, Erosion	Measured Occurrence
Artificial Beach	10 ft
Rip Rap	355 ft
Sea Wall	95 ft
Impervious Surface	535 ft
Mowed Lawn	3,057 ft
Erosion	160 ft
Nonconforming Buildings	2
Piers	46
Coarse Woody Habitat	56 logs/mile

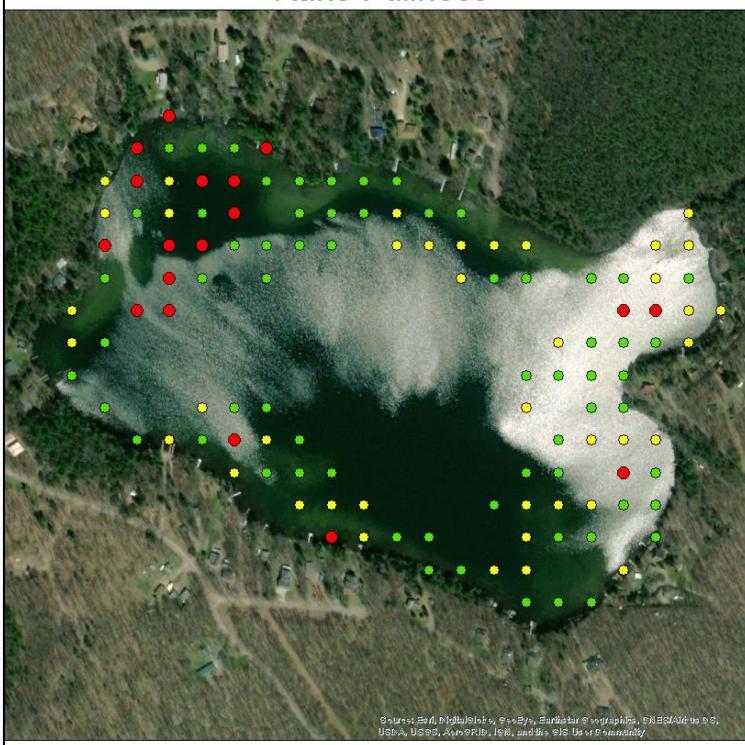
Shay Lake Aquatic Plant Survey 2018:  
Rake Fullness

- The aquatic plant community in Shay Lake is characterized by below-average diversity of plant species when compared to other lakes in the Oconto County Lakes Project, with a total of 19 species in the 2018 survey.
- During the 2018 aquatic plant survey of Shay Lake, 68% of the sites (75% of littoral area) had vegetative growth. The maximum depth of vegetation was 23 feet.
- The most frequently encountered plant species were chara (84%), slender naiad (29%) and wild celery (23%). All three species are native to Wisconsin.
- No invasive species were observed.
