# Oconto County Lakes Project

## WESCOTT LAKE STUDY SUMMARY REPORT 2020

*University of Wisconsin-Stevens Point and  
Oconto County Staff and Citizens*

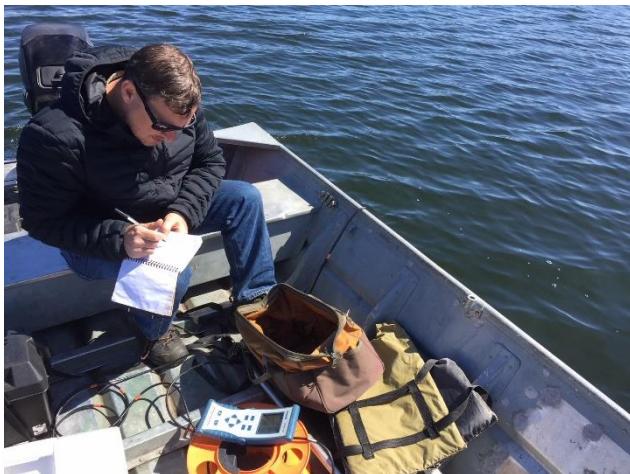
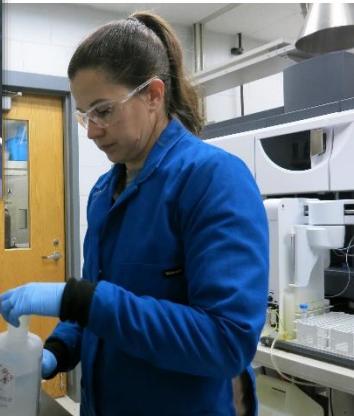
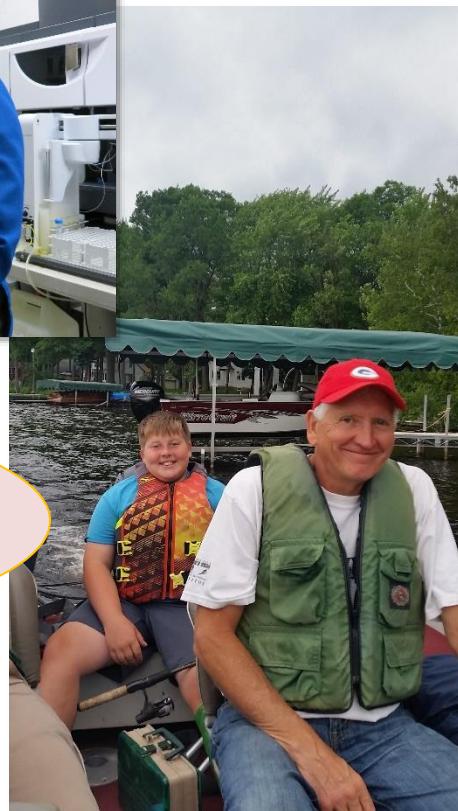
- Concentrations of potassium (1.31 mg/L) were low, but chloride (15.8 mg/L) and sodium (8.12 mg/L) had elevated concentrations. This suggests some impact from septic systems, road salt, animal waste and/or fertilizers.
- DACT, a screening tool to determine if your lake is being impacted by pesticides, was not detected.
- Water in Wescott Lake is hard (161 mg/L CaCO<sub>3</sub>), having an elevated level of dissolved minerals. These

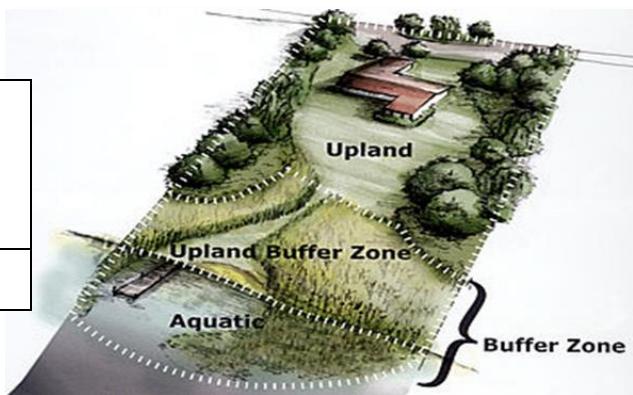
- Shorelands around Wescott Lake were surveyed in May 2018. Much of Wescott Lake's shoreland is healthy, but some stretches are in need of restoration.

| Total lakefront footage | No. Riparian lots | Measured shoreland disturbance (feet) | Measured shoreland disturbance (%) |
| 6,394 | 29 | 1,242 | 19% |
