Oconto County Lakes Project

WHITE LAKE STUDY SUMMARY REPORT

2021

- White Lake is a 50-acre drainage lake in central Oconto County with a maximum depth of 49 feet.
- Most water enters White Lake via groundwater and a small inlet stream from Pecor Lake on the north side. Most water leaves via a small outlet stream that is a tributary to Kelly Brook so the south. Surface water runoff and direct precipitation also contribute water.
- Visitors have access to the lake from one public carry-in access located on the lake's southeast side.
- This report summarizes data collected during the 2019-2020 lake study.

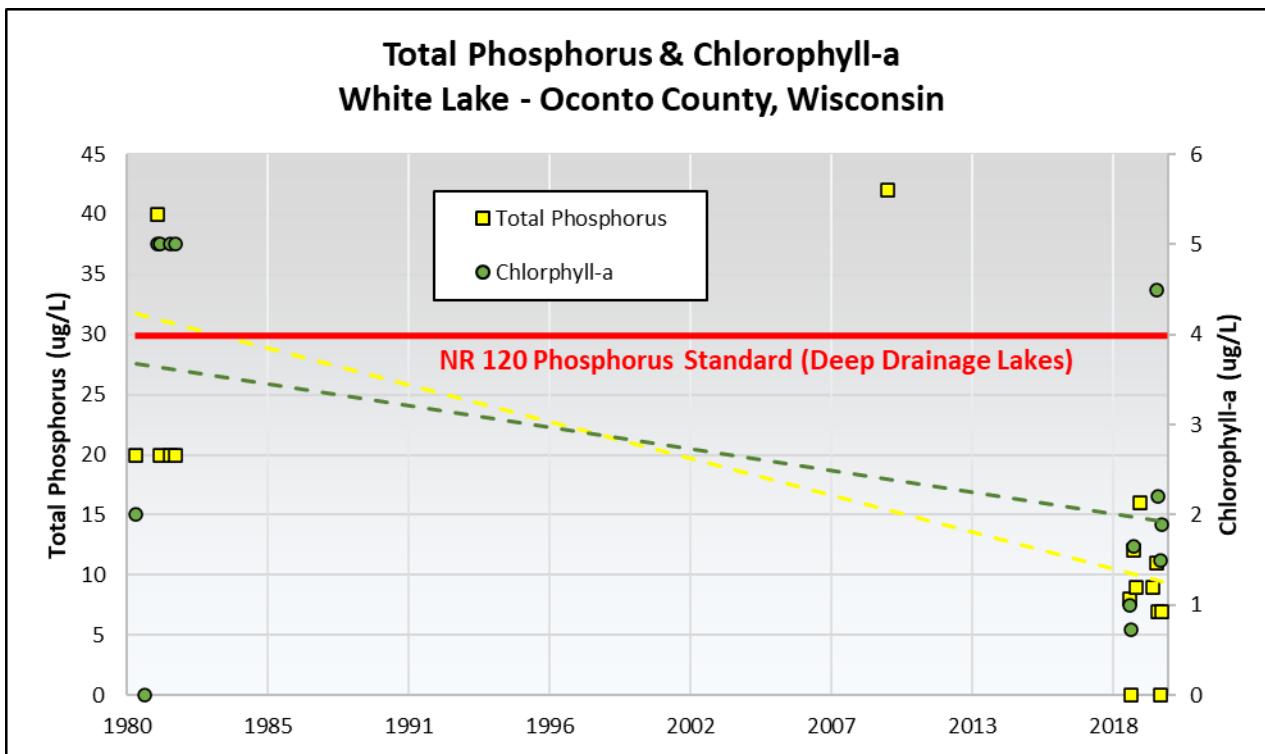
- Total Phosphorus was consistently below the Wisconsin state standard of 30 ug/L for deep drainage lakes during the two-year study. The long-term trend (based on summer samples) suggests a decreasing average concentration.
- Inorganic nitrogen remained below the threshold of 0.3 mg/L when algal blooms increase.
- Chlorophyll-a, an indirect measure of algae, remained below the threshold of 6 ug/L. Limited historic data suggests a decreasing trend.

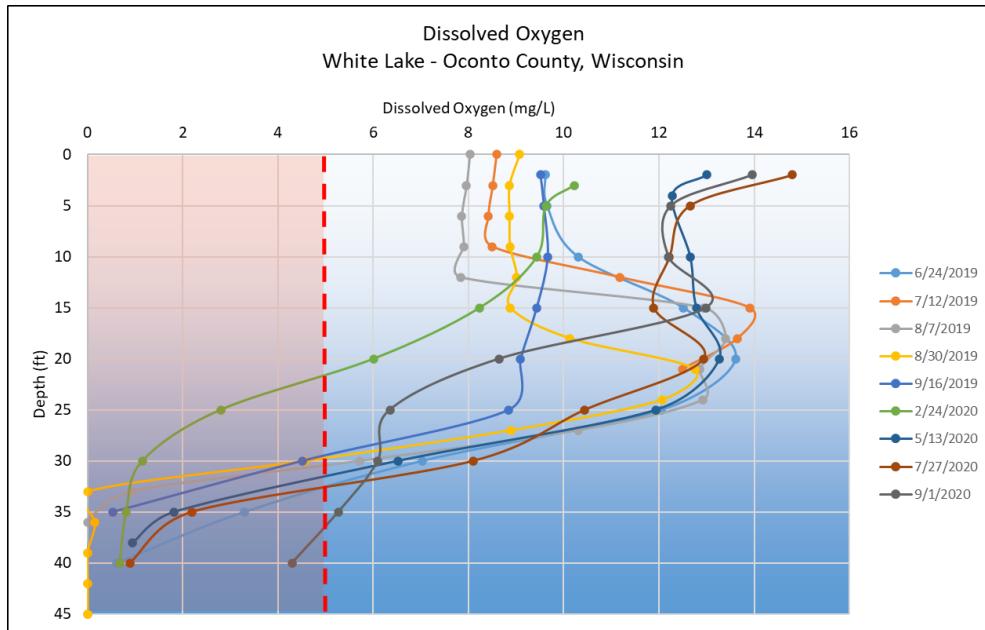
- Sufficient oxygen is available in the water column of White Lake throughout the year. The lowest concentrations were observed in late winter when only the top 20 feet has enough oxygen to support most fish species.
- Algae blooms at depth (between 15 and 25 feet) were indicated by the profiles.

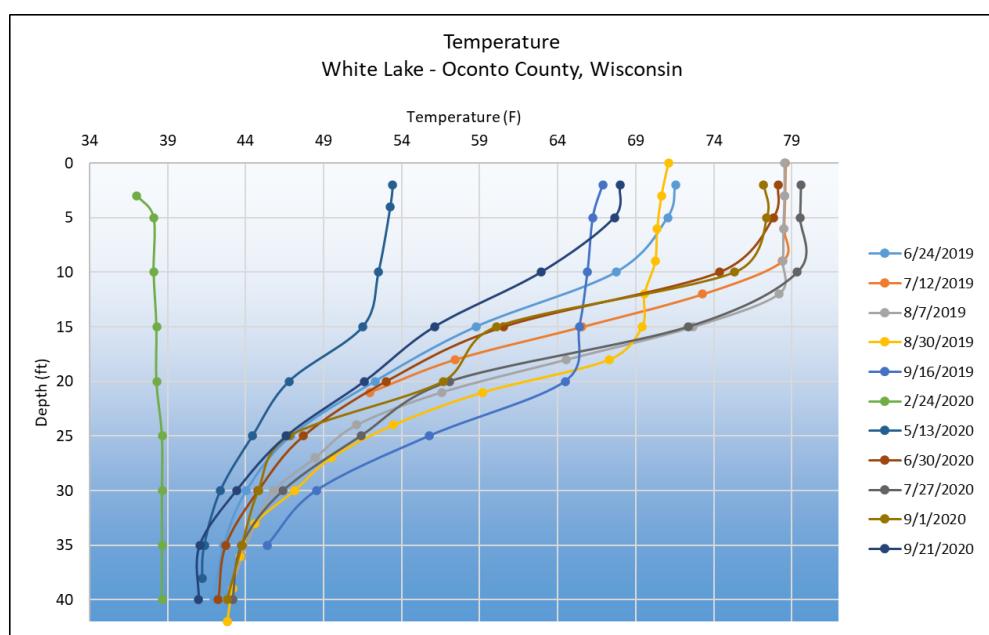
- The temperature gradient in White Lake shows a clear thermocline (~10-20 ft) during the growing season, typical of a deep, stratified lake.

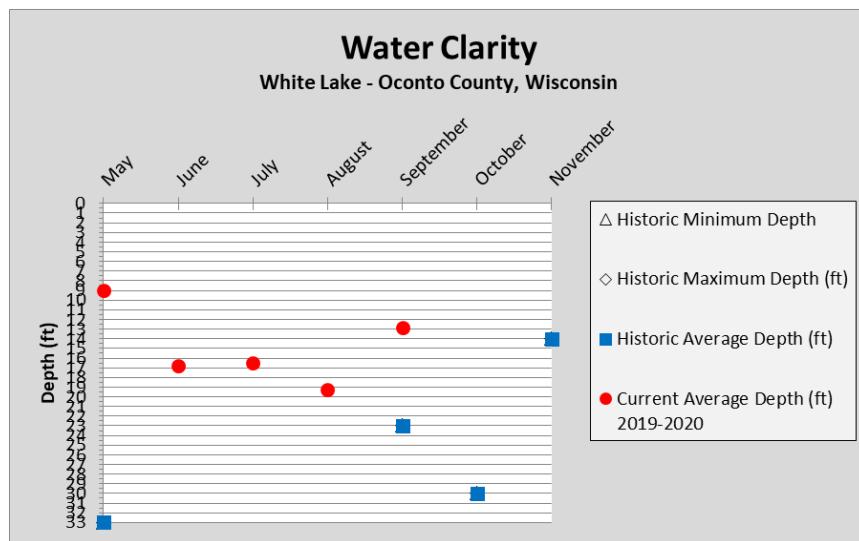
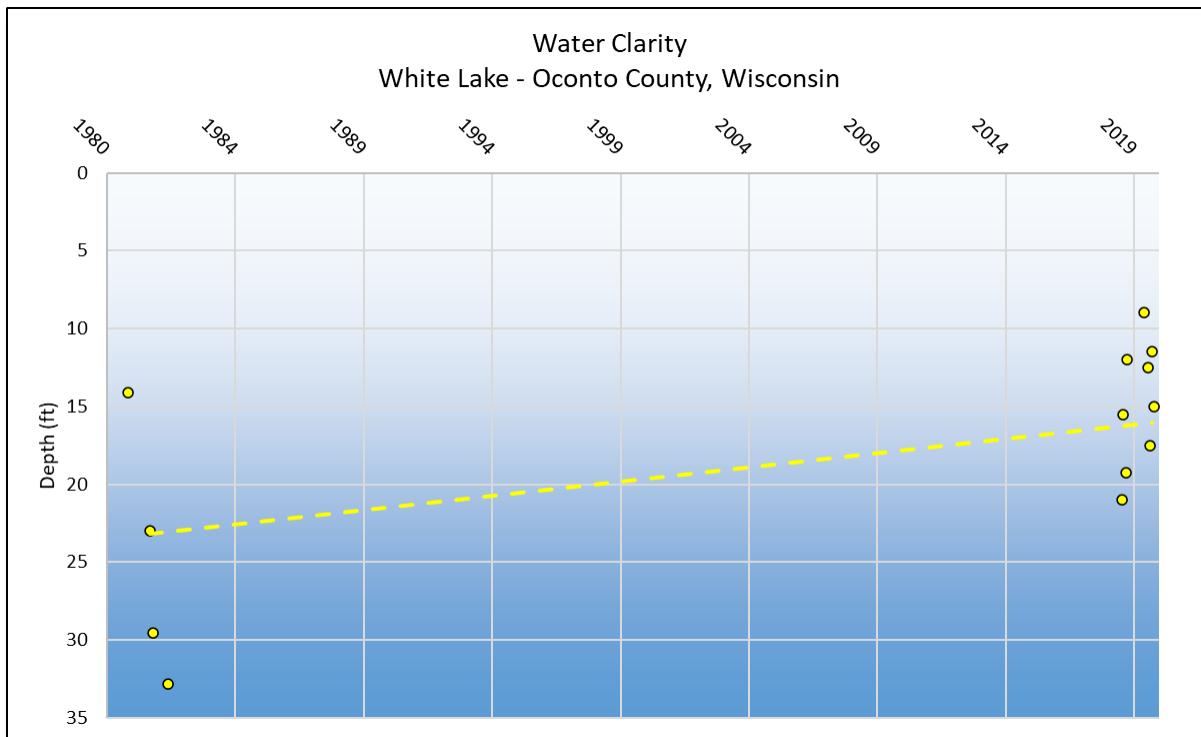
- The graph below shows water clarity measurements taken between May and November.
- During 2019-20, the poorest average water clarity was in May and best was in August. Limited historic data suggests a decreasing trend.

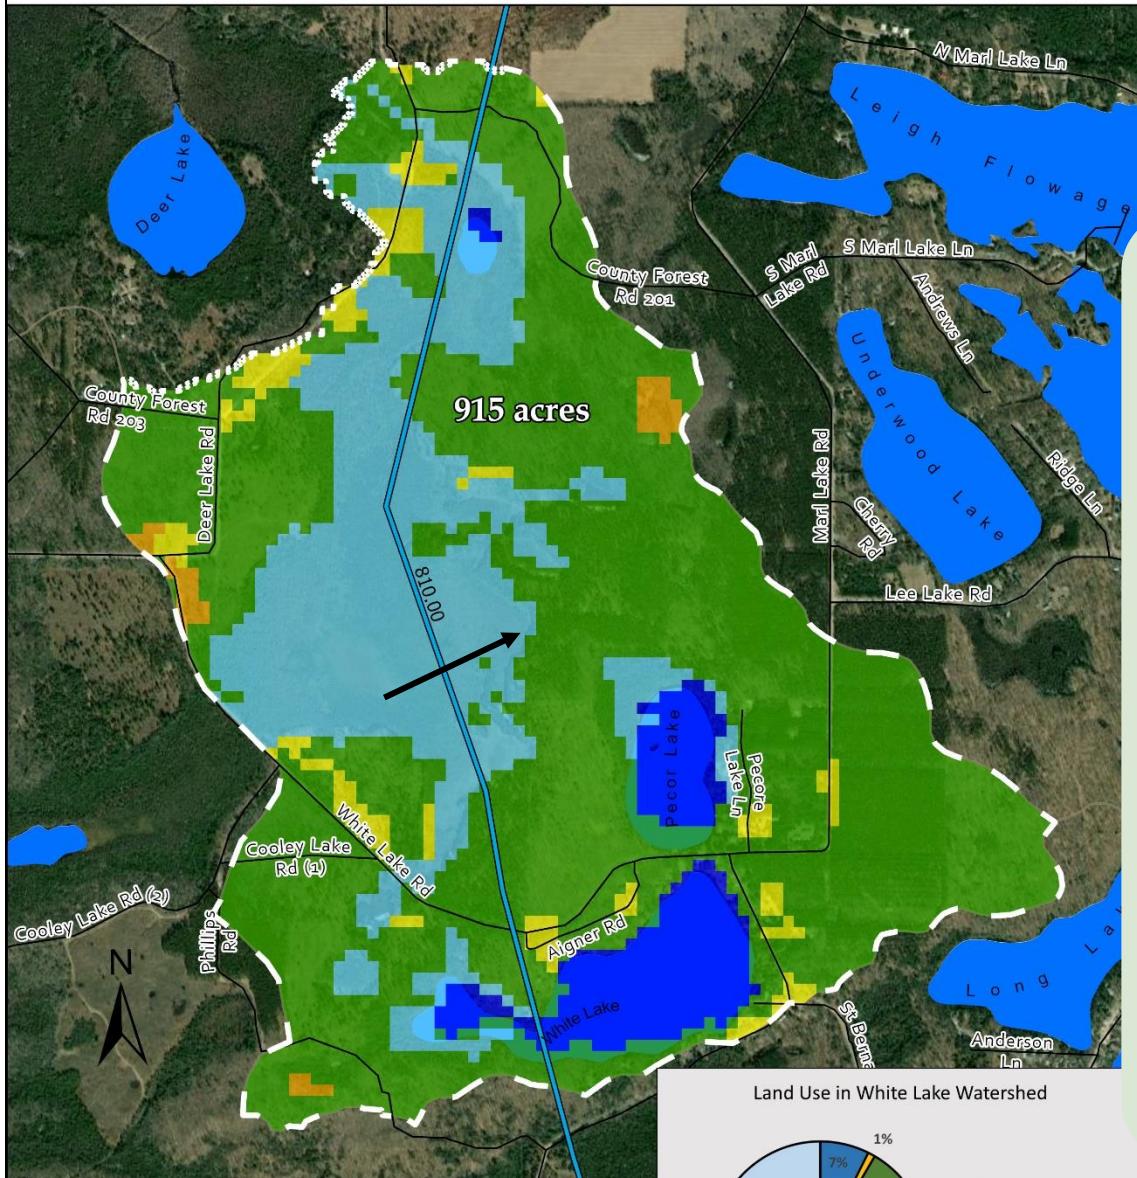
White Lake Surface Watershed & Groundwater Flow

Groundwater provides water to lakes in Oconto County throughout the entire year. Hard surfaces on the landscape prevent water from soaking into the ground and becoming groundwater. This results in less water flowing to the lake during snowmelt and rain events. Water that does not infiltrate to groundwater becomes **surface runoff** flowing across the surface of the landscape where it can move sediment and contaminants to the lake from within its watershed.

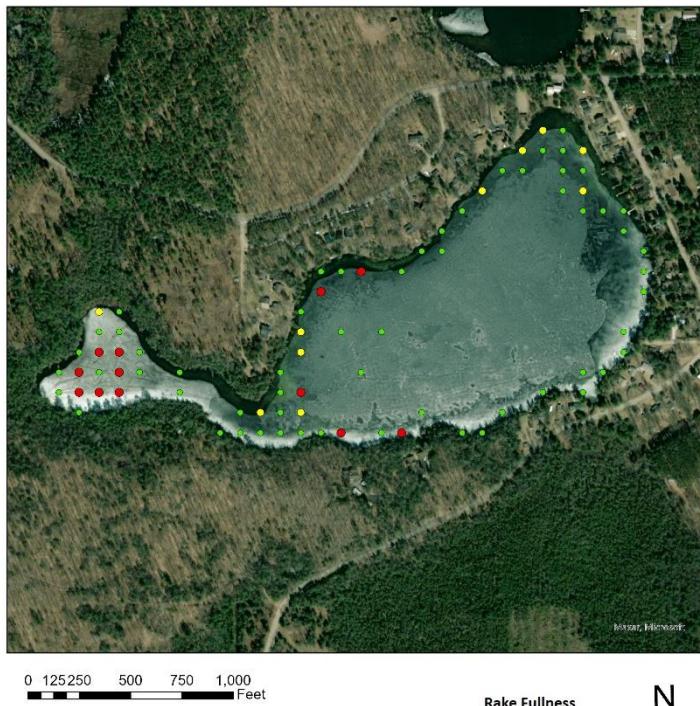
White Lake Aquatic Plant Survey 2019:
Rake Fullness

- The aquatic plant community in White Lake is characterized by average diversity of plant species when compared to other lakes in the Oconto County Lakes Project, with a total of 18 species in the 2019 survey.
- During the 2019 aquatic plant survey of White Lake, 36% of visited sites had vegetative growth. The maximum depth of vegetation was 28 feet and the Floristic Quality Assessment (FQI) was 24.
- The most frequently encountered plant species were chara (72%), slender naiad (17%) and wild celery (14%). All three species are native to Wisconsin.
- No invasive species were observed.

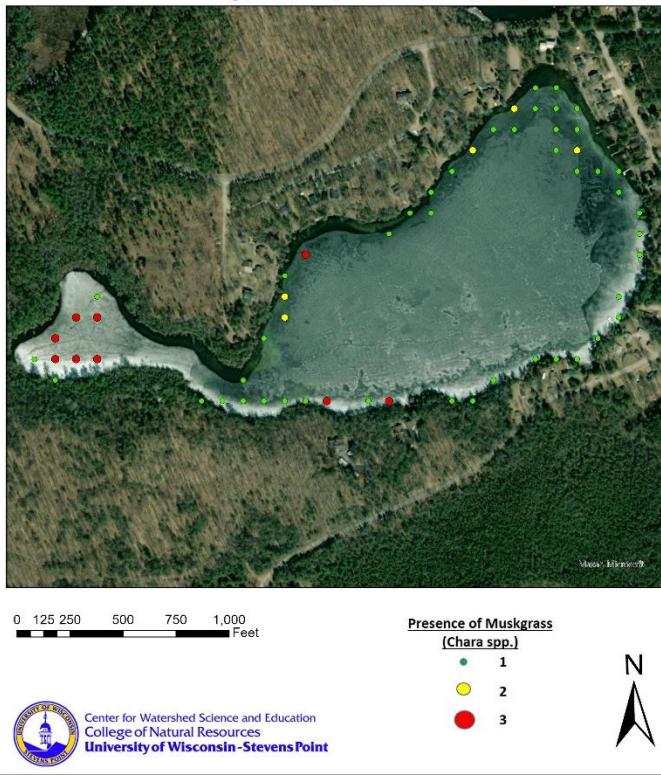
White Lake Aquatic Plant Survey: 2019 Muskgass (Chara spp.)

Chara is a type of macro algae that grows attached to muddy lake bottoms and has a musky odor. Muskgass, as it is known, filters the lake water and is helpful in preventing the establishment of invasive species.

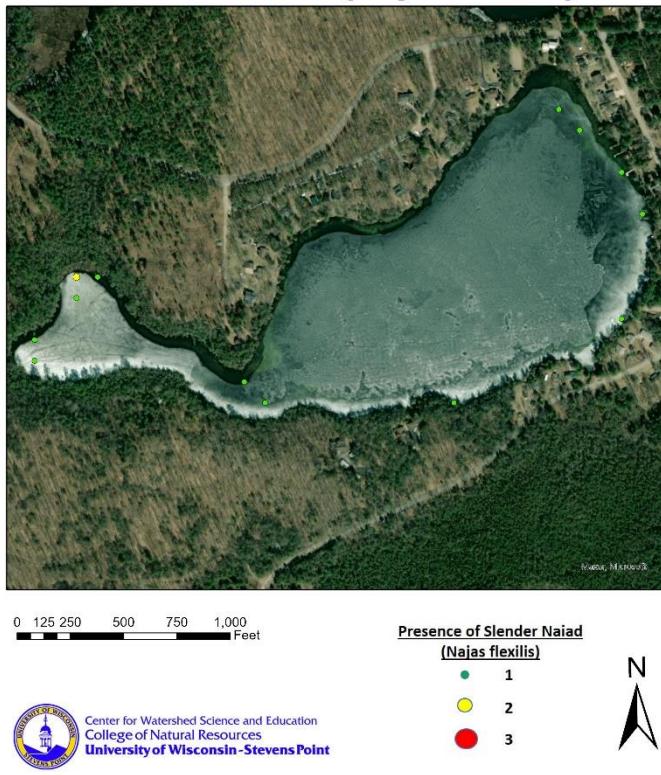
White Lake Aquatic Plant Survey: 2019 Slender naiad (Najas flexilis)

Slender naiad, also called nodding water-nymph, is a primary food source for waterfowl and provides habitat for many invertebrates.

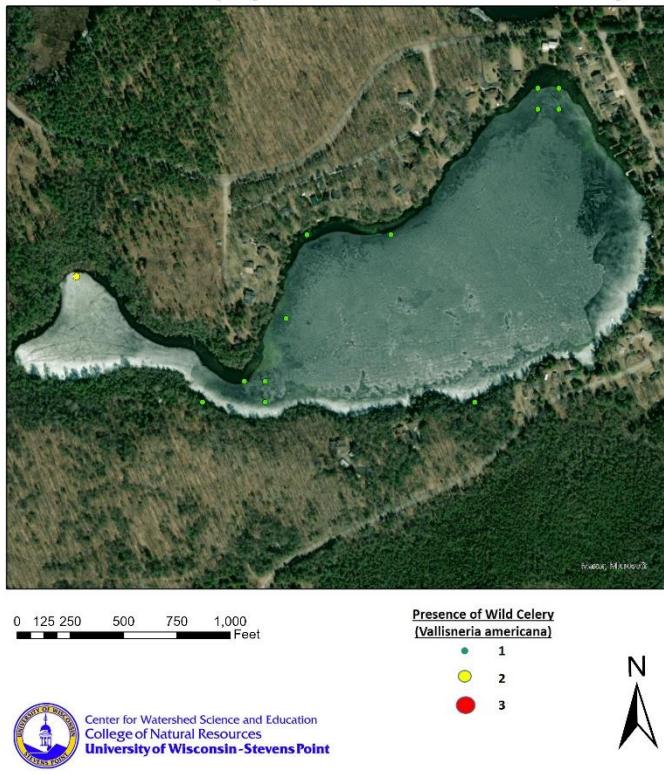
White Lake Aquatic Plant Survey: 2019 Wild celery (*Vallisneria americana*)

Wild celery has long, thin, ribbon-like leaves that are commonly up to four feet long. The seeds, roots and leaves are consumed by ducks and other waterfowl. Water celery provides excellent habitat for fish.
