Oconto County Lakes Project

BASS LAKE STUDY SUMMARY REPORT 2019

*University of Wisconsin-Stevens Point and
Oconto County Staff and Citizens*

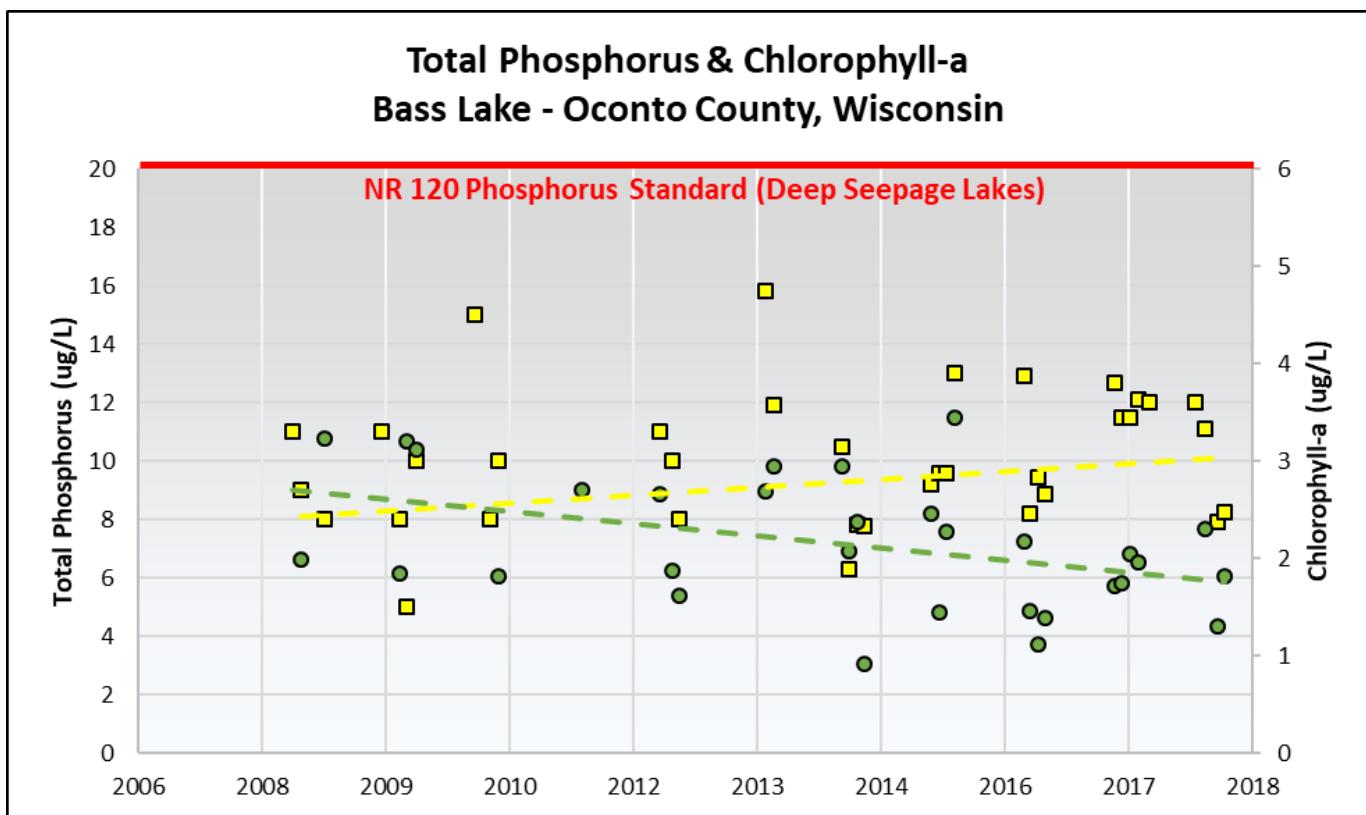
- Total Phosphorus was consistently below the standard of 20 ug/L for deep seepage lakes during the two-year study. The 14-year trend is slightly decreasing.
- Inorganic nitrogen remained below the threshold of 0.3 ug/L when algal blooms increase.
- Chlorophyll-a remained below 6 ug/L and appears to be decreasing over the long term.

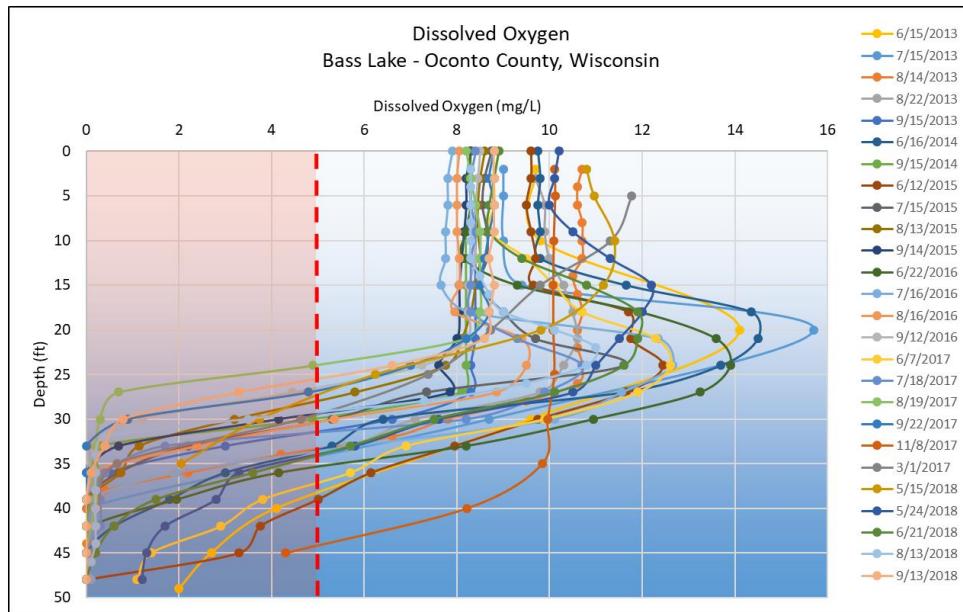
- Sufficient oxygen is available in Bass Lake throughout the year in the upper 25 feet of the water column.
- Bumps in dissolved oxygen concentrations at 15-30 feet suggest mild algal activity.

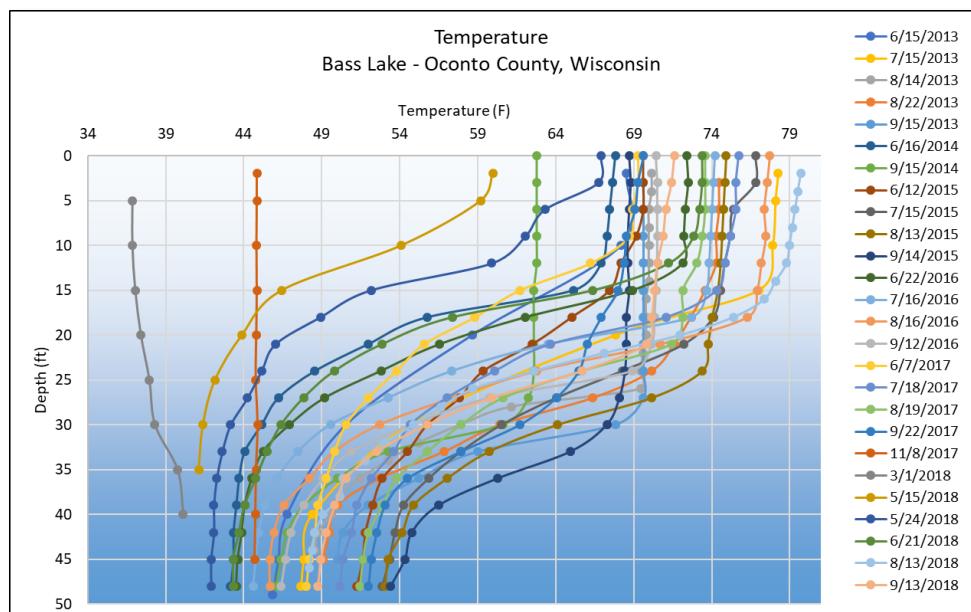
- The temperature gradient in Bass Lake shows a clear thermocline between 15-30 feet during much of the year.

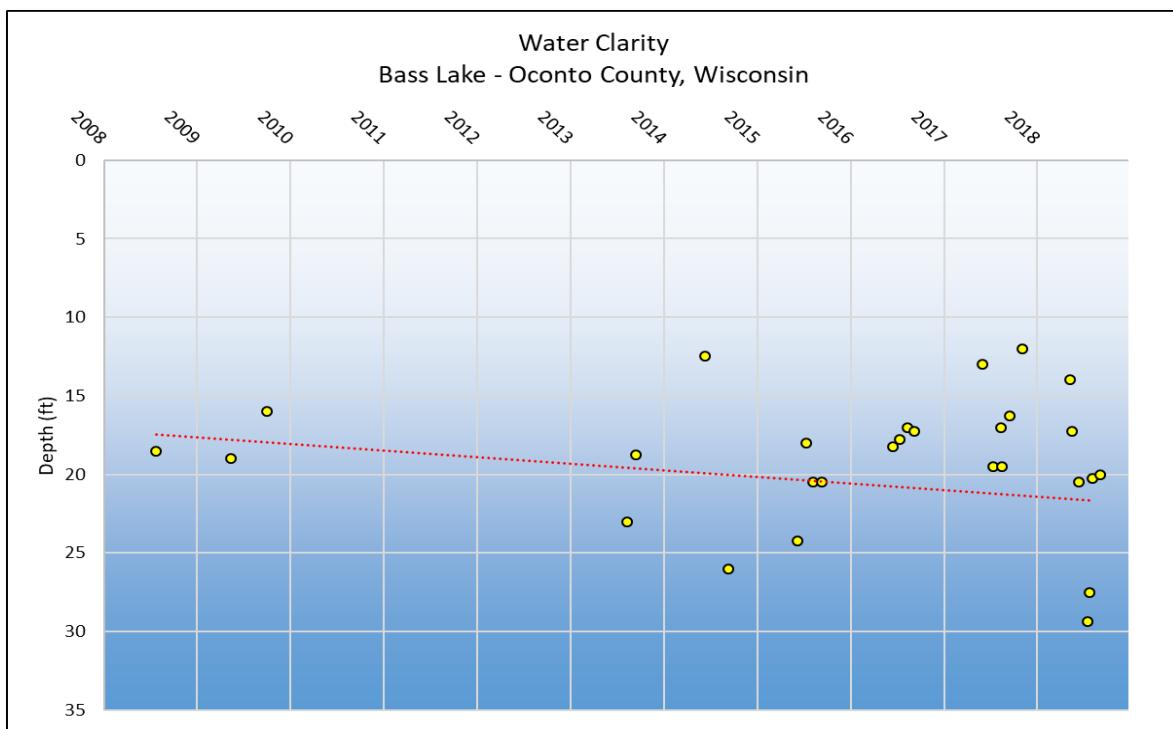
- The graph below shows water clarity measurements taken between April and November. It is typical for water clarity to vary throughout the year.
- During 2017-18, on average, the poorest water clarity in Bass Lake was in May and November and the best was in July. This is consistent with previous observations and demonstrates a slightly increasing trend over the past 10 years.

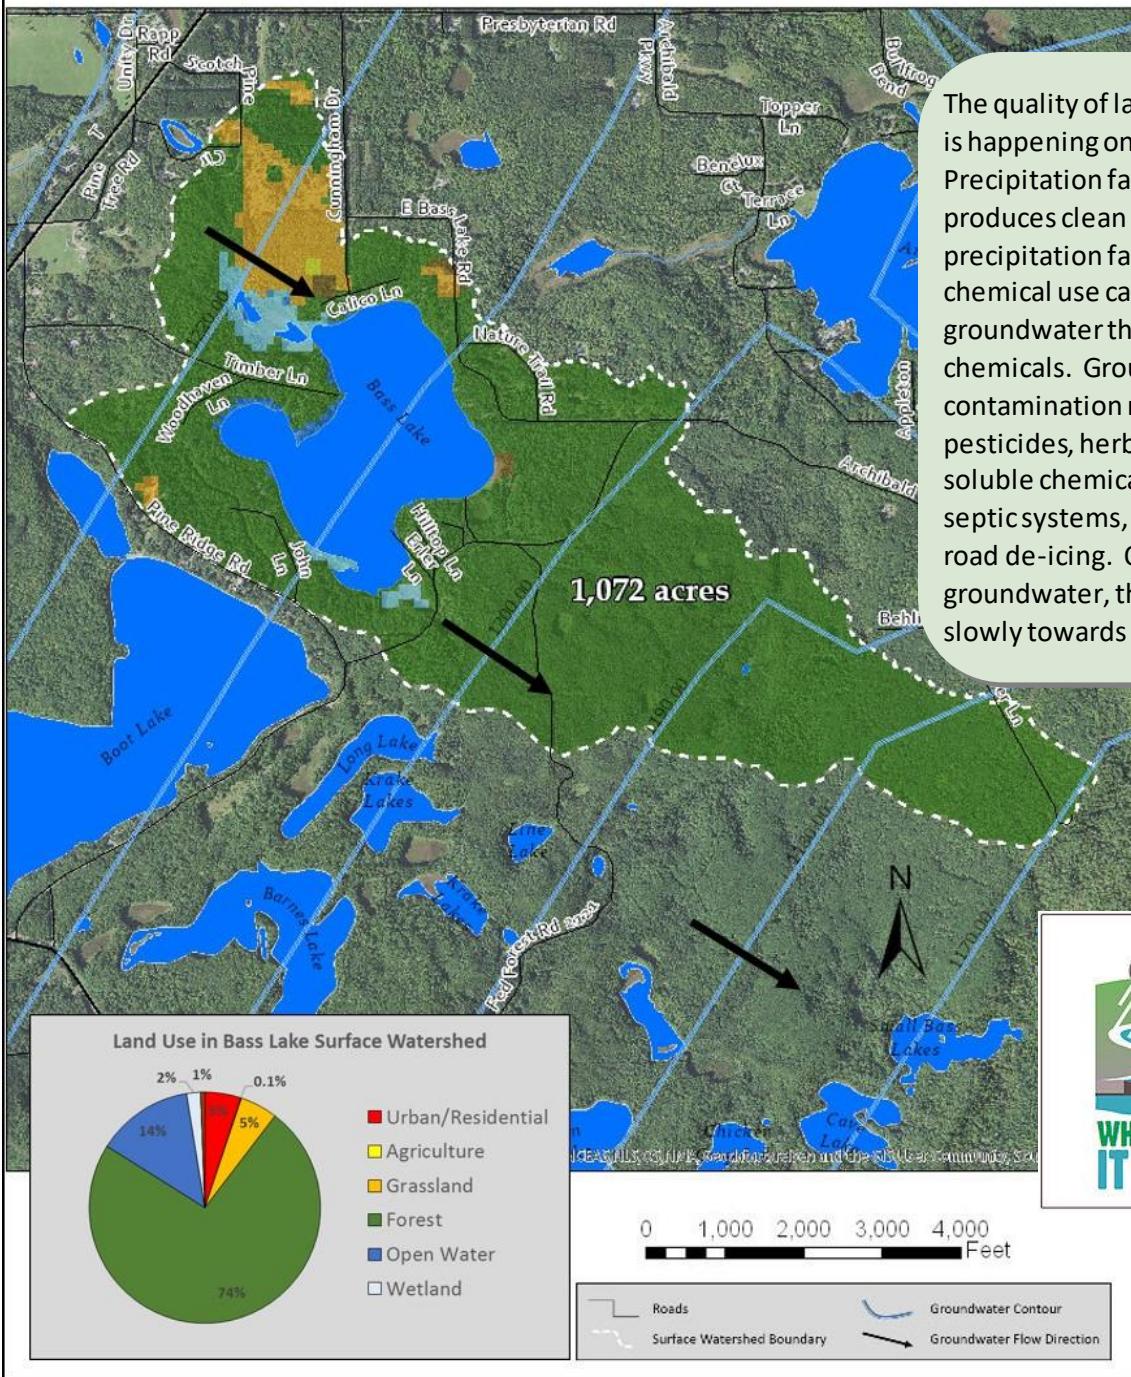
Bass Lake Surface Watershed & Groundwater Flow

Groundwater provides water to lakes in Oconto County throughout the entire year. Hard surfaces on the landscape prevent water from soaking into the ground and becoming groundwater. This results in less water flowing to the lake during snowmelt and rain events. Water that does not infiltrate to groundwater becomes **surface runoff** flowing across the surface of the landscape where it can move sediment and contaminants to the lake from within its watershed.

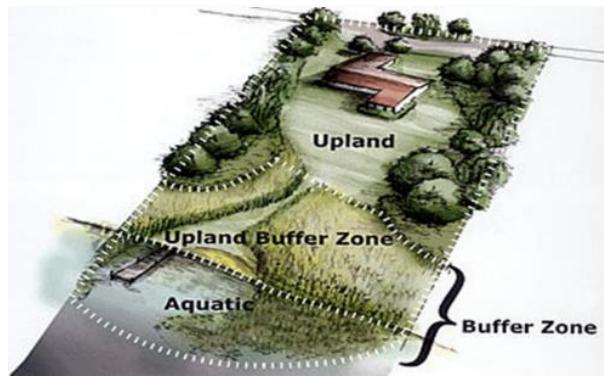
Shorelands around Bass Lake were surveyed in August 2017. Much of Bass Lake's shoreland is healthy, but some stretches are in need of restoration. Restoration would benefit the lake.

Total lakefront footage	No. Riparian lots	Total allowable (NR115) disturbed shoreland-feet	Total allowable (NR115) disturbed shoreland-%	Measured shoreland disturbance-feet	Measured shoreland disturbance-%
16,374	94	2,820	17%	5,656	35%

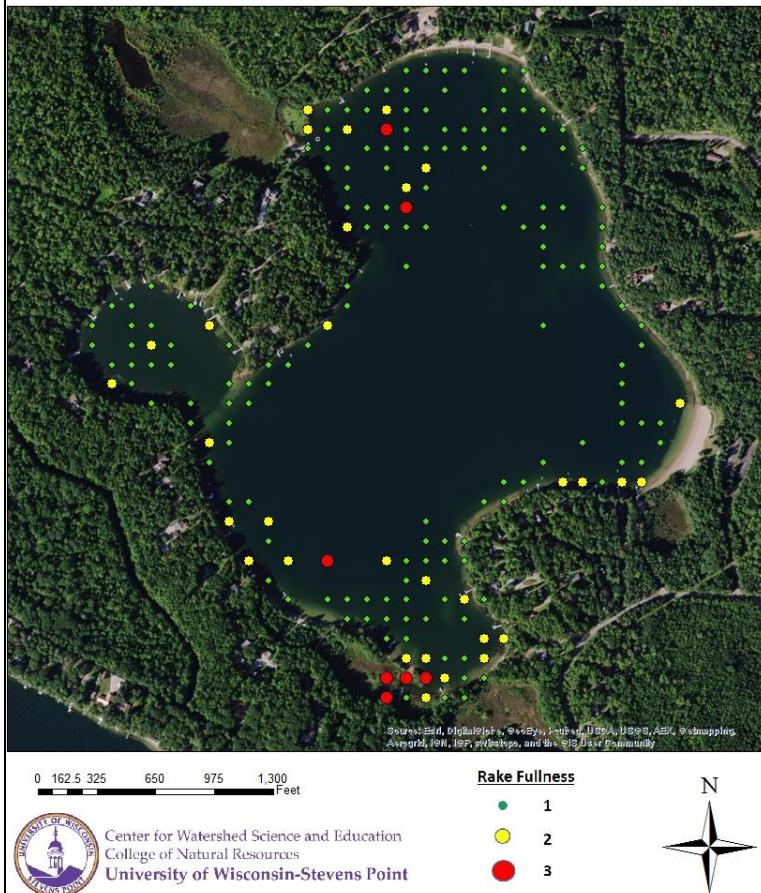
Bass Lake Aquatic Plant Survey 2017: Rake Fullness

- The aquatic plant community in Bass Lake is characterized by above-average diversity of plant species when compared to other lakes in the Oconto County Lakes Project, with a total of 30 species in the 2017 survey.
- During the 2017 aquatic plant survey of Bass Lake, 41% of the sites (52% of littoral area) had vegetative growth. The maximum depth of vegetation was 29 feet.
- The most frequently encountered plant species were chara (77%), variable pondweed (16%), and slender naiad (14%). All three species are native to Wisconsin. Additionally, the rare small bladderwort (high quality, sensitive species) was observed.

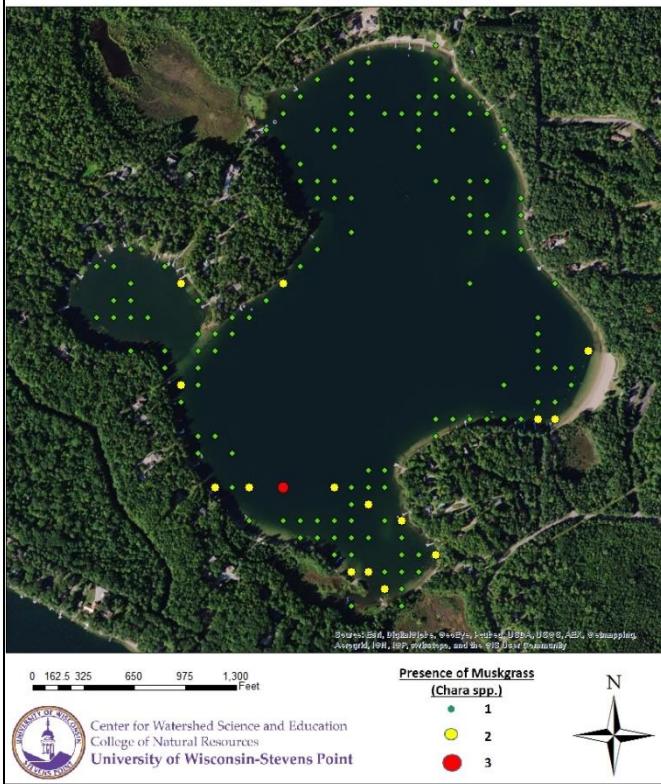
Bass Lake Aquatic Plant Survey 2017: Muskgass (Chara spp.)

Chara is a type of macro algae that grows attached to muddy lake bottoms and has a musky odor. Muskgass, as it is known, filters the lake water and is helpful in preventing the establishment of invasive species.

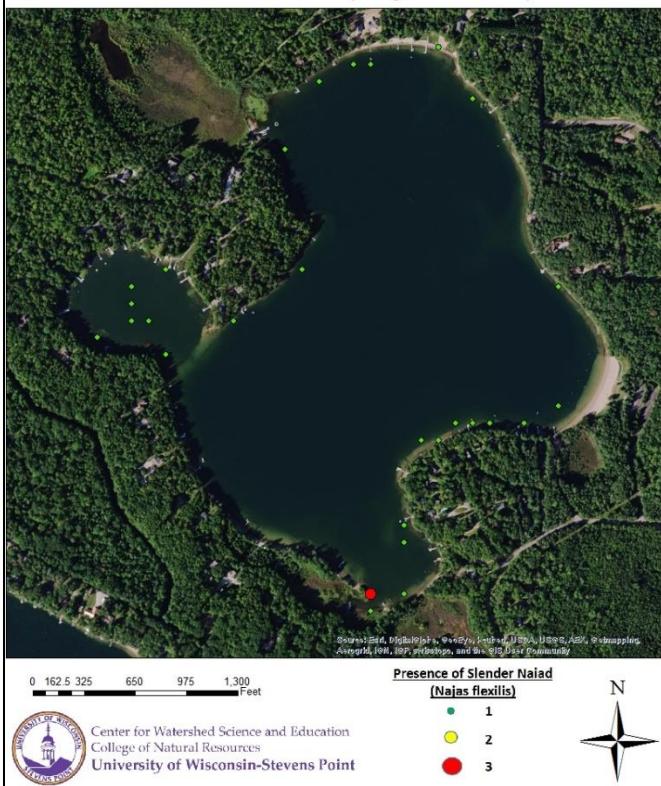
Bass Lake Aquatic Plant Survey 2017: Slender Naiad (Najas flexilis)

Slender naiad has glossy, finely toothed leaves appearing as whorls near the end of stems. Also known as the water-nymph, the whole plant is eaten by waterfowl and provides shelter for small fish and insects.

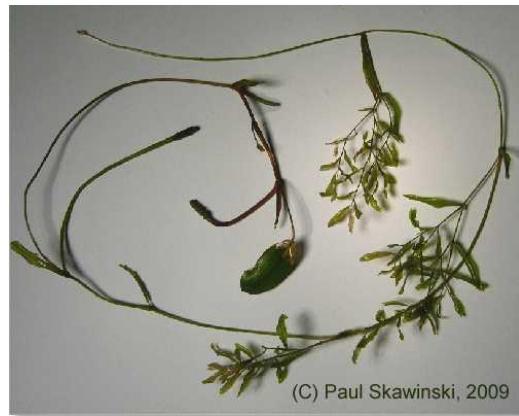
Variable pondweed has both floating and submersed leaves which provide food and habitat for fish.
