# Oconto County Lakes Project

## PECOR LAKE STUDY

### SUMMARY REPORT

2021

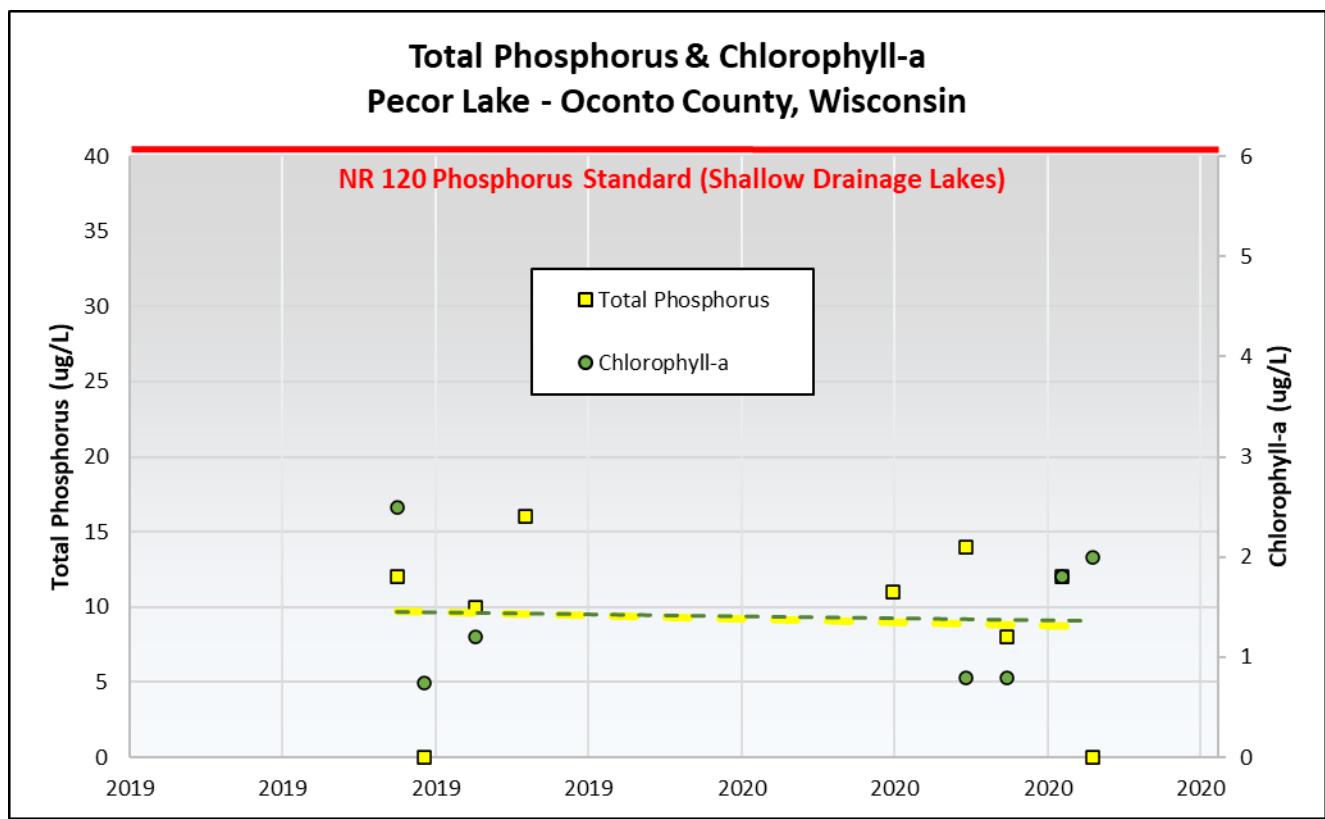
- Total Phosphorus was consistently below the Wisconsin state standard of 40 ug/L for shallow drainage lakes during the two-year study. The two-year trend is stable.
- Inorganic nitrogen remained below the threshold of 0.3 mg/L when algal blooms increase.
- Chlorophyll-a, an indirect measure of algae, stayed well below the threshold of 6 ug/L.

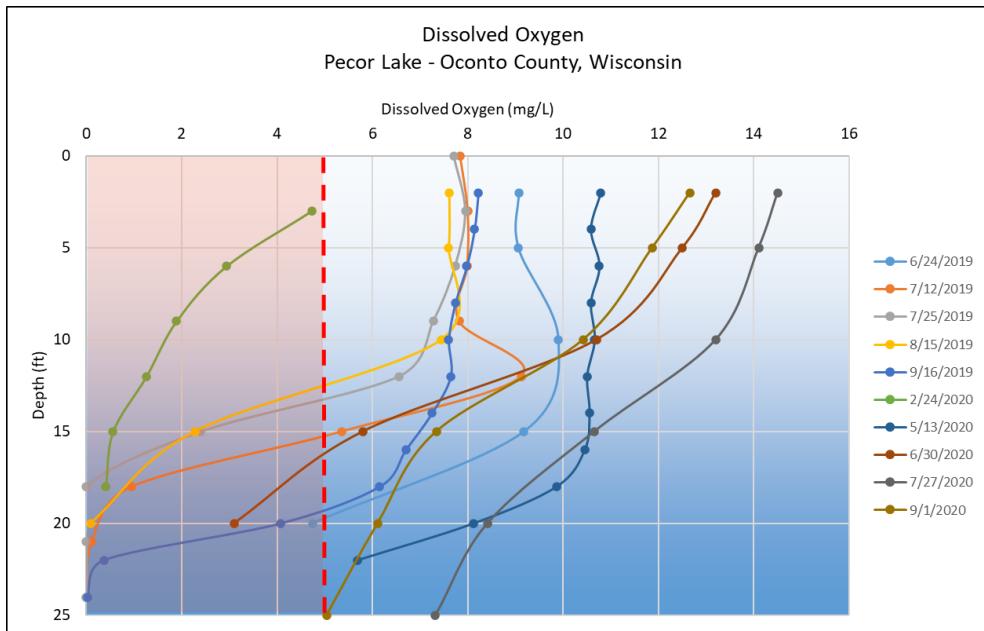
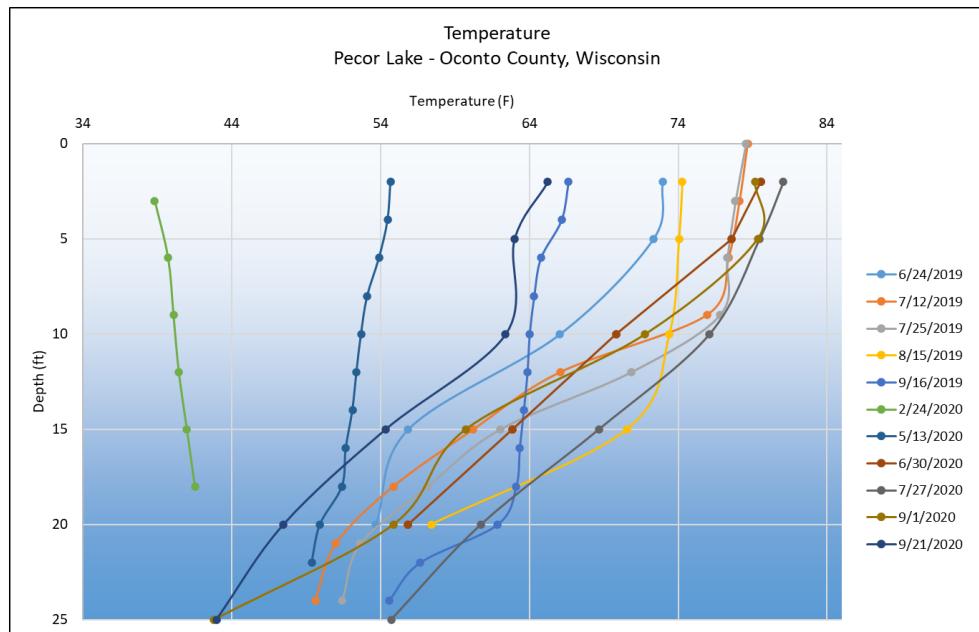
Sufficient **dissolved oxygen** in lake water is essential to the survival of aquatic organisms. The amount of dissolved oxygen present within a lake varies by season and depth. It is determined by the biological activity that consumes or produces oxygen, by water mixing through wind, changes in temperature, and inputs of surface and groundwater. Generally, at least 5 mg/L oxygen is required for fish.

- Sufficient oxygen is available in the water column of Pecor Lake most of the year, however, by late winter, concentrations can be very low, indicating this lake may be susceptible to fish kills.
- Some algae blooms at depth (~10 feet) in summer are shown by these profiles.

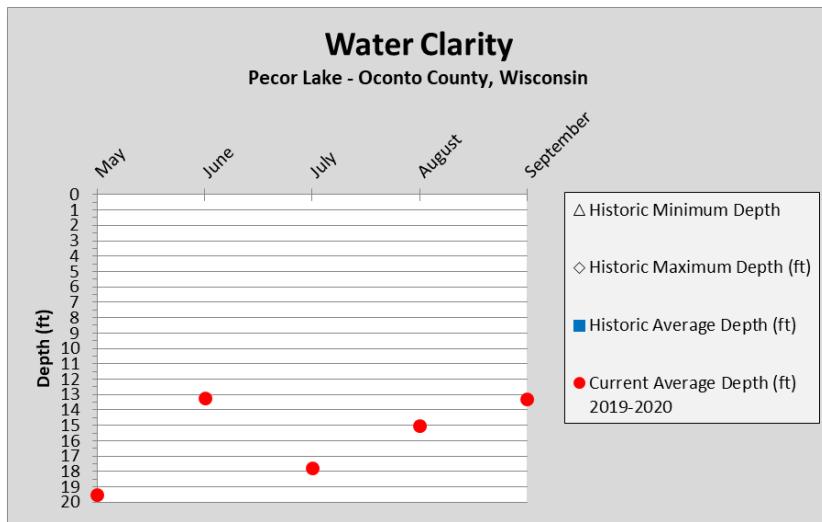
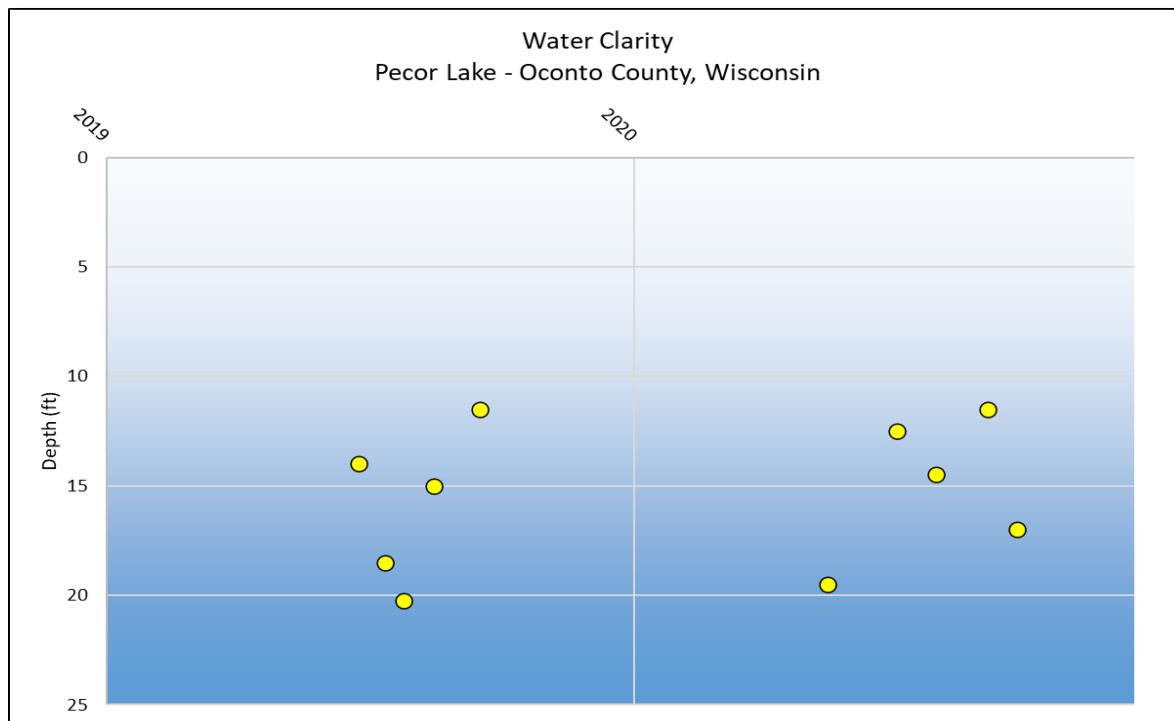
**Water clarity** is a measure of how deep light can penetrate (Secchi depth). Clarity is affected by water color, turbidity (suspended sediment), and algae. Water clarity helps determine where rooted aquatic plants can grow. It is typical for water clarity to vary throughout the year.

- The graph below shows water clarity measurements taken between May and September.
- During 2019-20, on average, the poorest water clarity in Pecor Lake was in June and September; the best was in May.

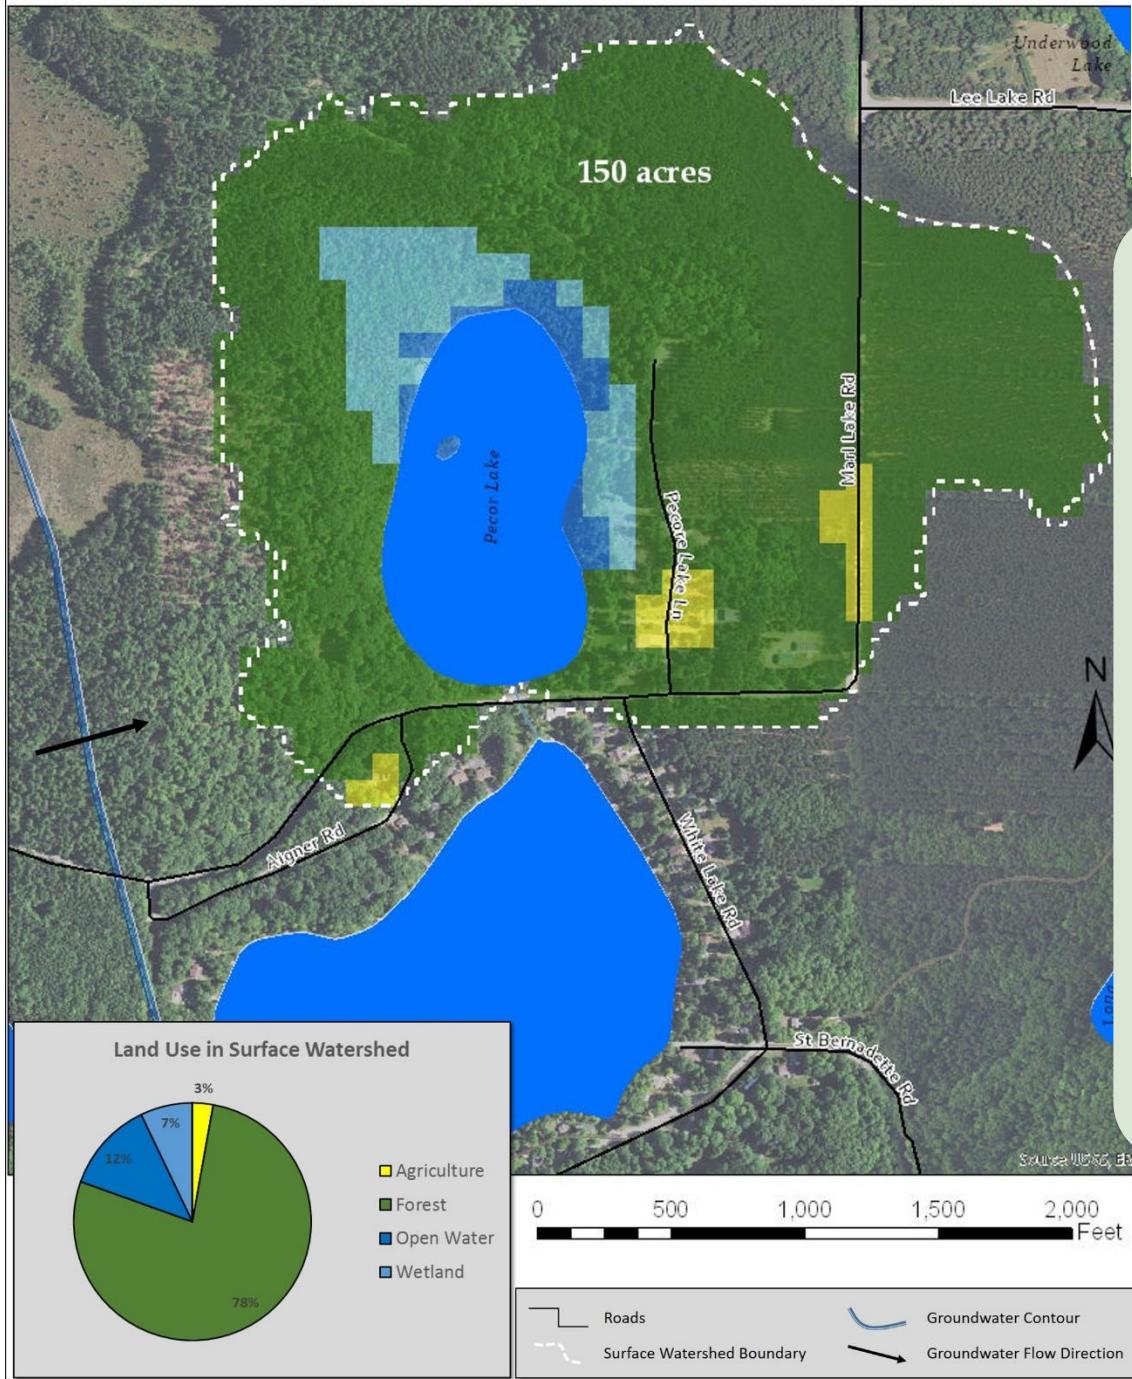
## Pecor Lake Surface Watershed & Groundwater Flow

**Groundwater** provides water to lakes in Oconto County throughout the entire year. Hard surfaces on the landscape prevent water from soaking into the ground and becoming groundwater. This results in less water flowing to the lake during snowmelt and rain events. Water that does not infiltrate to groundwater becomes **surface runoff** flowing across the surface of the landscape where it can move sediment and contaminants to the lake from within its watershed.

The quality of lake water reflects what is happening on the land surface. Precipitation falling on forests produces clean groundwater, whereas precipitation falling on land that has chemical use can produce runoff and groundwater that contains these chemicals. Groundwater contamination may include nitrogen, pesticides, herbicides and other soluble chemicals originating from septic systems, crops, barnyards, and road de-icing. Once in the groundwater, these chemicals move slowly towards a lake or river.

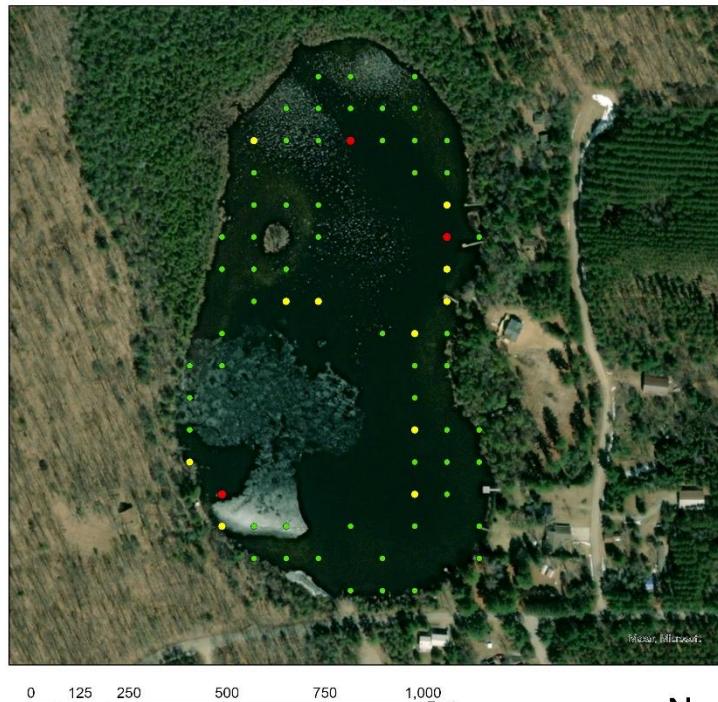
## Pecor Lake Aquatic Plant Survey 2019: Rake Fullness

- The aquatic plant community in Pecor Lake is characterized by average diversity of plant species when compared to other lakes in the Oconto County Lakes Project, with a total of 20 species in the 2019 survey.
- During the 2019 aquatic plant survey of Pecor Lake, 54% of visited sites had vegetative growth. The maximum depth of vegetation was 10 feet.
- The most frequently encountered plant species were chara (66%), slender naiad (49%) and white water lily (26%). All three species are native to Wisconsin.
- No invasive species were observed.

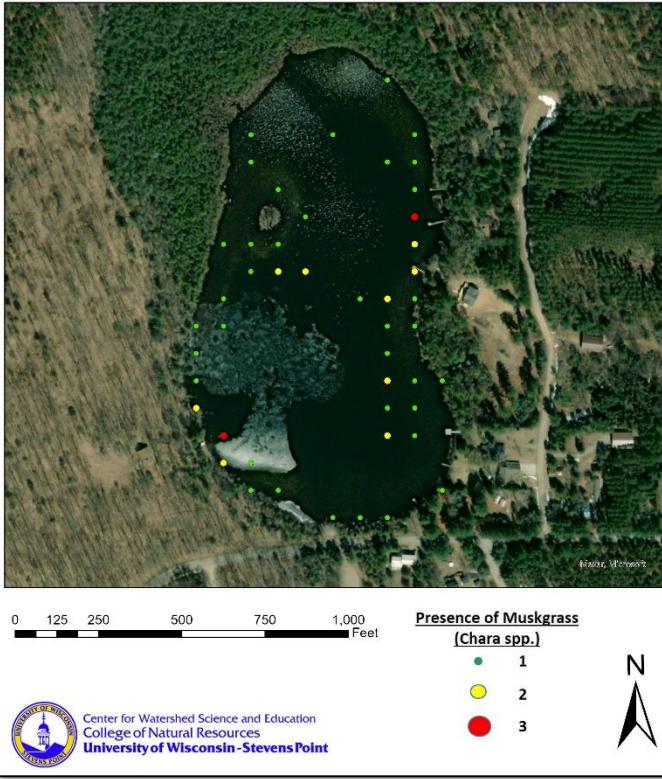
## Pecor Lake Aquatic Plant Survey: 2019 Muskgass (Chara spp.)

**Chara** is a type of macro algae that grows attached to muddy lake bottoms and has a musky odor. Muskgass, as it is known, filters the lake water and is helpful in preventing the establishment of invasive species.

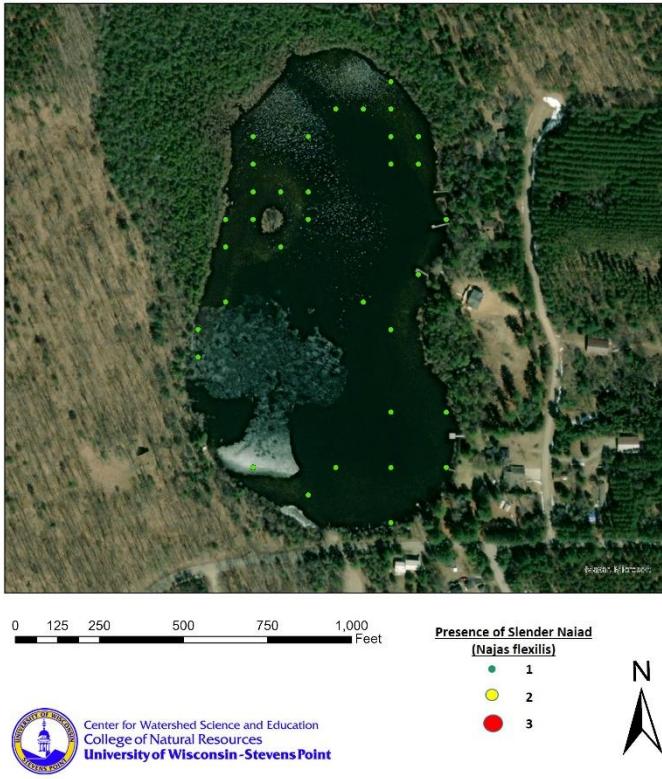
## Pecor Lake Aquatic Plant Survey: 2019 Slender naiad (Najas flexilis)

**Slender naiad**, also called nodding water-nymph, is a primary food source for waterfowl and provides habitat for many invertebrates.

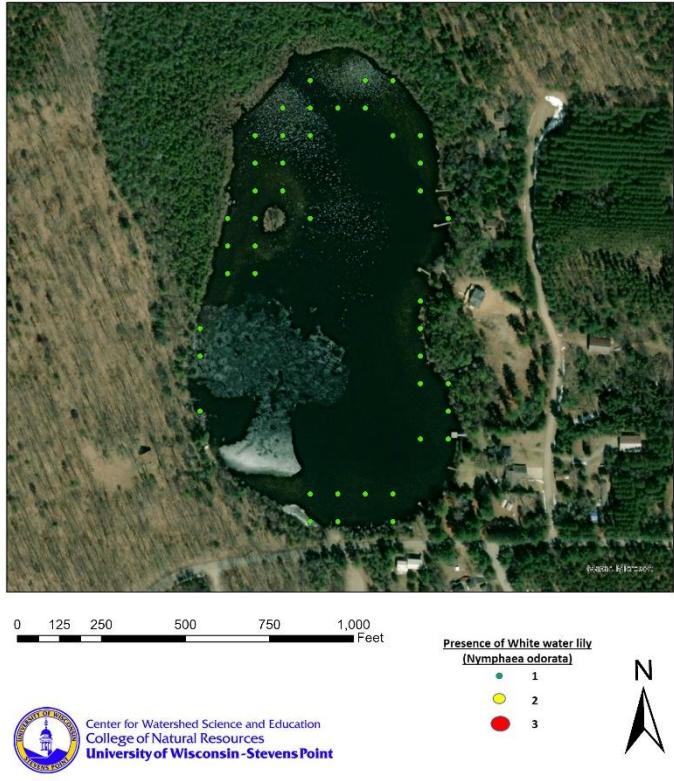
## Pecor Lake Aquatic Plant Survey: 2019 White water lily (*Nymphaea odorata*)

**White water lily** has round stalks that grow up from a rhizome in the sediment connecting to large round floating leaves. By mid-summer, white flowers also float at the surface. Lilies are important cover for fish, are food by many species, and help prevent erosion by slowing wave action.
