# Oconto County Lakes Project

## BOULDER LAKE STUDY

### SUMMARY REPORT

2023

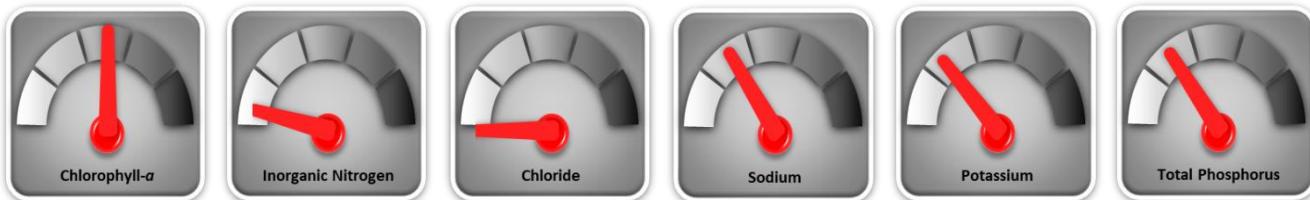
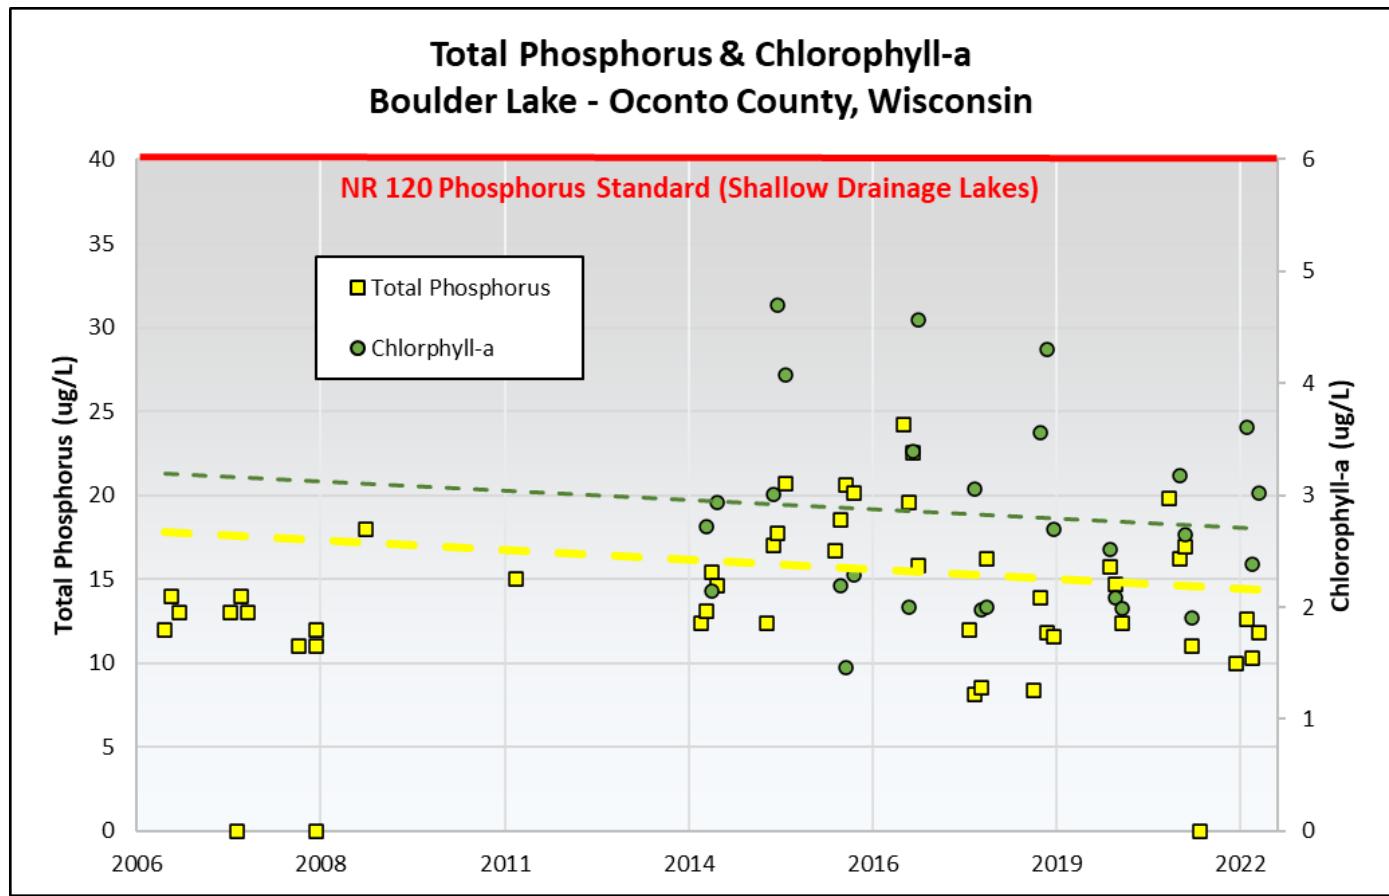
- Total Phosphorus was consistently below the Wisconsin state standard of 40 ug/L for shallow drainage lakes during the two-year study. The long-term trend suggests slowly decreasing average concentrations.
- Inorganic nitrogen remained below the threshold of 0.3 mg/L when algal blooms increase.
- Chlorophyll-a, an indirect measure of algae, remained below the threshold of 6 ug/L throughout the study.

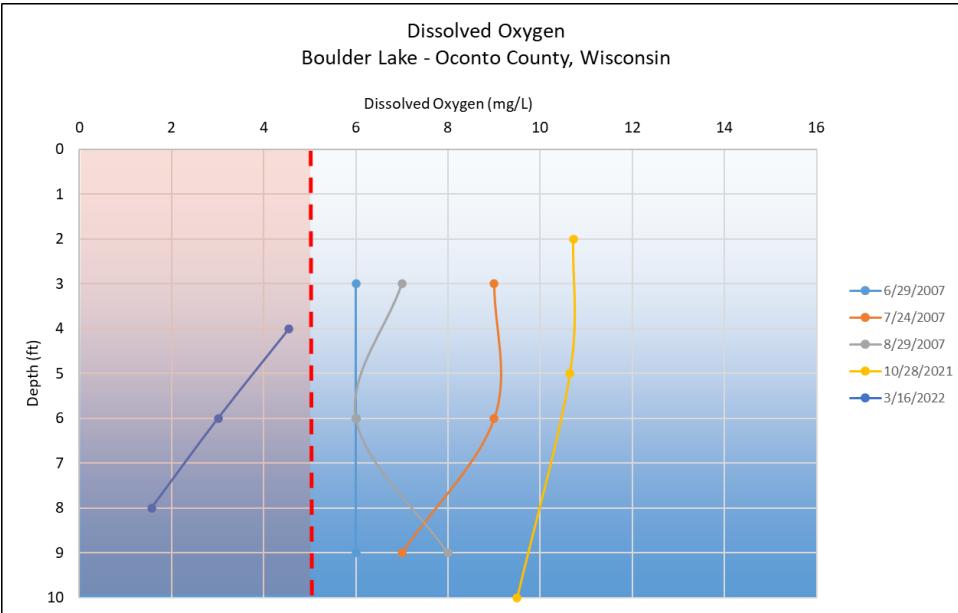
➤ Sufficient oxygen is available in the water column of Boulder Lake through most of the year but may become anoxic in late winter. Generally, the top 4 feet maintains enough oxygen to support most fish species.

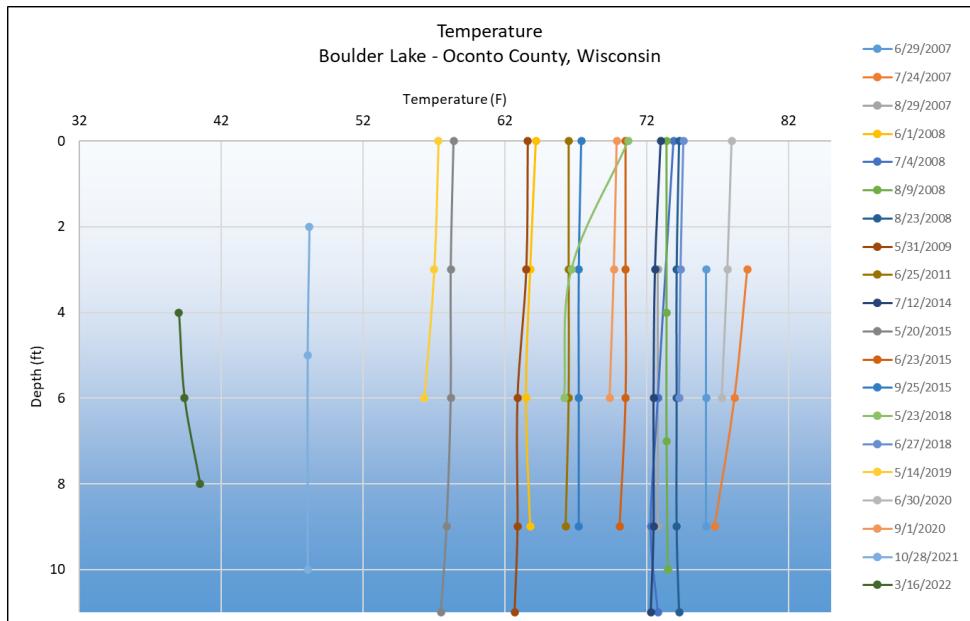
- Temperature profiles in Boulder Lake are typical of a shallow, mixed lake with similar water temperatures from surface to bottom at each sampling event.

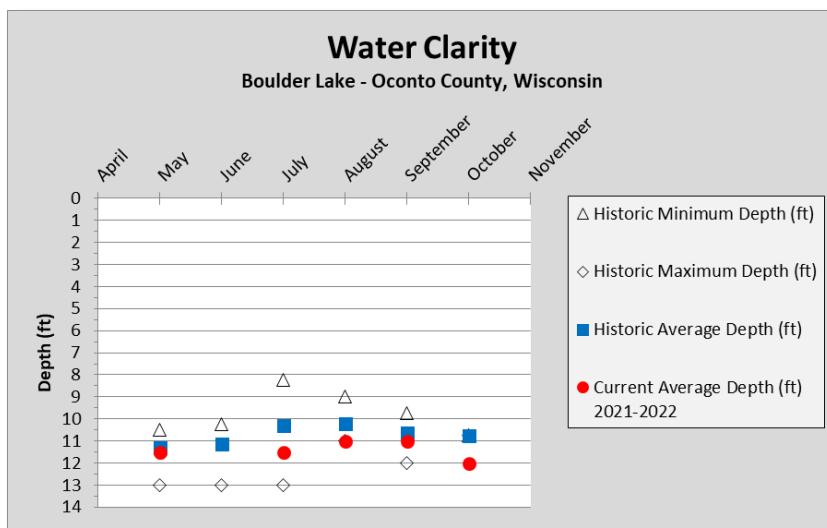
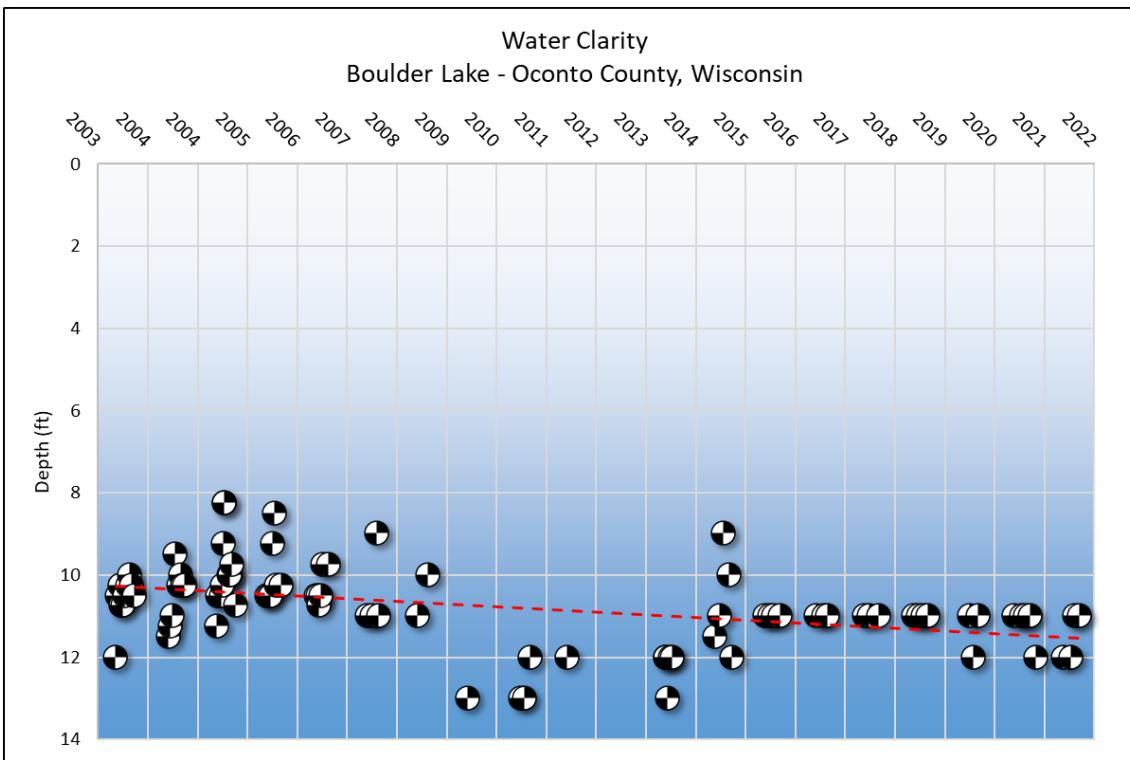
- The graphs below show water clarity measurements taken between May and November.
- During 2021-22, the poorest average water clarity was in August and best was in October. Comparison to previous data suggests a trend of slightly increasing water clarity.

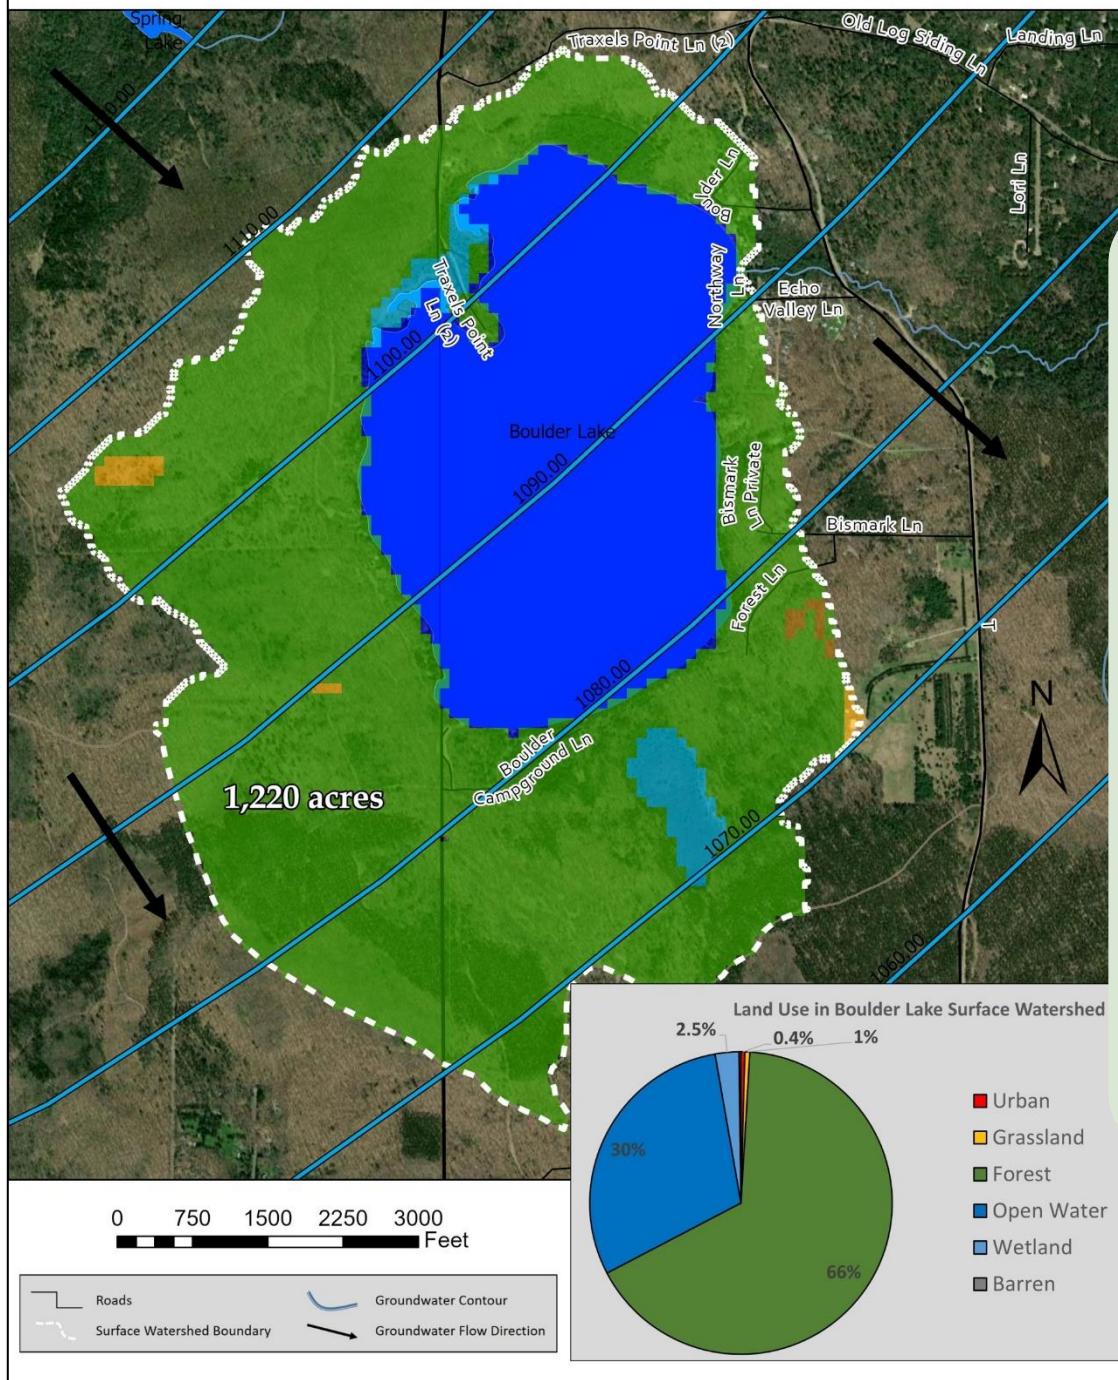
## Boulder Lake Surface Watershed & Groundwater Flow

**Groundwater** provides water to lakes in Oconto County throughout the entire year. Hard surfaces on the landscape prevent water from soaking into the ground and becoming groundwater. This results in less water flowing to the lake during snowmelt and rain events. Water that does not infiltrate to groundwater becomes **surface runoff** flowing across the surface of the landscape where it can move sediment and contaminants to the lake from within its watershed.

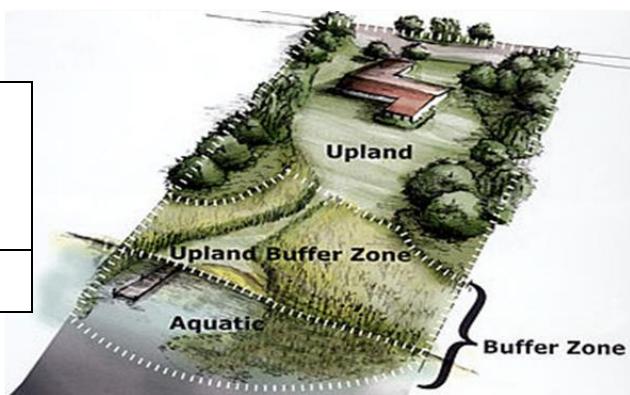
- Shorelands around Boulder Lake were surveyed in August 2021. Many shoreland areas are healthy, but some stretches are in need of restoration.

Total lakefront footage (feet)	No. Riparian lots	Measured shoreland disturbance (feet)	Measured shoreland disturbance (%)
18,291	73	4,961	27%

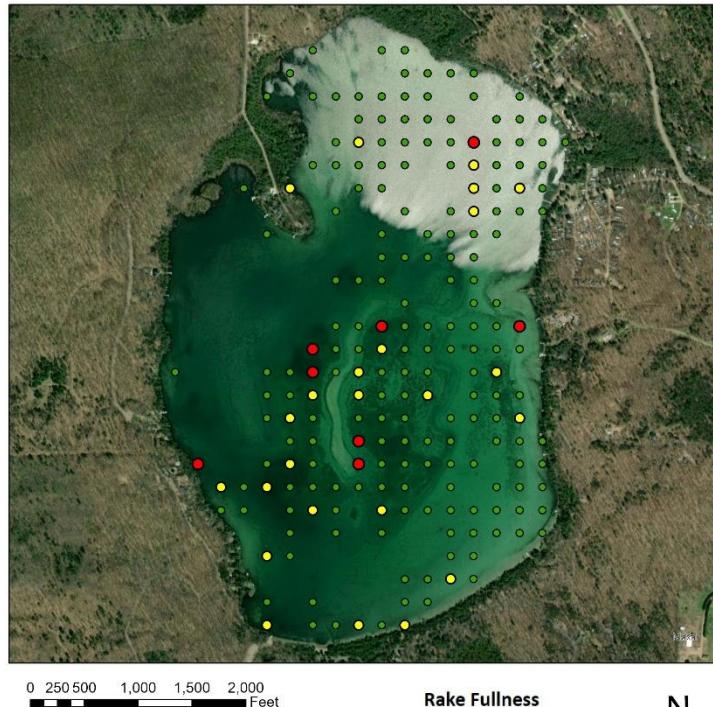
Boulder Lake Aquatic Plant Survey 2021:  
Rake Fullness

- The aquatic plant community in Boulder Lake is characterized by below average diversity of plant species when compared to other lakes in the Oconto County Lakes Project, with a total of 14 species in the 2021 survey.
- During the 2021 aquatic plant survey of Boulder Lake, 58% of visited sites had vegetative growth. The maximum depth of vegetation was 11 feet and the Floristic Quality Assessment (FQI) was 21.2.
- The most frequently encountered plant species were chara (91%), Illinois pondweed (20%), and variable pondweed (16%).
- Eurasian water-milfoil, an invasive species in Wisconsin, was observed at one location.

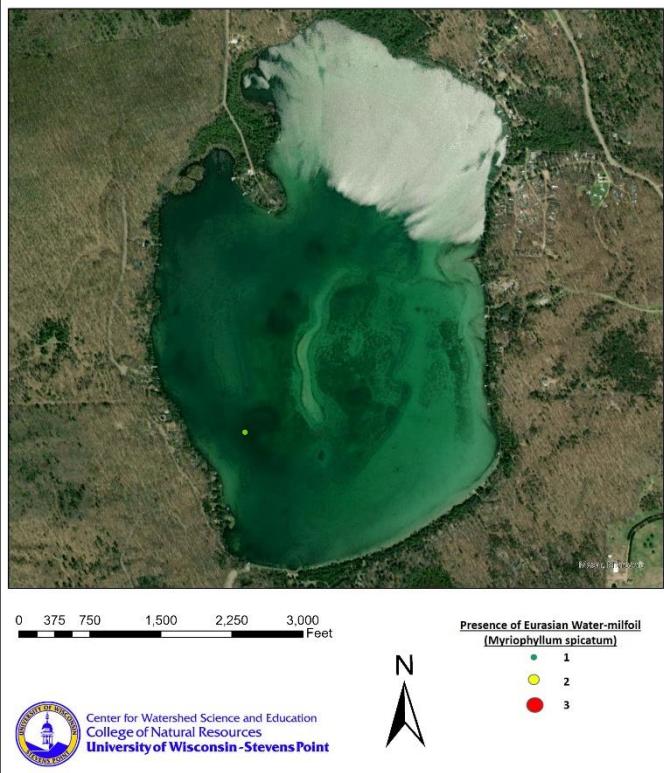
## Boulder Lake Aquatic Plant Survey 2021: Eurasian Water-milfoil (*Myriophyllum spicatum*)

- Eurasian water-milfoil, first documented in Boulder Lake in 2012, was observed at one location in the 2021 aquatic plant survey.
- Banded mystery snail was first documented in 2012.
