# Oconto County Lakes Project

## LONG LAKE (BRAZEAU) STUDY

### SUMMARY REPORT

2023

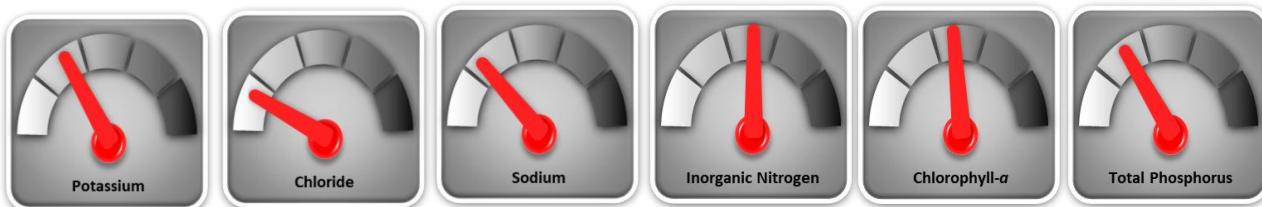
- Total Phosphorus was consistently below the Wisconsin state standard of 40 ug/L for shallow seepage lakes during the two-year study. Continued monitoring is necessary to determine any trends.
- Inorganic nitrogen remained below the threshold of 0.3 mg/L when algal blooms increase.
- Chlorophyll-a, an indirect measure of algae, remained below the threshold of 6 ug/L throughout the study.

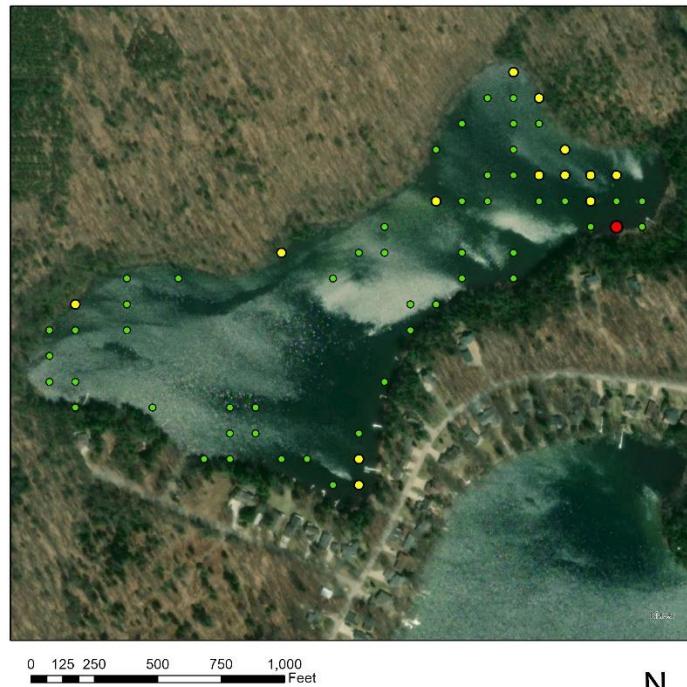
## Long Lake Aquatic Plant Survey 2021: Rake Fullness

- The aquatic plant community in Long Lake is characterized by average diversity of plant species when compared to other lakes in the Oconto County Lakes Project, with a total of 18 species in the 2021 survey.
- During the 2021 aquatic plant survey of Long Lake, 56% of visited sites had vegetative growth. The maximum depth of vegetation was 12 feet and the Floristic Quality Assessment (FQI) was 22.2.
- The most frequently encountered plant species were Slender naiad (49%), White water lily (35%), and Arrowhead (18%).
- No invasive species were observed.

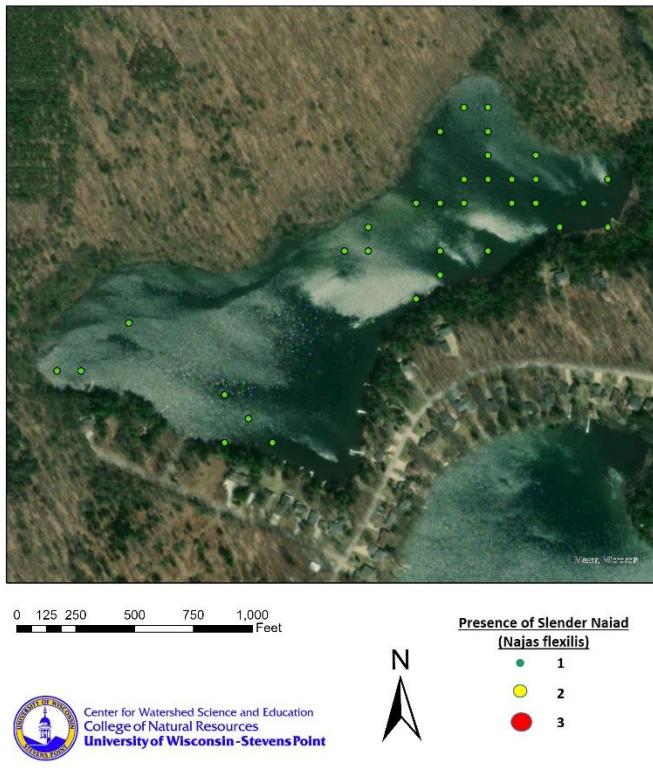
## Long Lake Aquatic Plant Survey 2021: Slender naiad (*Najas flexilis*)

**Slender naiad** has glossy, finely toothed leaves appearing as whorls near the end of stems. Also known as the water-nymph, the whole plant is eaten by waterfowl and provides shelter for small fish and insects.

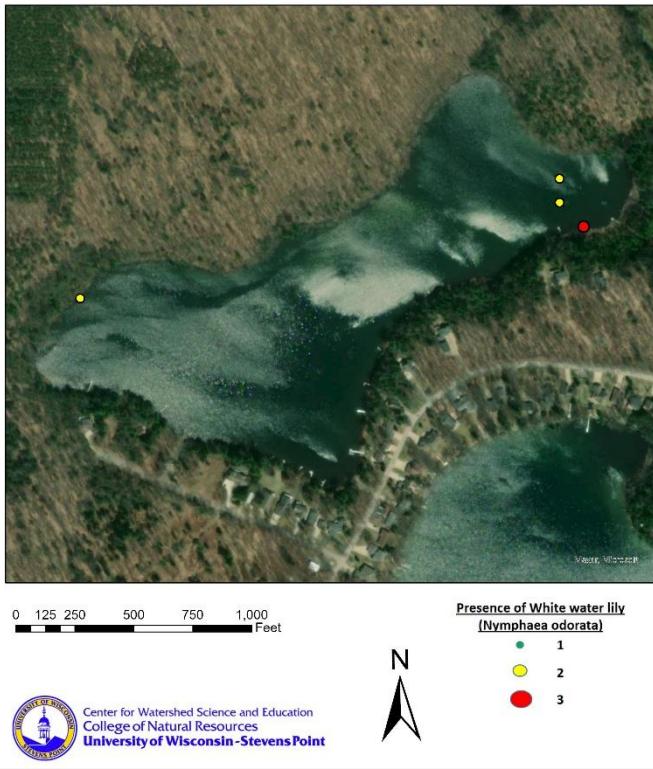
## Long Lake Aquatic Plant Survey 2021: White water lily (*Nymphaea odorata*)

**White water lily** has round stalks that grow up from a rhizome in the sediment connecting to large round floating leaves. By mid-summer, white flowers also float at the surface. Lilies are important cover for fish, are food by many species, and help prevent erosion by slowing wave action.
