Oconto County Lakes Project

FINNEGAN LAKE STUDY

SUMMARY REPORT

2024

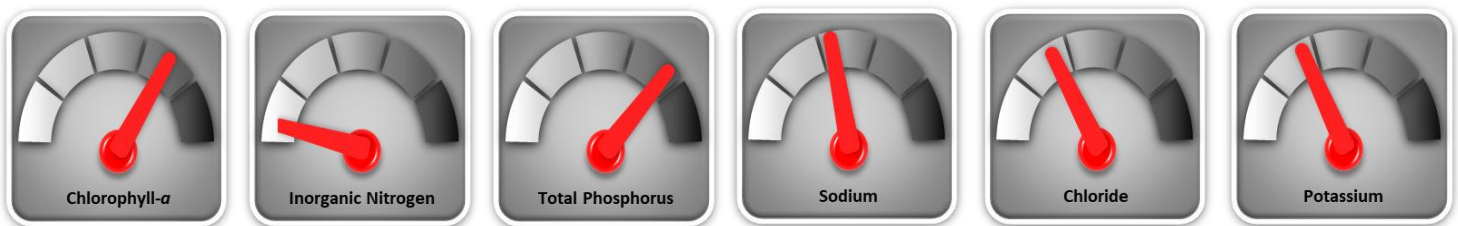
- Total Phosphorus was periodically above the Wisconsin state standard of 30 ug/L for deep seepage lakes during the two-year study. Limited data suggests this average concentration is coming down.
- Inorganic nitrogen remained below the threshold of 0.3 mg/L when algal blooms increase.
- Chlorophyll-a, an indirect measure of algae, reached the threshold of 6 ug/L in one sample during the study.

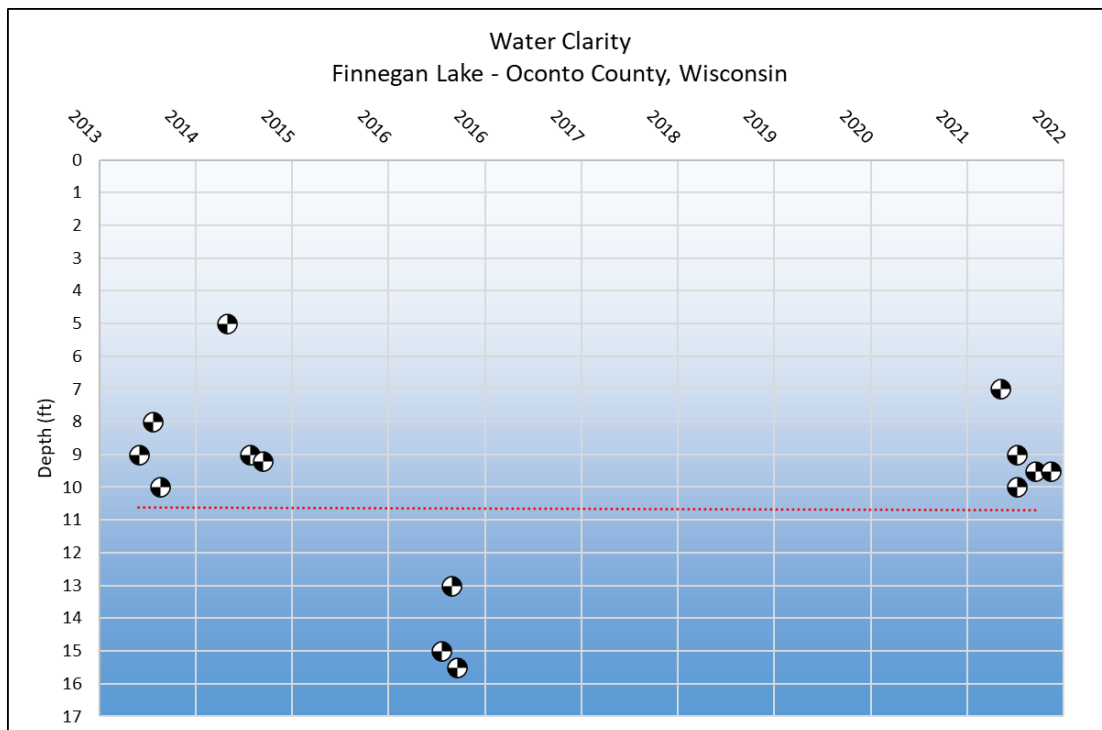
- The graphs below show water clarity measurements taken between May and November.
- During 2022-23, water clarity was best in June and worst in August. These averages are generally worse than historical averages.

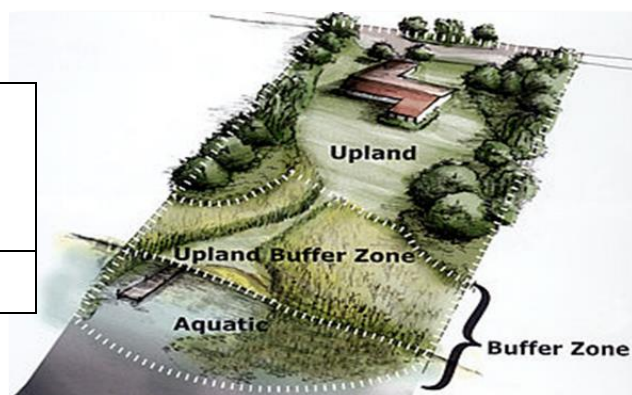
- Shorelands around Finnegan Lake were surveyed in July 2022. Most of Finnegan Lake's shoreland is healthy, but some sections are in need of restoration.

Total lakefront footage	No. Riparian lots	Measured shoreland disturbance (feet)	Measured shoreland disturbance (%)
1,750	7	62	4%

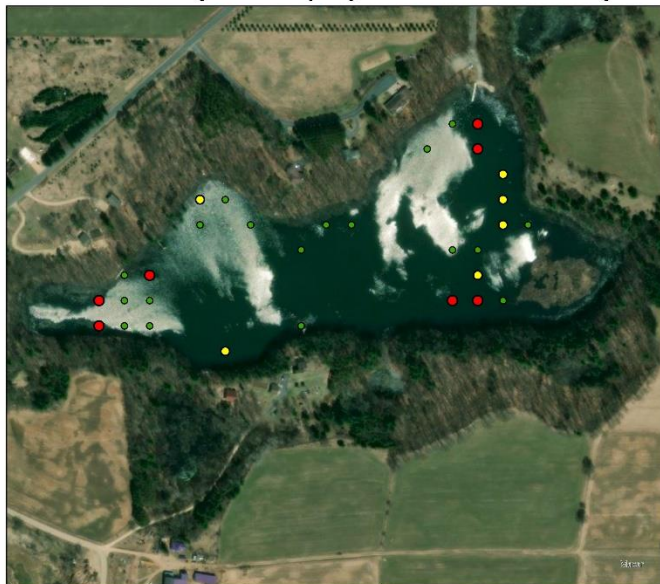
Finnegan Lake Aquatic Plant Survey 2022: Coontail (*Ceratophyllum demersum*)

Coontail lacks roots and can form dense mats just below the surface. It is usually in calm, nutrient-rich water and provides habitat for young fish and other aquatic animals. Waterfowl will eat the seeds and foliage.

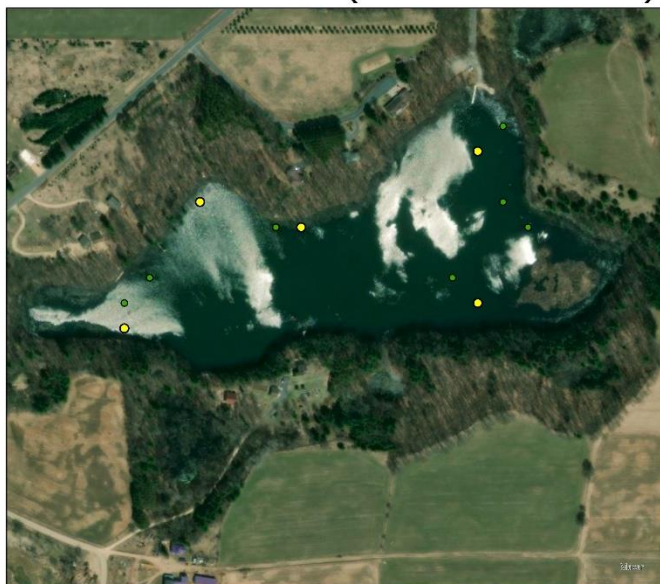
Finnegan Lake Aquatic Plant Survey 2022: Common waterweed (*Elodea canadensis*)

Common waterweed is a common and widespread plant in Wisconsin lakes. It is important forage and cover for aquatic animals and an important food source for waterfowl.

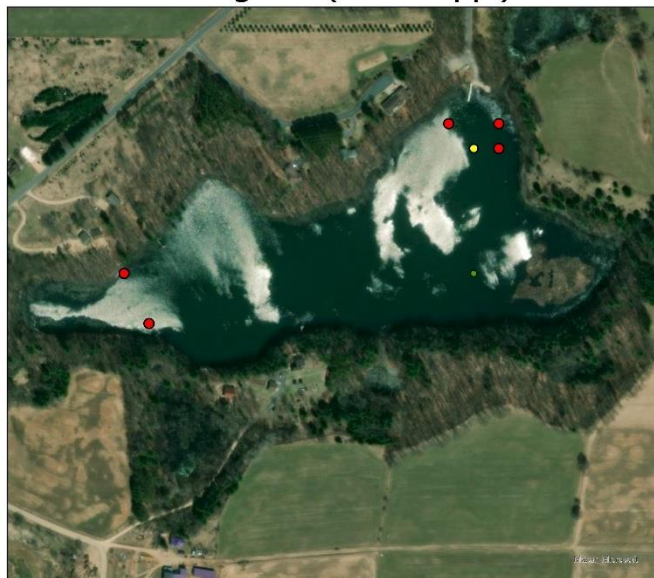
Finnegan Lake Aquatic Plant Survey 2022: Muskgrass (*Chara* spp.)

Chara is a type of macro algae that grows attached to muddy lake bottoms and has a musky odor. Muskgrass, as it is known, filters the lake water and is helpful in preventing the establishment of invasive species.

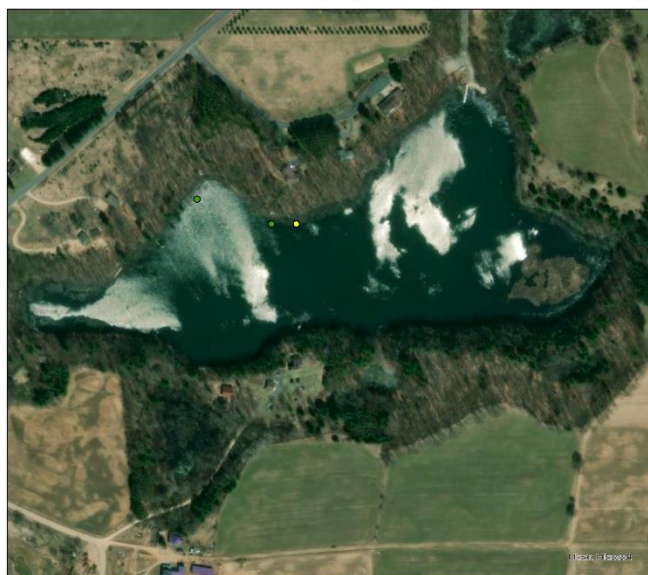
Finnegan Lake Aquatic Plant Survey 2022: Eurasian Water-milfoil (*Myriophyllum spicatum*)

Eurasian watermilfoil is one of the most common invasive aquatic plants in Wisconsin. It can form dense mats that choke out native plants and inhibit navigation. New plants can grow from stem fragments that root on contact with the substrate.

- Eurasian water-milfoil, first documented in 2003, was observed in three locations during the 2022 survey.
- Chinese mystery snails (2015), Banded mystery snails (2015) and phragmites (2015) have previously been documented in Finnegan Lake.
