Oconto County Lakes Project

CHAIN LAKE STUDY

SUMMARY REPORT

2023

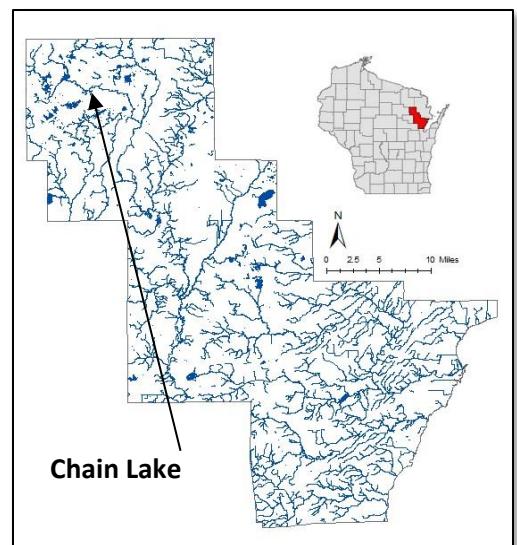
Chain Lake
Mapping by AutoChart

Surface Area: 76 acres

Maximum Depth: 42 feet

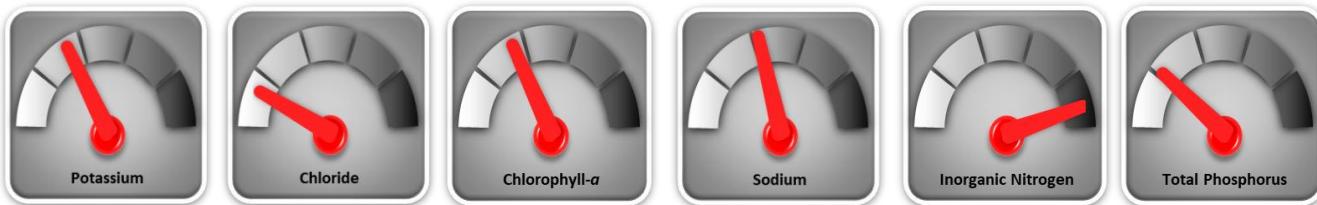
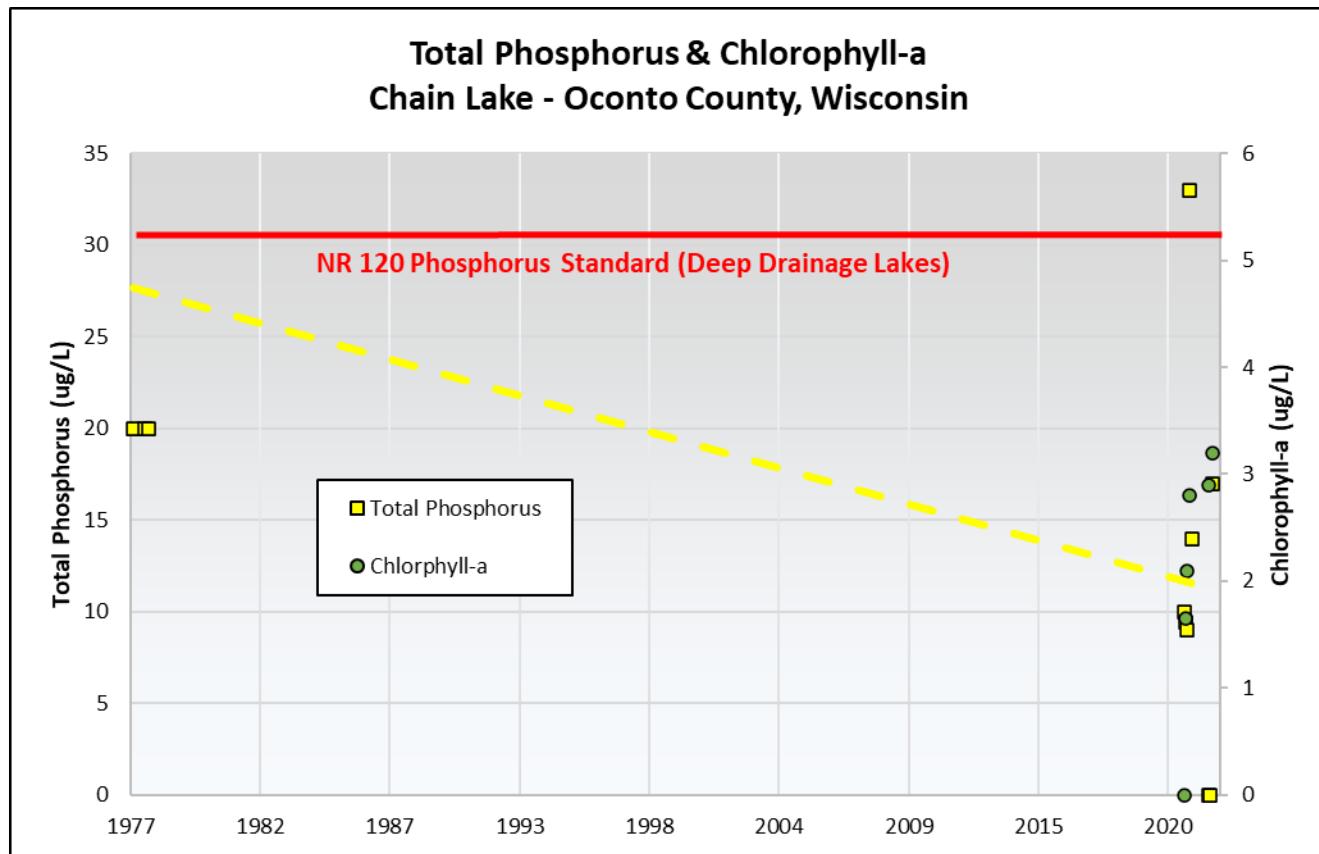
- Total Phosphorus remained below the Wisconsin state standard of 30 ug/L for deep drainage lakes for all but one sample during the two-year study. The long-term trend based on limited historic data suggests decreasing average concentrations.
- Inorganic nitrogen (0.55 mg/L) was above the threshold of 0.3 mg/L when algal blooms increase.
- Chlorophyll-a, an indirect measure of algae, remained below the threshold of 6 ug/L throughout the study.

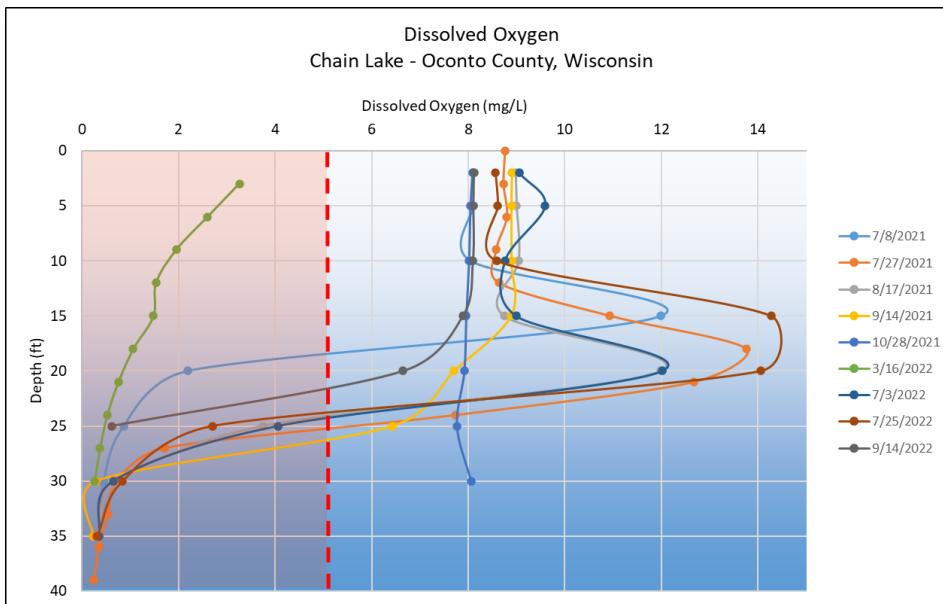
➤ Sufficient oxygen is available in the water column of Chain Lake through most of the year but may become anoxic in late winter. Generally, the top 20 feet of water column maintains enough oxygen to support most fish species. Algae blooms at depth are common just above the thermocline as shown by increases in dissolved oxygen.

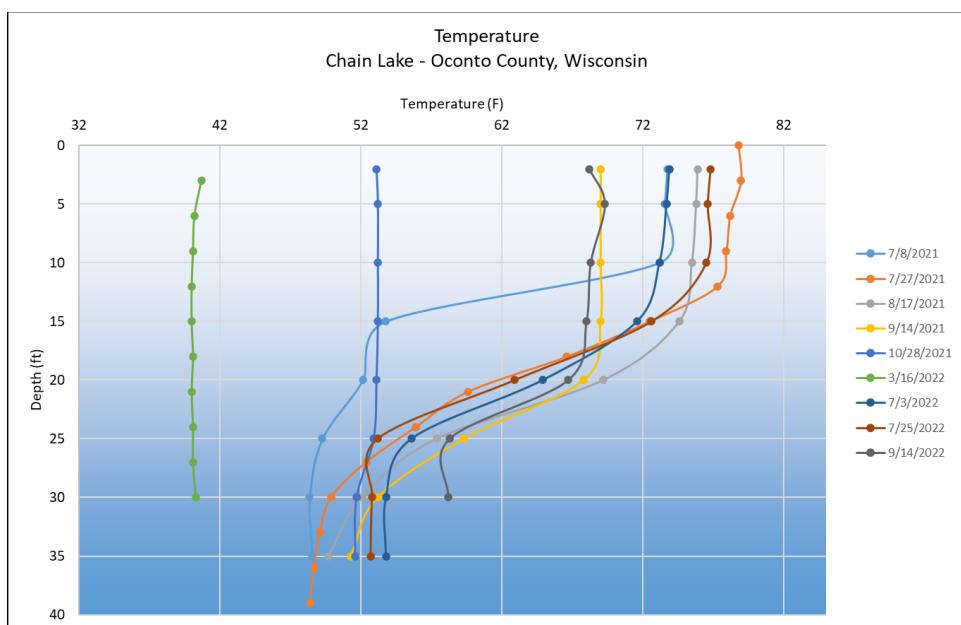
➤ Temperature profiles in Chain Lake are typical of a deep, stratified lake with a clear thermocline from 15-25 feet during the growing season. This stratification isolates deeper, cooler water from more oxygen-rich warmer water above.

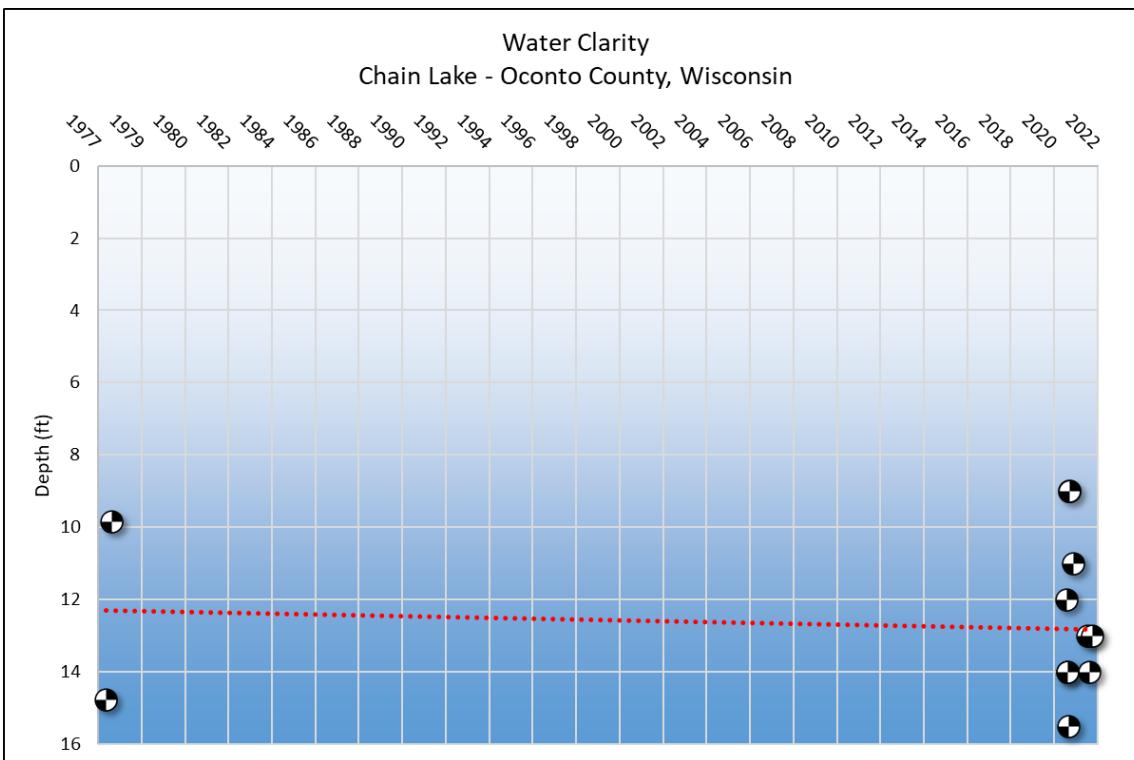
- The graphs below show water clarity measurements taken between May and November.
- During 2021-22, the poorest average water clarity was in September-October and best was in August. Comparison to previous data suggests a stable trend.

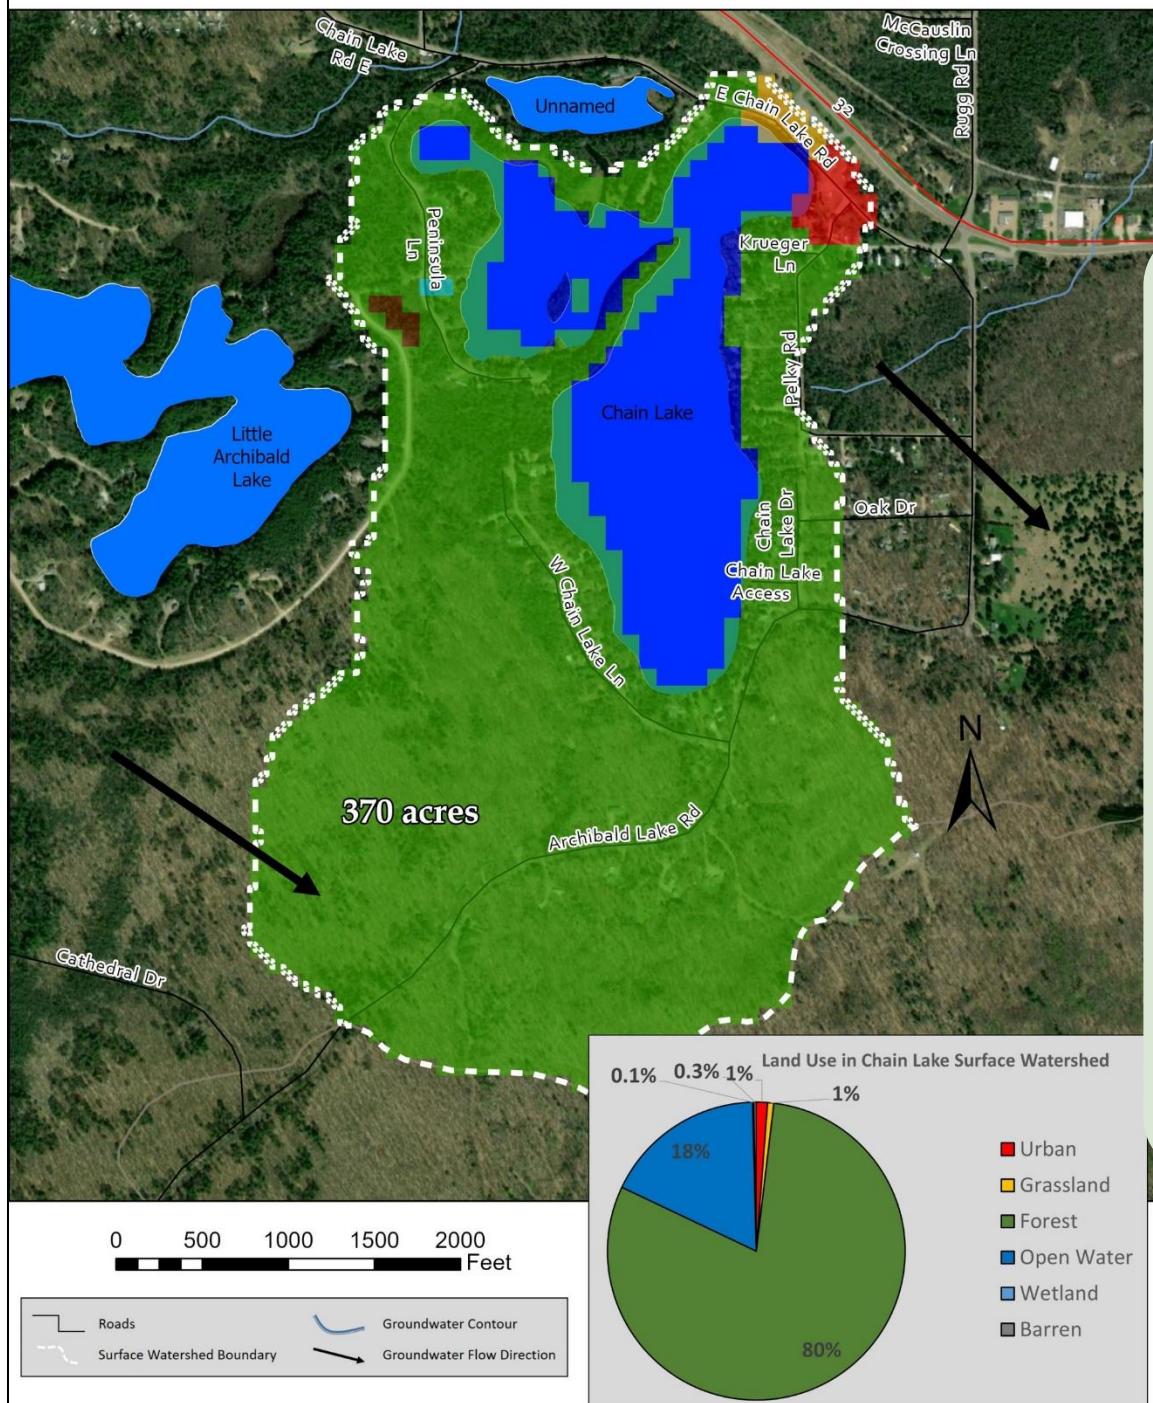
Chain Lake Surface Watershed & Groundwater Flow

Groundwater provides water to lakes in Oconto County throughout the entire year. Hard surfaces on the landscape prevent water from soaking into the ground and becoming groundwater. This results in less water flowing to the lake during snowmelt and rain events. Water that does not infiltrate to groundwater becomes **surface runoff** flowing across the surface of the landscape where it can move sediment and contaminants to the lake from within its watershed.

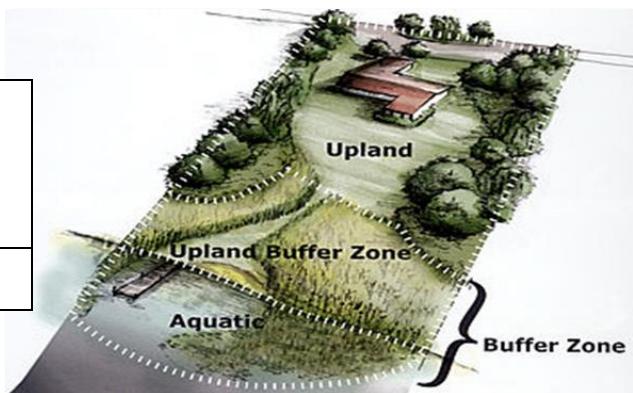
- Shorelands around Chain Lake were surveyed in July 2021. Many shoreland areas are healthy, but some stretches are in need of restoration.

| Total lakefront footage (feet) | No. Riparian lots | Measured shoreland disturbance (feet) | Measured shoreland disturbance (%) |
| 9,196 | 83 | 1,721 | 19% |

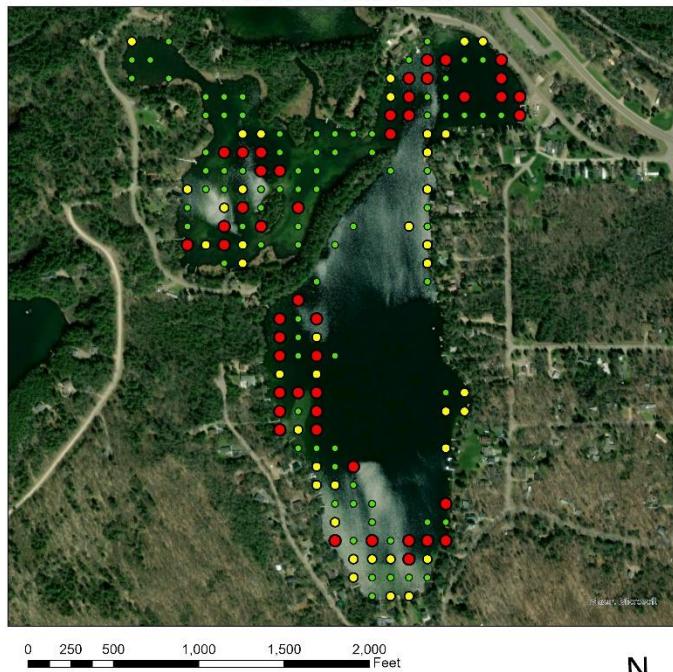
Chain Lake Aquatic Plant Survey 2021:
Rake Fullness

- The aquatic plant community in Chain Lake is characterized by above average diversity of plant species when compared to other lakes in the Oconto County Lakes Project, with a total of 23 species in the 2021 survey.
- During the 2021 aquatic plant survey of Long Lake, 76% of visited sites had vegetative growth. The maximum depth of vegetation was 23 feet and the Floristic Quality Assessment (FQI) was 30.7.
- The most frequently encountered plant species were Northern water-milfoil (27%), Slender naiad (25%), Fern pondweed (21%), and Flat-stem pondweed (21%).
- No invasive species were observed.
