# Oconto County Lakes Project

## BOUNDARY LAKE STUDY SUMMARY REPORT

2025

# Background

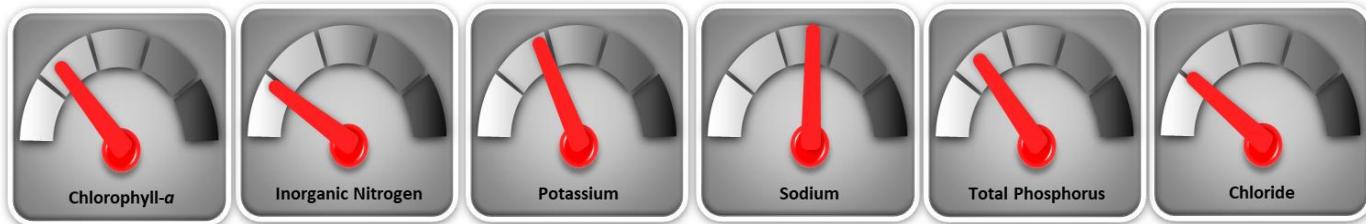
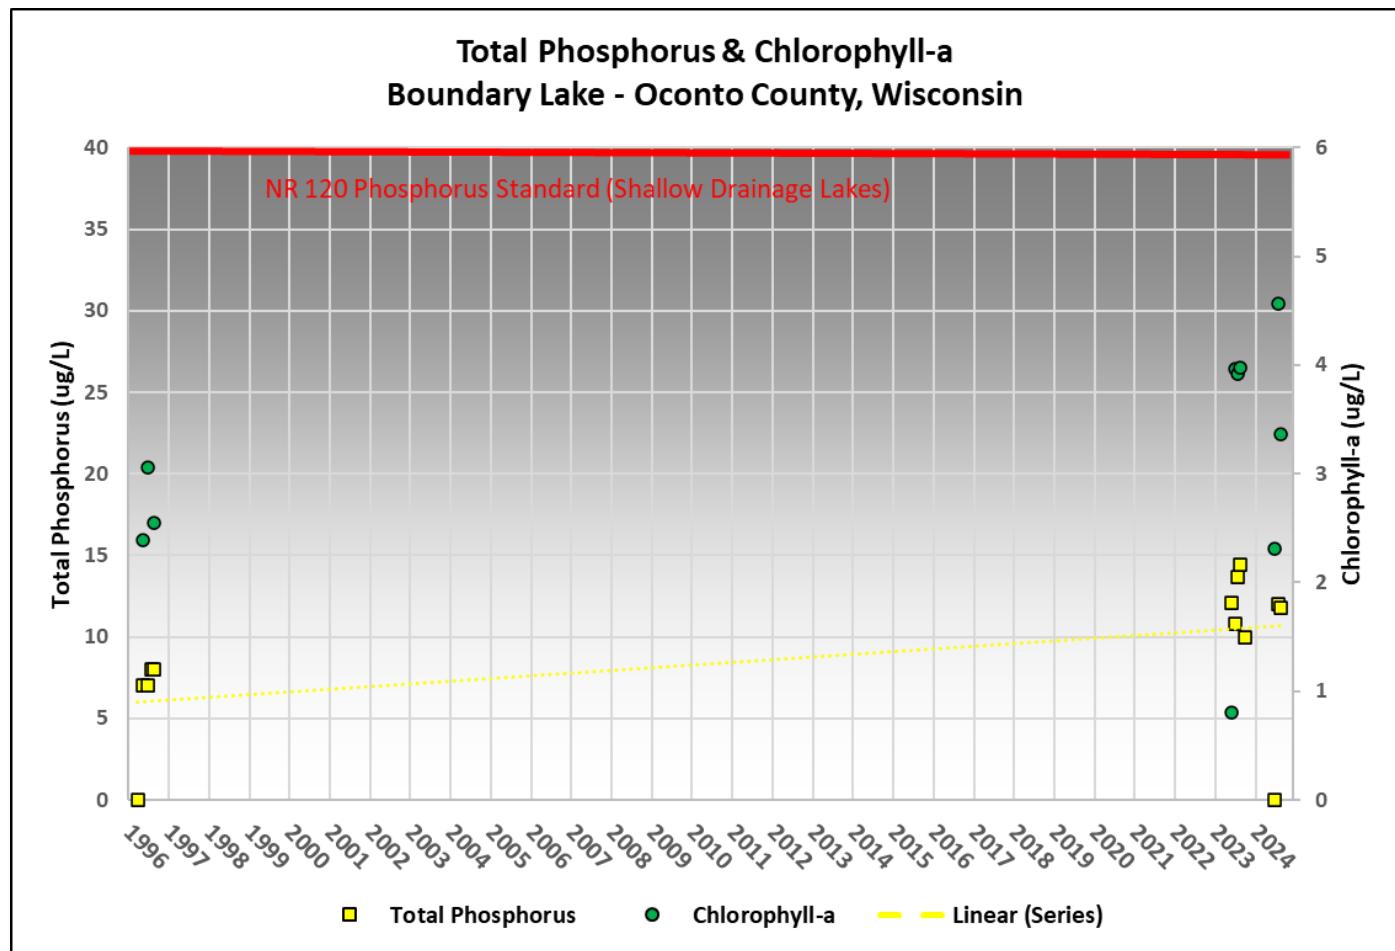
- Total Phosphorus remained well below the Wisconsin state standard of 40 ug/L for drainage lakes during the two-year study. Limited data suggests this average concentration is stable.
- Inorganic nitrogen remained below the threshold of 0.3 mg/L when algal blooms increase.
- Chlorophyll-a, an indirect measure of algae, remained below the threshold of 6 ug/L during the study.

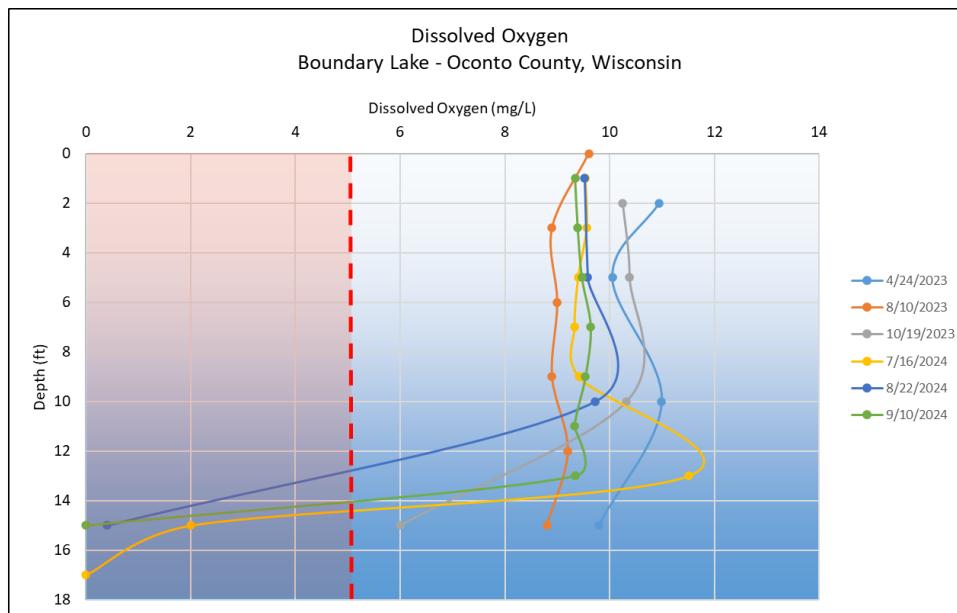
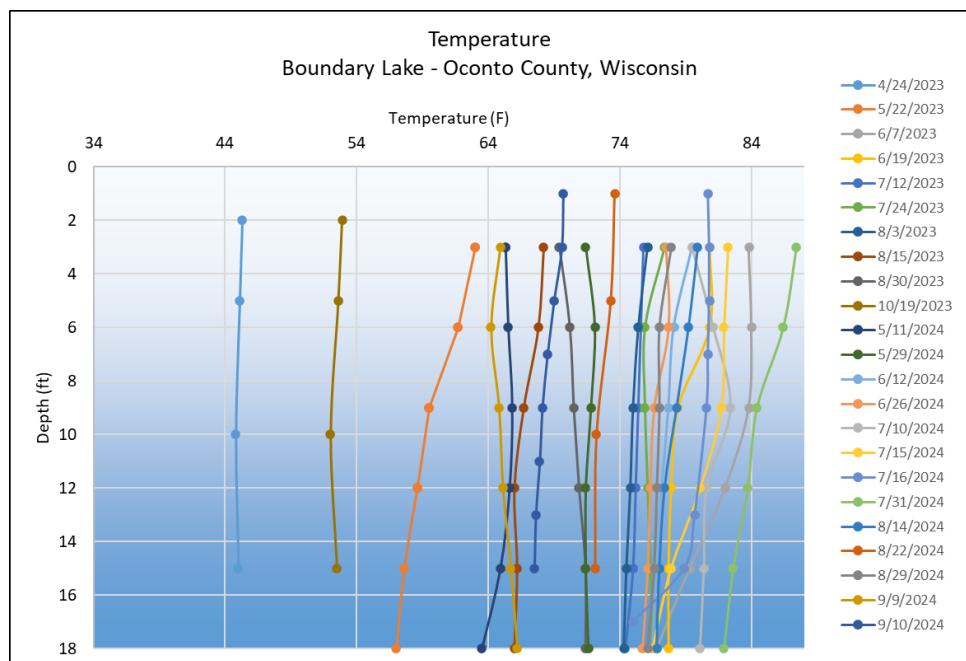
- Sufficient oxygen is available in the water column of Boundary Lake throughout the year. At least the top 13 feet of water column contains enough oxygen to support most fish species.
- Spike in DO concentration in July at depth is indicative of an algae bloom.

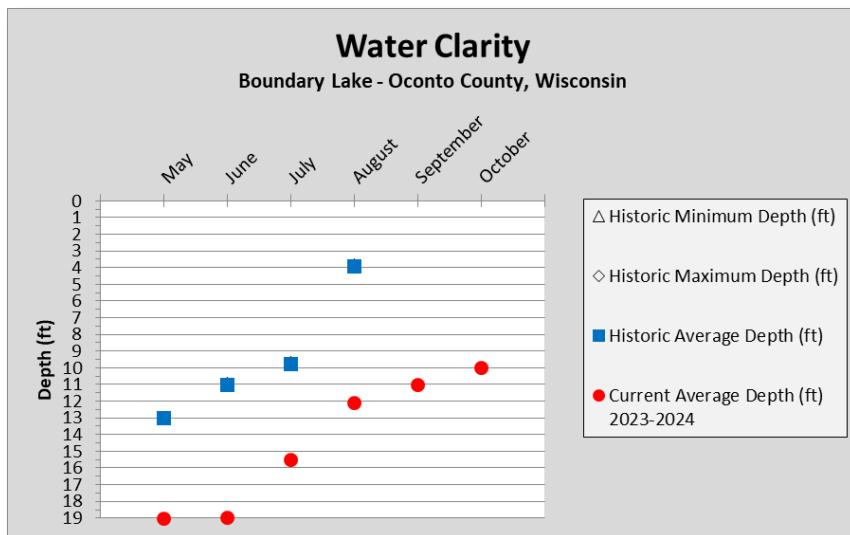
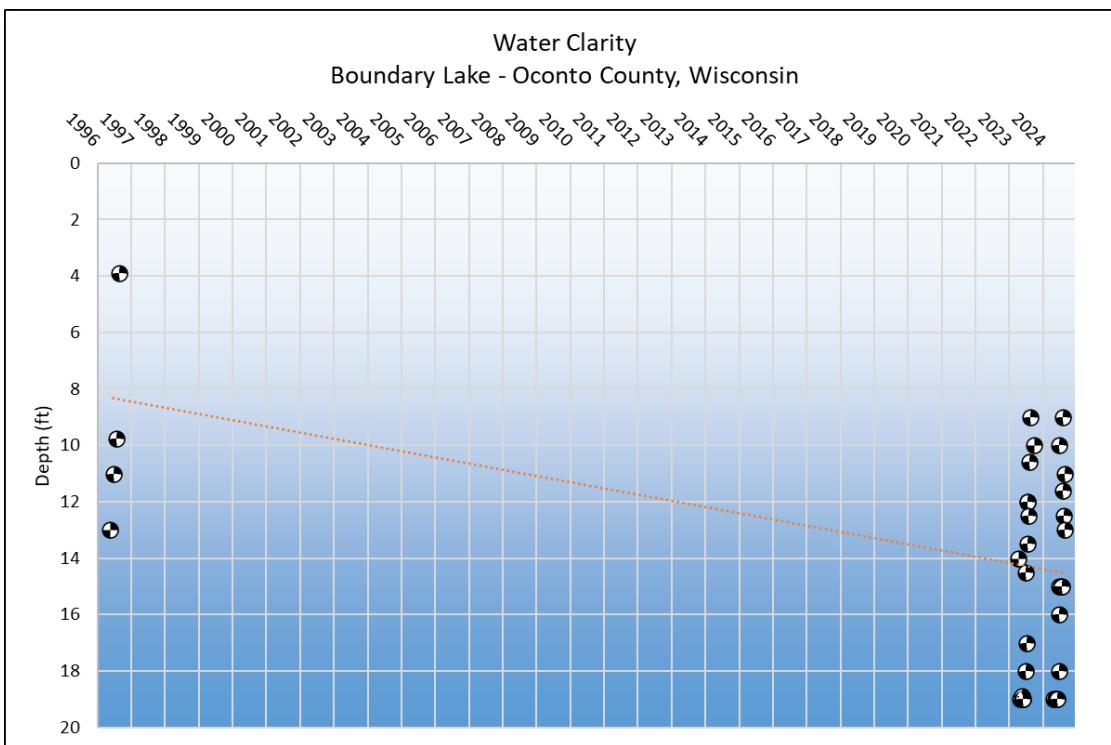
- The graphs below show water clarity measurements taken between May and October.
  - During 2023-24, water clarity was best in May/June and worst in October. These averages are generally better than historical averages.

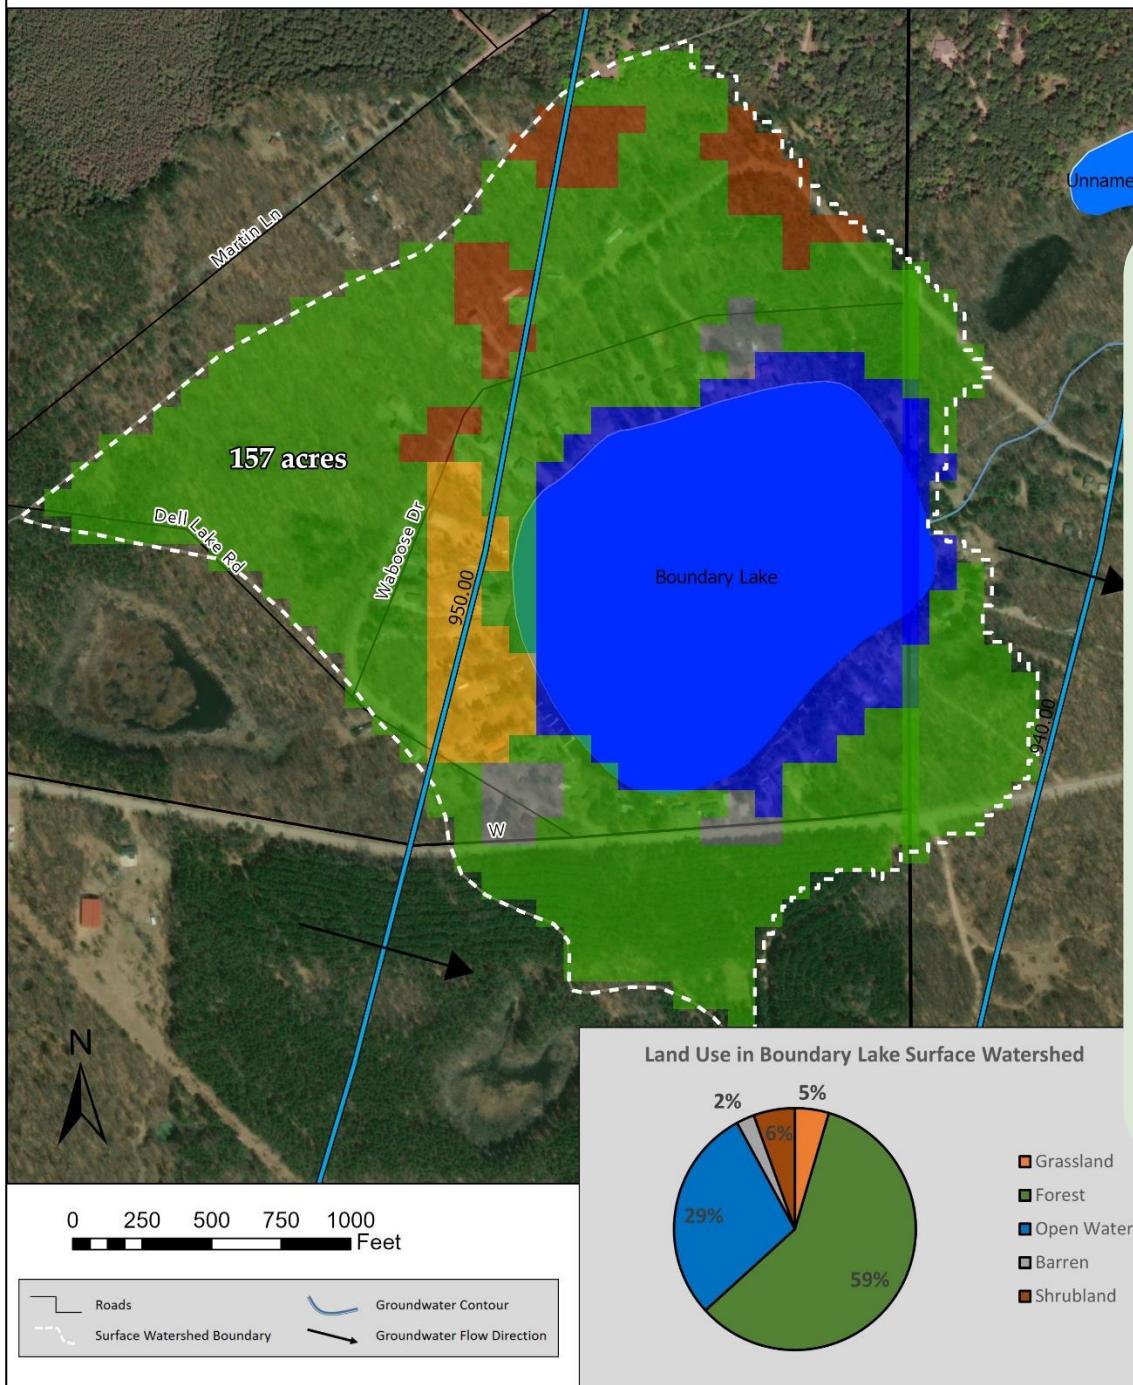
## Boundary Lake Surface Watershed & Groundwater Flow

The quality of lake water reflects what is happening on the land surface. Precipitation falling on forests produces clean groundwater, whereas precipitation falling on land that has chemical use can produce runoff and groundwater that contains these chemicals. Groundwater contamination may include nitrogen, pesticides, herbicides and other soluble chemicals originating from septic systems, crops, barnyards, and road de-icing. Once in the groundwater, these chemicals move slowly towards a lake or river.

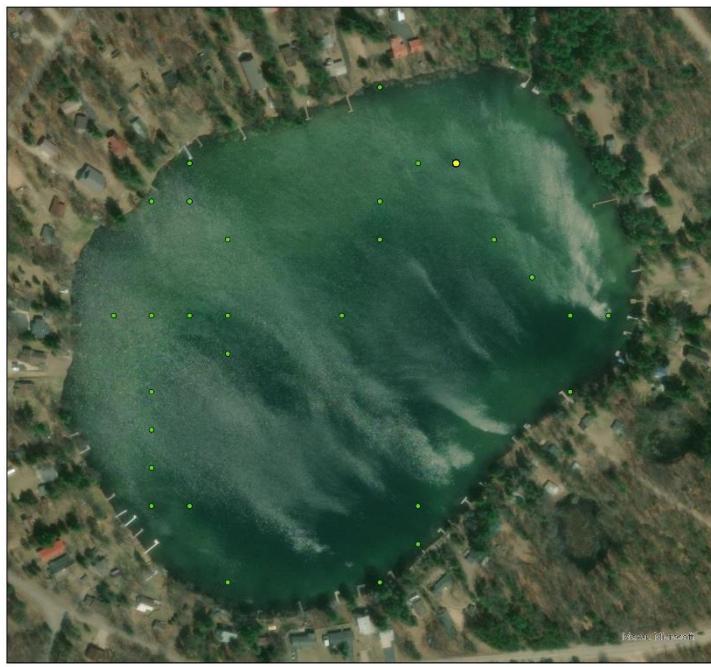
Boundary Lake Aquatic Plant Survey 2023:  
Rake Fullness

**Rake Fullness**

- 1
- 2
- 3

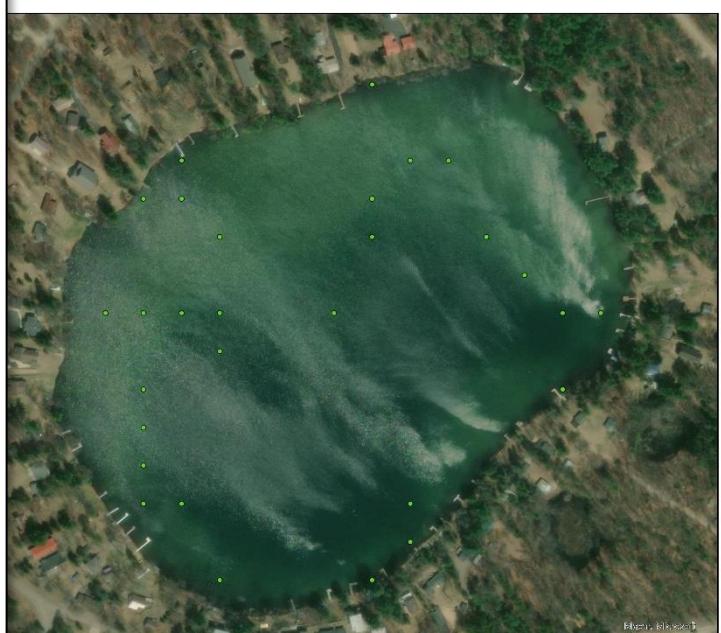
Boundary Lake Aquatic Plant Survey 2023:  
Total Number of Species

**Total Number of Species**

- 1-3
- 4-7
- 8+
