Oconto County Lakes Project

SUNRISE LAKE STUDY SUMMARY REPORT

2025

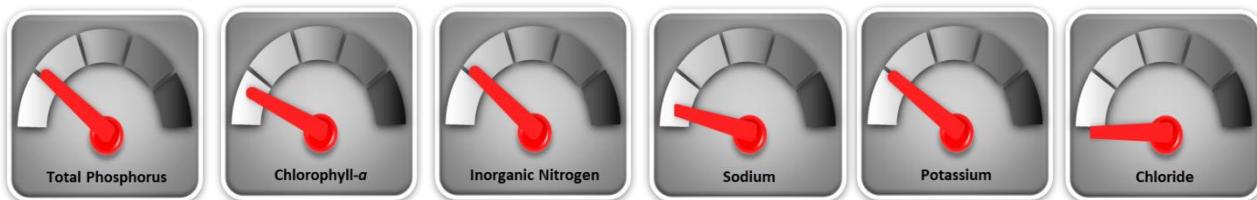
Total Phosphorus & Chlorophyll-a Sunrise Lake - Oconto County, Wisconsin

- Total Phosphorus was mostly below the Wisconsin state standard of 20 ug/L for seepage lakes during the two-year study except for one sample in June 2024. Additional monitoring is required to determine trends.
- Inorganic nitrogen remained below the threshold of 0.3 mg/L when algal blooms increase.
- Chlorophyll-a, an indirect measure of algae, remained below the threshold of 6 ug/L during the study.

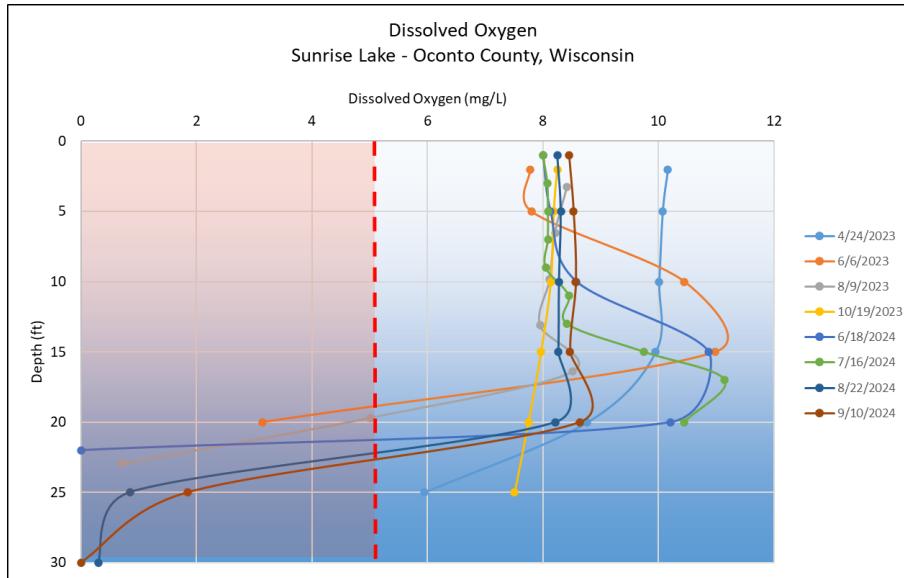
- Sufficient oxygen is available in the water column of Sunrise Lake throughout the year. At least the top 17 feet of water column contains enough oxygen to support most fish species.
- Spike in DO concentration just above the thermocline is indicative of algae blooms.

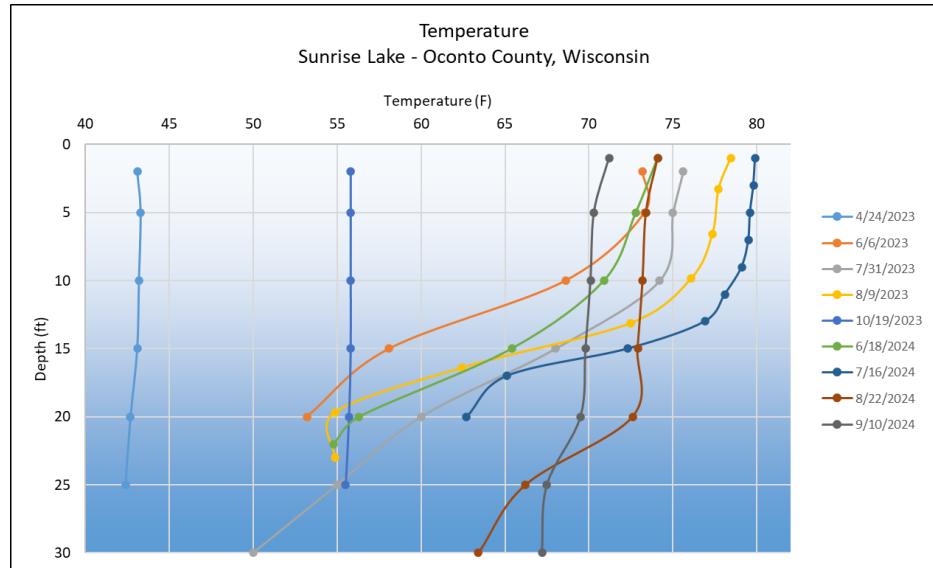
- Temperature profiles in Sunrise Lake show a thermocline developing during the growing season between 10 and 15 feet. This stratification is inherent in a 'deep' lake.

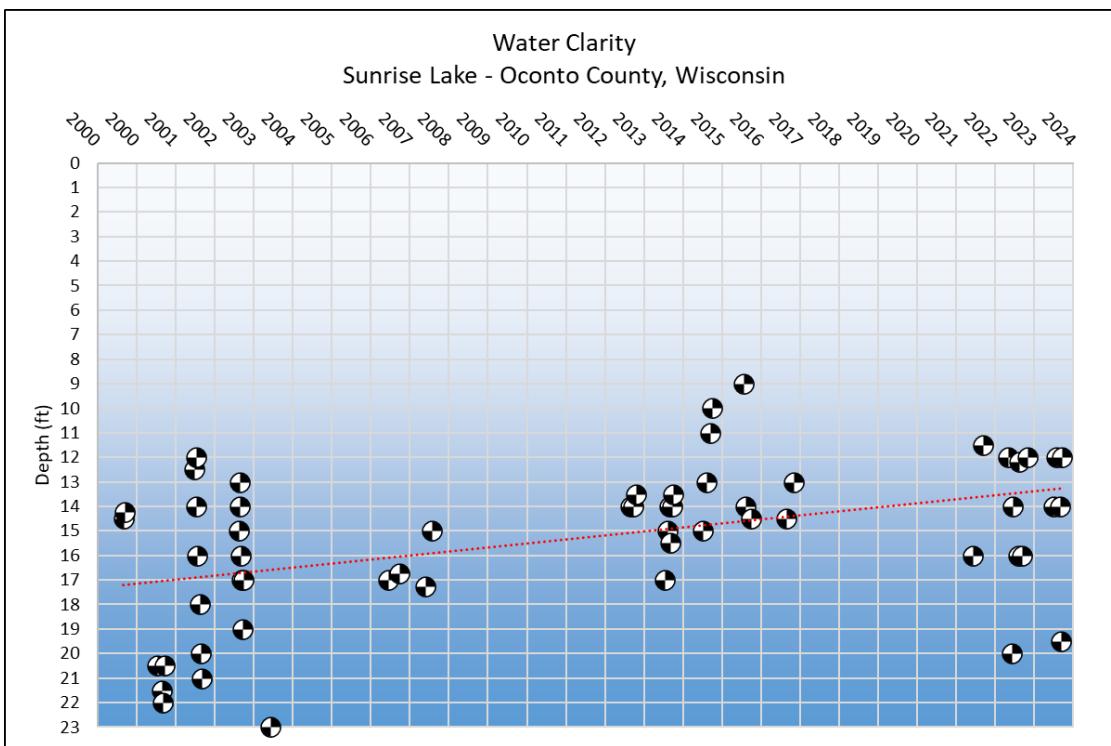
- The graphs below show water clarity measurements taken between May and October. The long-term trend suggests a slightly decreasing clarity over time.
- During 2023-24, water clarity was best in May/June and worst in October. These averages are similar to historic averages.

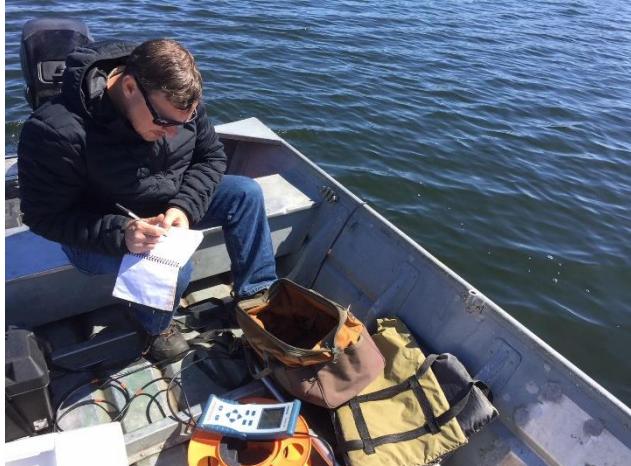
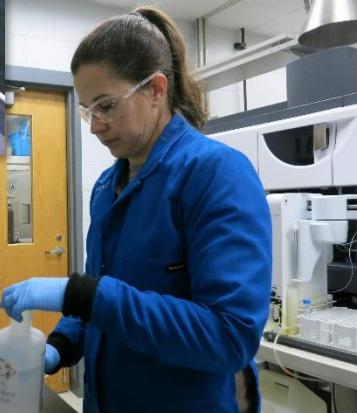
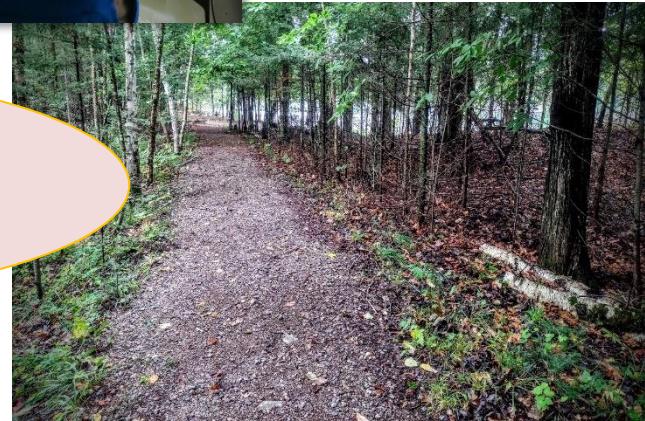
- Concentrations of potassium (0.774 mg/L), chloride (2.5 mg/L) and sodium (3.046 mg/L) were low. This suggests minimal impacts from human activity such as septic systems, road salt, animal waste and fertilizers.
- DACT, a screening tool to determine if your lake is being impacted by pesticides, was not detected.
- Water in Sunrise Lake is very soft (15 mg/L CaCO₃), having a low level of dissolved minerals. This makes Sunrise Lake more vulnerable to the impacts of nutrient inputs.

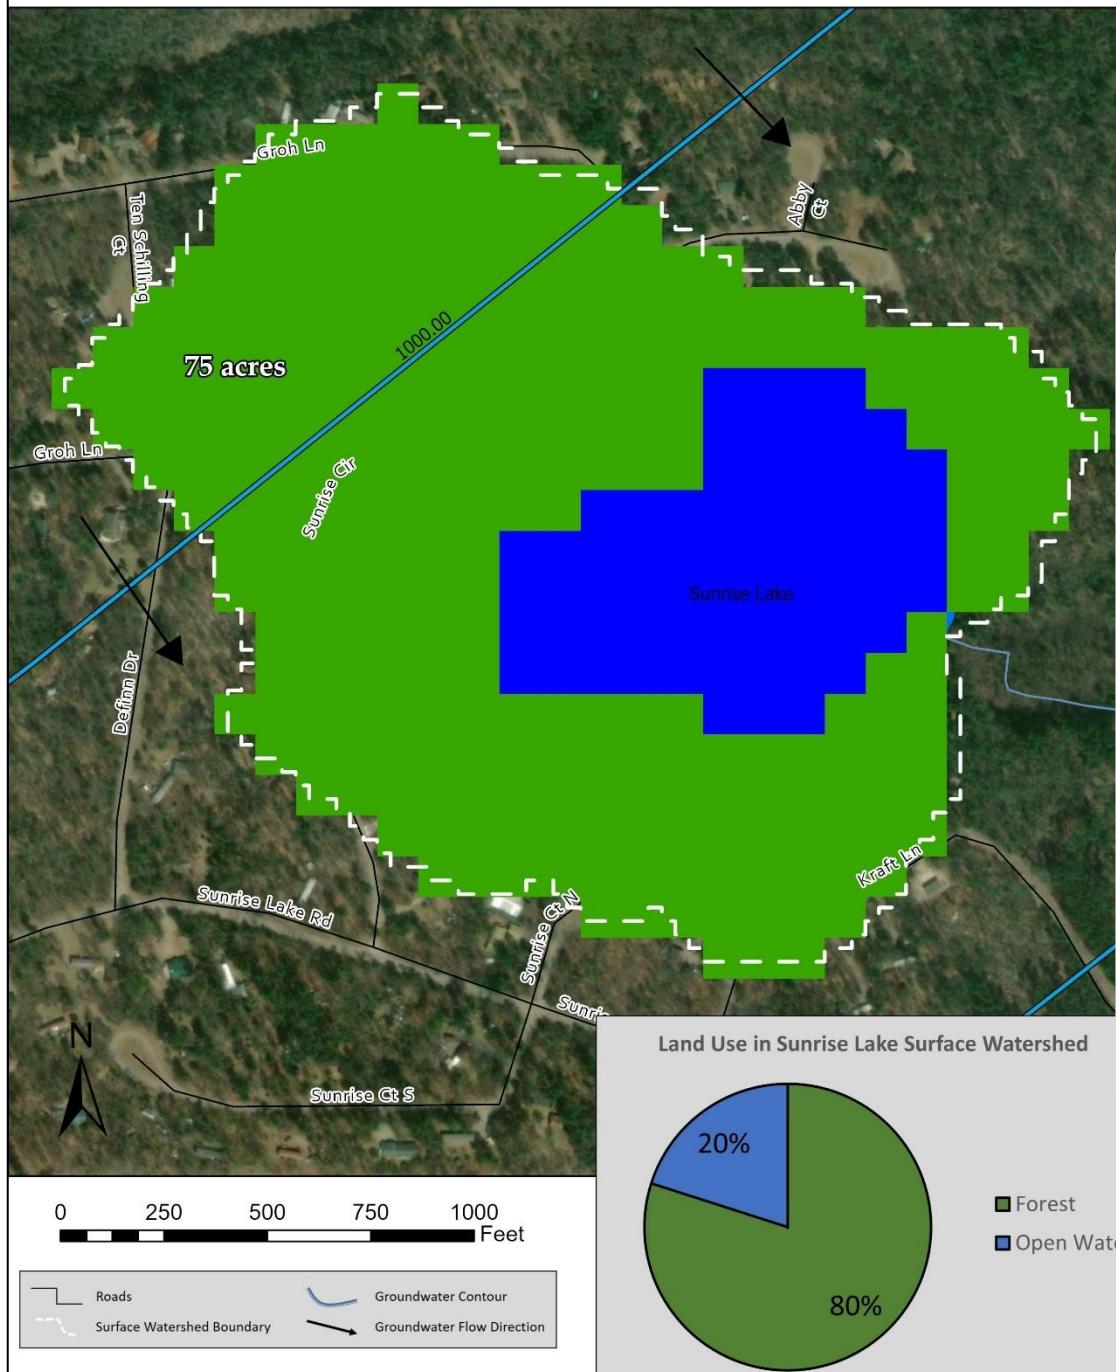
Sunrise Lake Surface Watershed & Groundwater Flow

Groundwater provides water to lakes in Oconto County throughout the entire year. Hard surfaces on the landscape prevent water from soaking into the ground and becoming groundwater. This results in less water flowing to the lake during snowmelt and rain events. Water that does not infiltrate to groundwater becomes **surface runoff** flowing across the surface of the landscape where it can move sediment and contaminants to the lake from within its watershed.

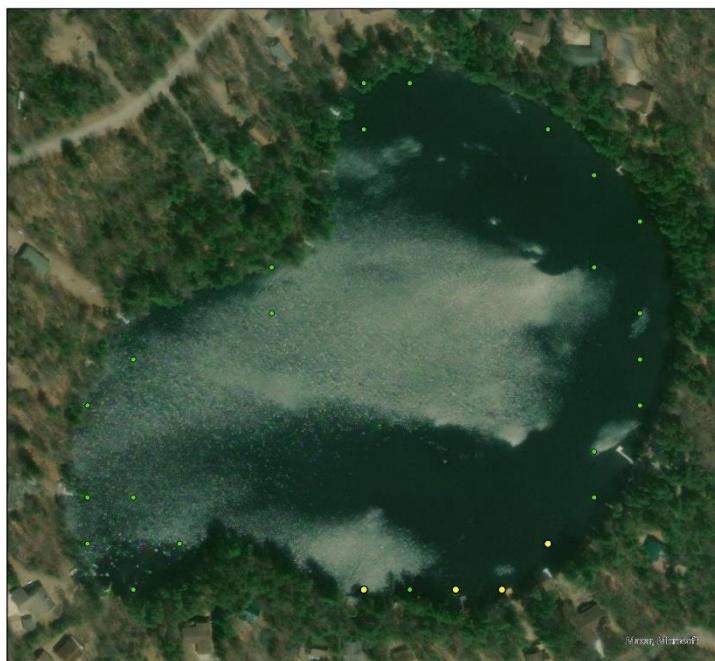
**Sunrise Lake Aquatic Plant Survey 2023:
Rake Fullness**

- The aquatic plant community in Sunrise Lake is characterized by below average diversity of plant species when compared to other lakes in the Oconto County Lakes Project, with a total of 11 species in the 2023 survey.
- During the 2023 aquatic plant survey of Sunrise Lake, 38% of visited sites had vegetative growth. The maximum depth of vegetation was 22 feet and the Floristic Quality Assessment (FQI) was 22.
- The most frequently encountered plant species were watershield (39%), pipewort (35%), and ribbon-leaved pondweed (27%).
- No invasive species were observed.

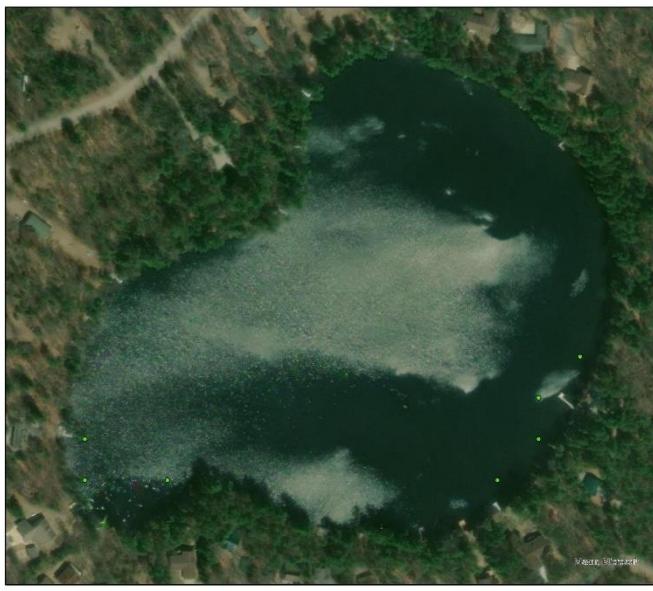
Sunrise Lake Aquatic Plant Survey 2023:
Ribbon-leaf pondweed (*Potamogeton epihydrus*)

Presence of Ribbon-leaf pondweed
(*Potamogeton epihydrus*)
