Oconto County Lakes Project

GILKEY LAKE STUDY SUMMARY REPORT

2025

Center for Watershed Science and Education
College of Natural Resources
University of Wisconsin-Stevens Point

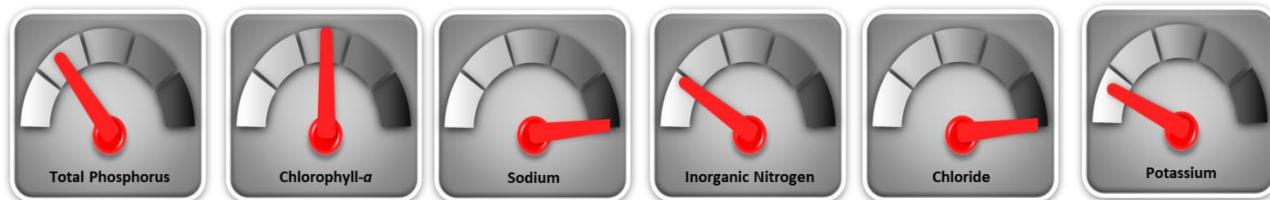
Total Phosphorus & Chlorophyll-a Gilkey Lake - Oconto County, Wisconsin

- Total Phosphorus remained well below the Wisconsin state standard of 40 ug/L for shallow seepage lakes during the two-year study. Limited data suggests this average concentration is coming down.
- Inorganic nitrogen remained below the threshold of 0.3 mg/L when algal blooms increase.
- Chlorophyll-a, an indirect measure of algae, remained below the threshold of 6 ug/L during the study.

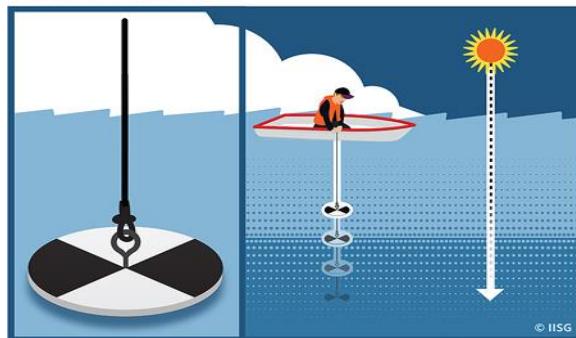
Water clarity is a measure of how deep light can penetrate (Secchi depth). Clarity is affected by water color, turbidity (suspended sediment), and algae. Water clarity helps determine where rooted aquatic plants can grow. It is typical for water clarity to vary throughout the year.

- The graphs below show water clarity measurements taken between April and November. Limited data suggests a long-term trend of slightly decreasing depths.
- During 2023-24, water clarity was best in July and worst in June. These averages are generally worse than historical averages.

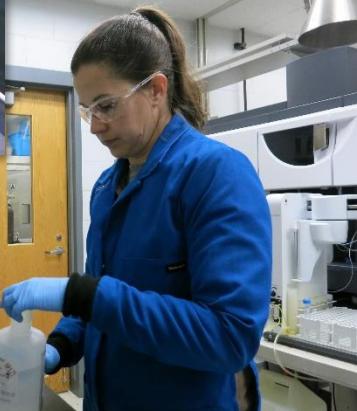
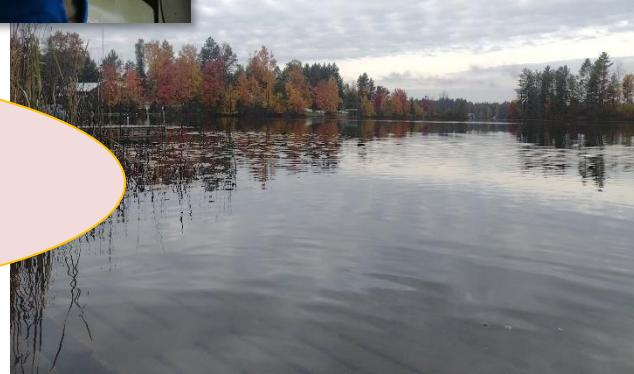
- Concentrations of potassium (0.78 mg/L) were low, but chloride (18.5 mg/L) and sodium (12.6 mg/L) were elevated. This suggests impacts from human activity such as septic systems, road salt, animal waste and fertilizers.
- DACT, a screening tool to determine if your lake is being impacted by pesticides, was detected at low levels.
- Water in Gilkey Lake is moderately hard (73 mg/L CaCO₃), having a reduced level of dissolved minerals making it more vulnerable to algae blooms and the effects of acid rain.

Other chemistry data was collected from lake water samples, such as basic cations, pollutants and acid rain input, and physical parameters. Results of such analyses can provide insights into a variety of other potential impacts to the lake. While concentrations of these compounds in lake water is usually low, higher concentrations can be indicators of other potential issues.

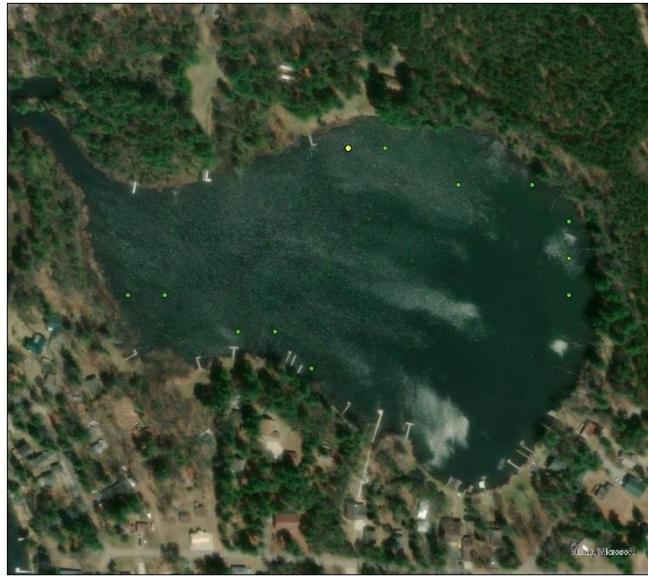
Gilkey Lake Aquatic Plant Survey 2023: White water lily (*Nymphaea odorata*)

Presence of White water lily (*Nymphaea odorata*)

White water lily has round stalks that grow up from a rhizome in the sediment connecting to large round floating leaves. By mid-summer, white flowers also float at the surface. Lilies are important cover for fish, are food by many species, and help prevent erosion by slowing wave action.
