Oconto County Lakes Project

BASS LAKE (Riverview) STUDY SUMMARY REPORT

2025

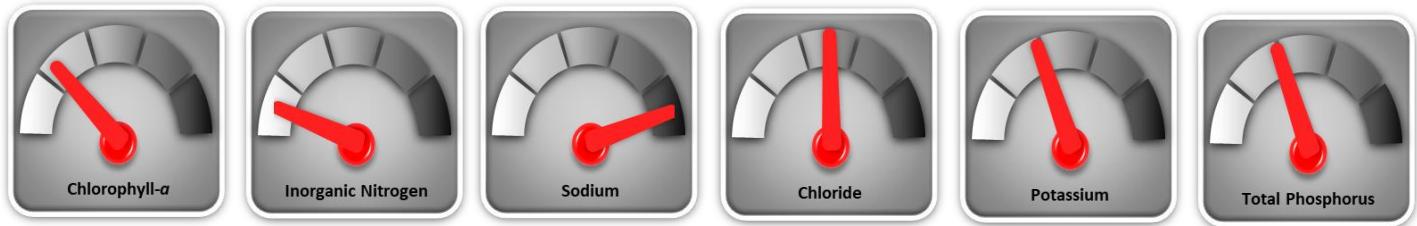
Total Phosphorus & Chlorophyll-a Bass Lake (Riverview) - Oconto County, Wisconsin

- Total Phosphorus remained below the Wisconsin state standard of 40 ug/L for shallow spring lakes during the two-year study. Limited data suggests this average concentration is coming down.
- Inorganic nitrogen remained below the threshold of 0.3 mg/L when algal blooms increase.
- Chlorophyll-a, an indirect measure of algae, remained below the threshold of 6 ug/L during the study.

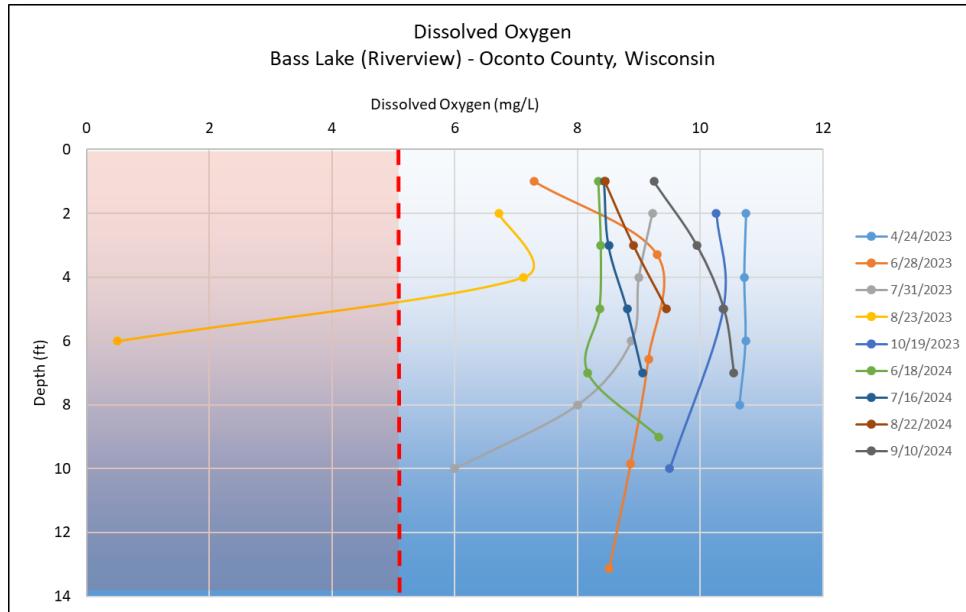
➤ Sufficient **dissolved oxygen** is available in the water column of Bass Lake throughout the year. Generally, the top 5 feet maintains enough oxygen to support most fish species.

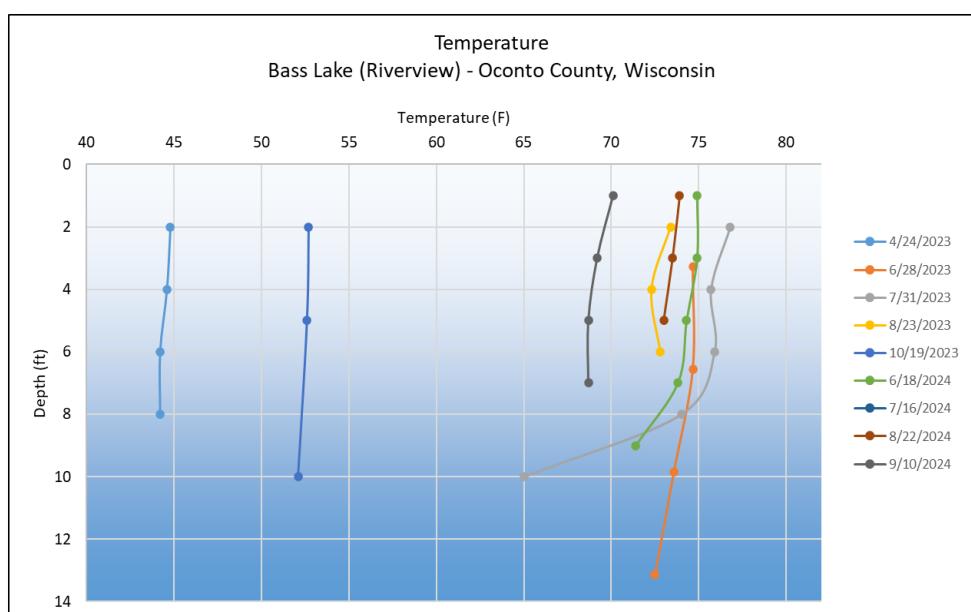
➤ Temperature profiles in Bass Lake are typical for a shallow, mixed lake having similar temperature with depth at each sample event.

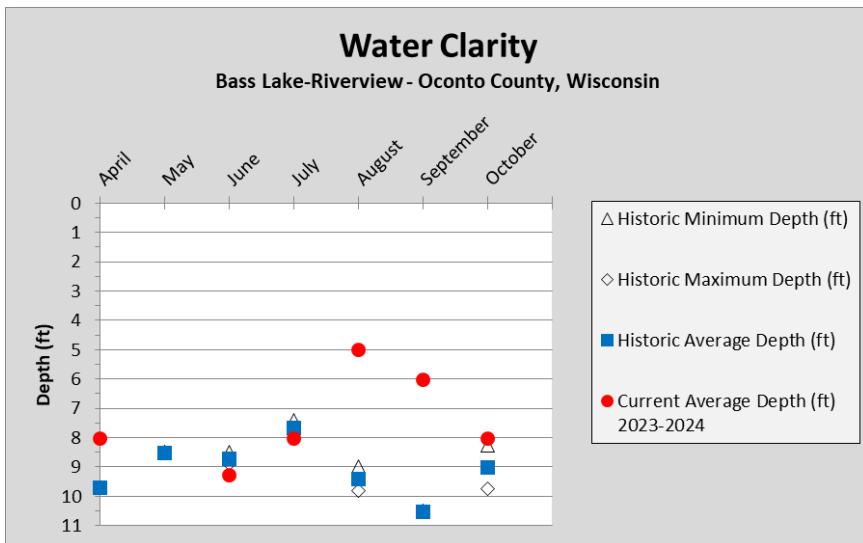
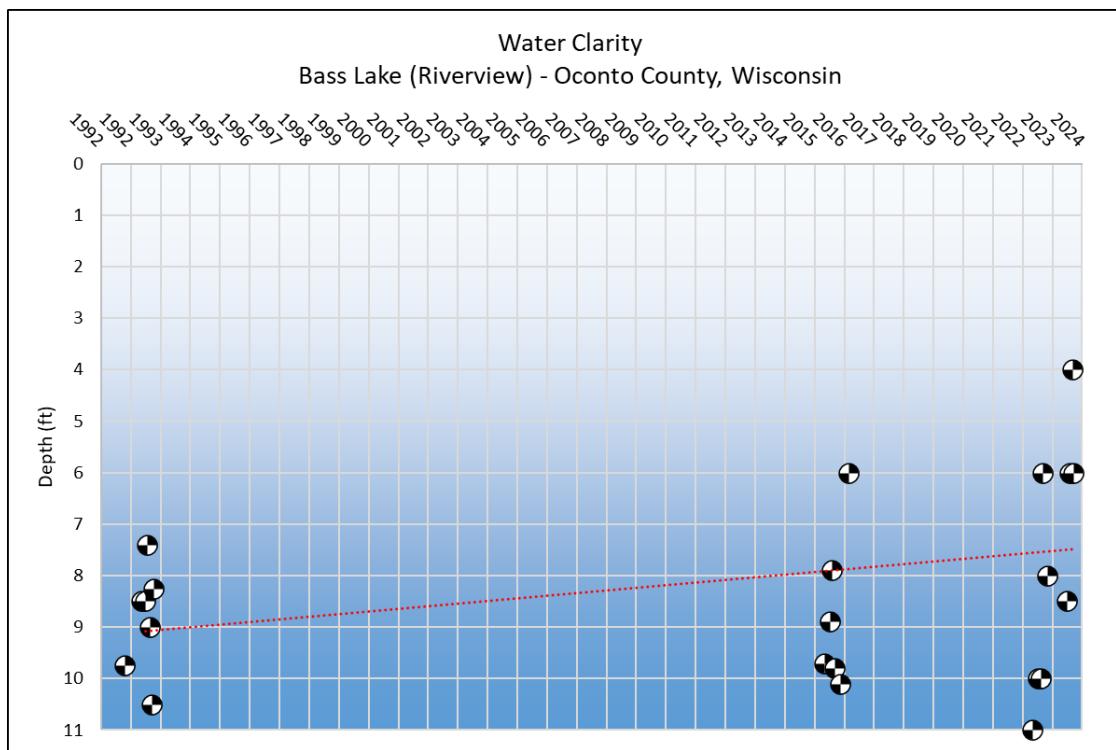
- The graphs below show water clarity measurements taken between May and November. Limited data suggests a long-term trend of slightly decreasing depths.
- During 2023-24, water clarity was best in June and worst in August. These averages are generally worse than historical averages.

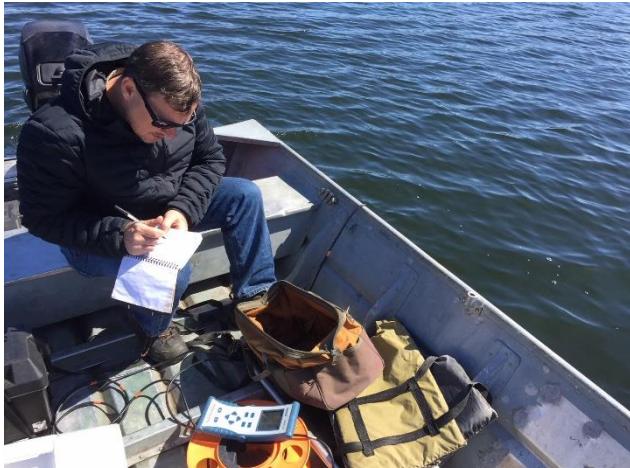
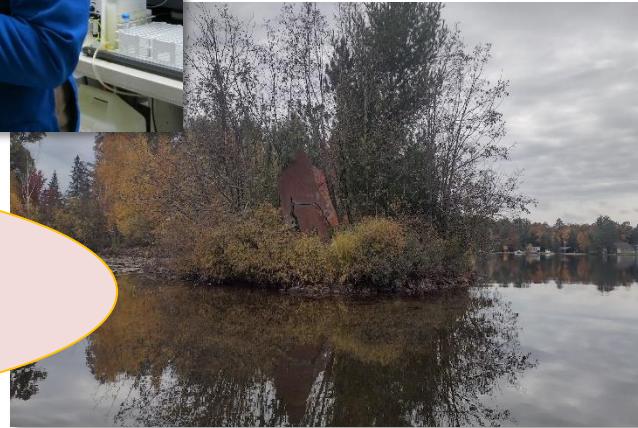
- Concentrations of potassium (0.83 mg/L) were low, but chloride (6.4 mg/L) and sodium (5.5 mg/L) were slightly elevated. This suggests some low level impacts from human activity such as septic systems, road salt, animal waste and fertilizers.
- DACT, a screening tool to determine if your lake is being impacted by pesticides, was not detected.
- Water in Bass Lake is moderately hard (67 mg/L CaCO₃), having a reduced level of dissolved minerals making it more vulnerable to algae blooms and the effects of acid rain.

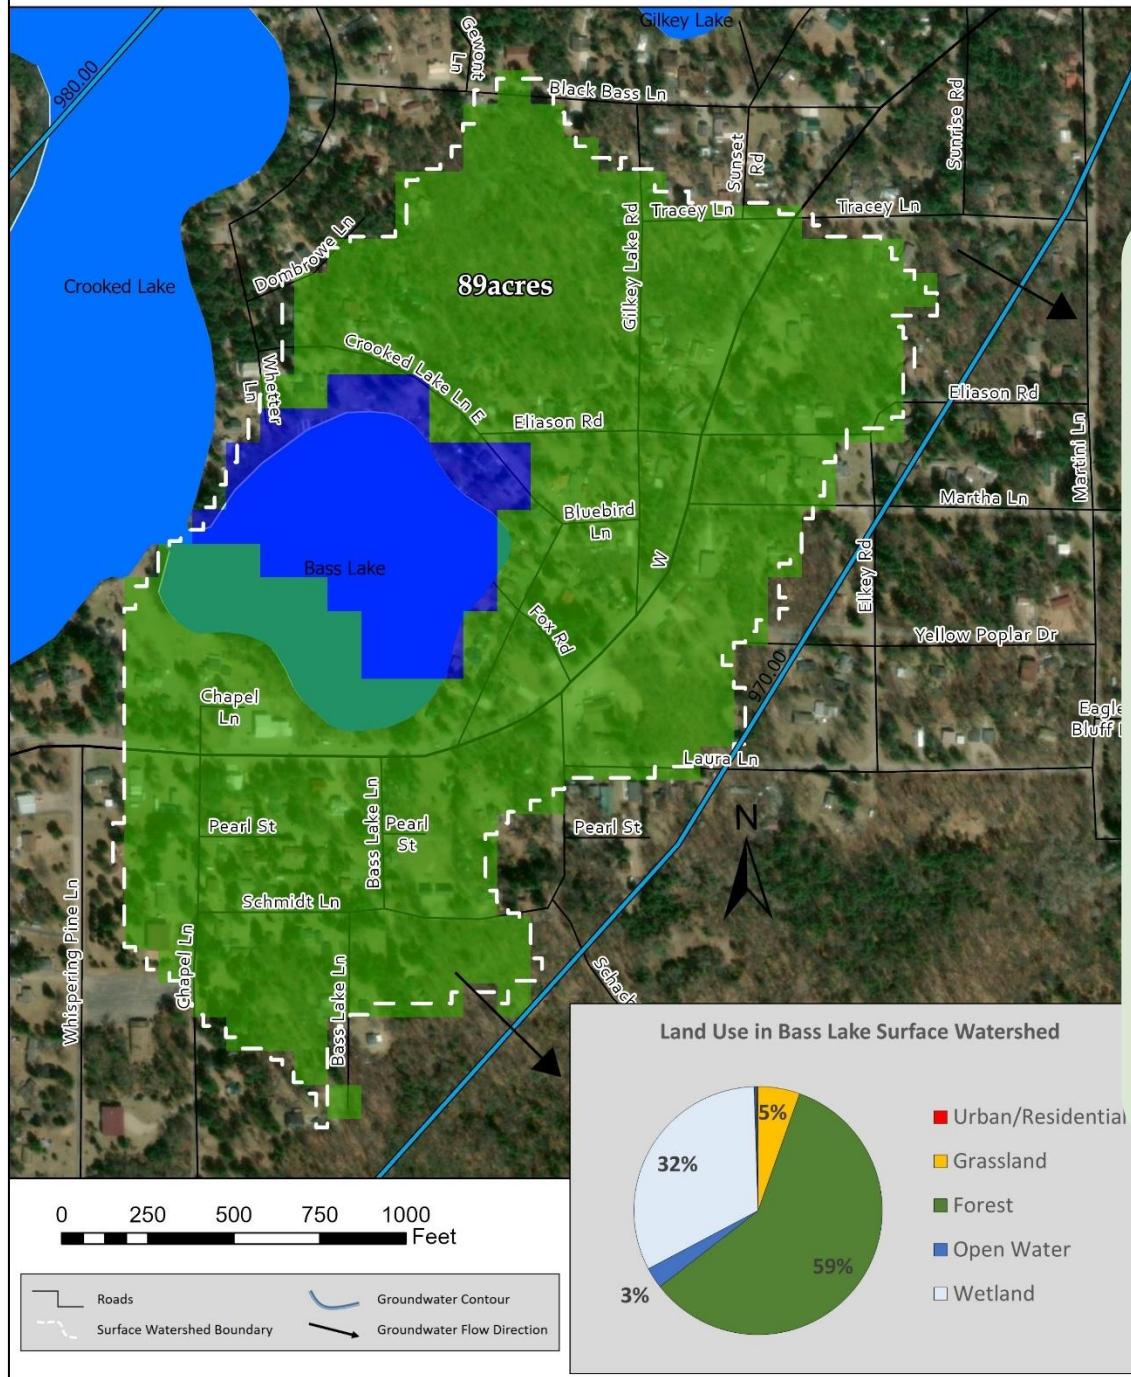
Bass Lake Surface Watershed & Groundwater Flow

Groundwater provides water to lakes in Oconto County throughout the entire year. Hard surfaces on the landscape prevent water from soaking into the ground and becoming groundwater. This results in less water flowing to the lake during snowmelt and rain events. Water that does not infiltrate to groundwater becomes **surface runoff** flowing across the surface of the landscape where it can move sediment and contaminants to the lake from within its watershed.

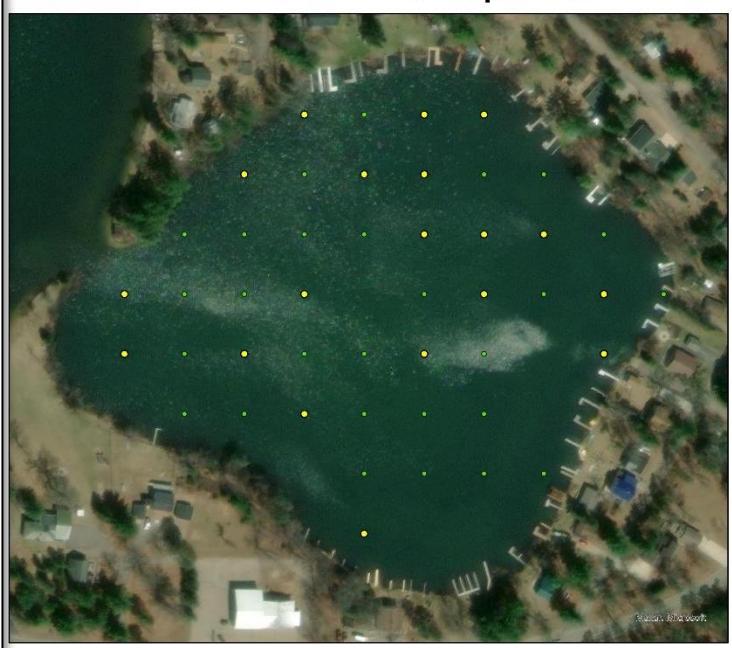
Bass Lake Aquatic Plant Survey 2023:
Total Number of Species

- The aquatic plant community in Bass Lake is characterized by slightly below average diversity of plant species when compared to other lakes in the Oconto County Lakes Project, with a total of 19 species in the 2021 survey.
- During the 2021 aquatic plant survey of Bass Lake, 89% of visited sites had vegetative growth. The maximum depth of vegetation was 11 feet and the Floristic Quality Assessment (FQI) was 24.3.
- The most frequently encountered plant species were southern naiad (54%), waterweed (32%), and bladderwort (30%)
- Eurasian water-milfoil was observed in 7 locations and filamentous algae was observed in 17 locations.

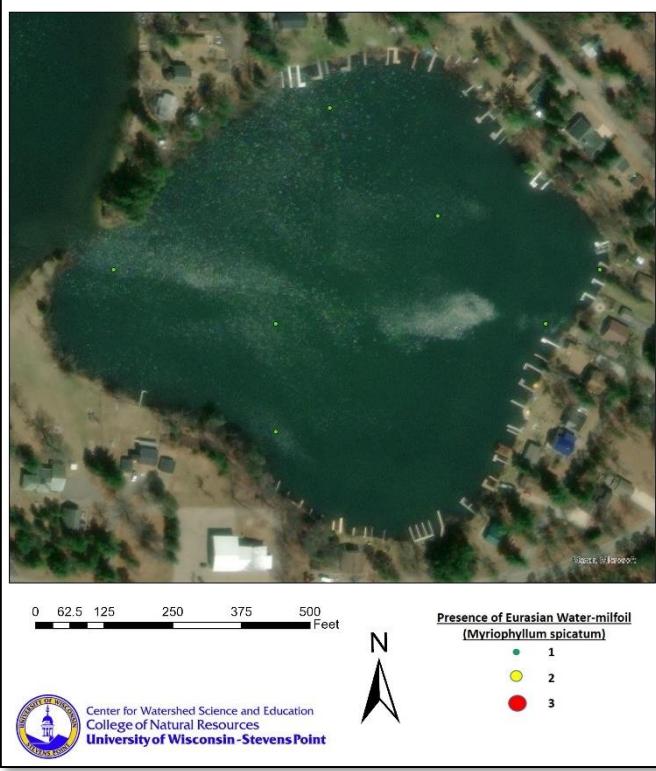
Bass Lake Aquatic Plant Survey 2023: Eurasian Water-milfoil (*Myriophyllum spicatum*)

Eurasian watermilfoil is one of the most common invasive aquatic plants in Wisconsin. It can form dense mats that choke out native plants and inhibit navigation. New plants can grow from stem fragments that root on contact with the substrate.

- Eurasian water-milfoil, first documented in 2002, was observed in seven locations during the 2021 survey.
- Curly-Leaf pondweed (2016) has previously been documented in Bass Lake.
