Oconto County Lakes Project

SMOKE LAKE STUDY

SUMMARY REPORT

2022

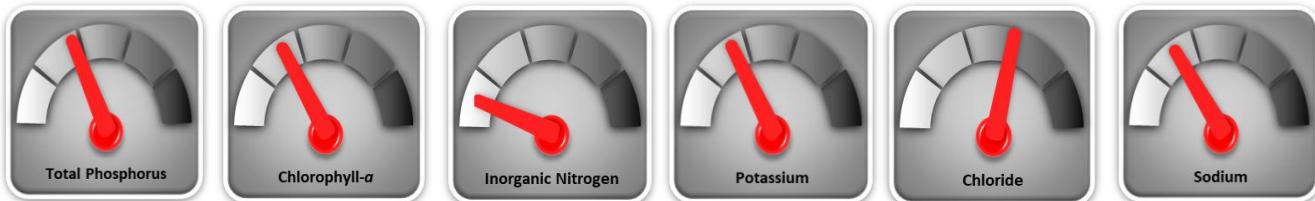
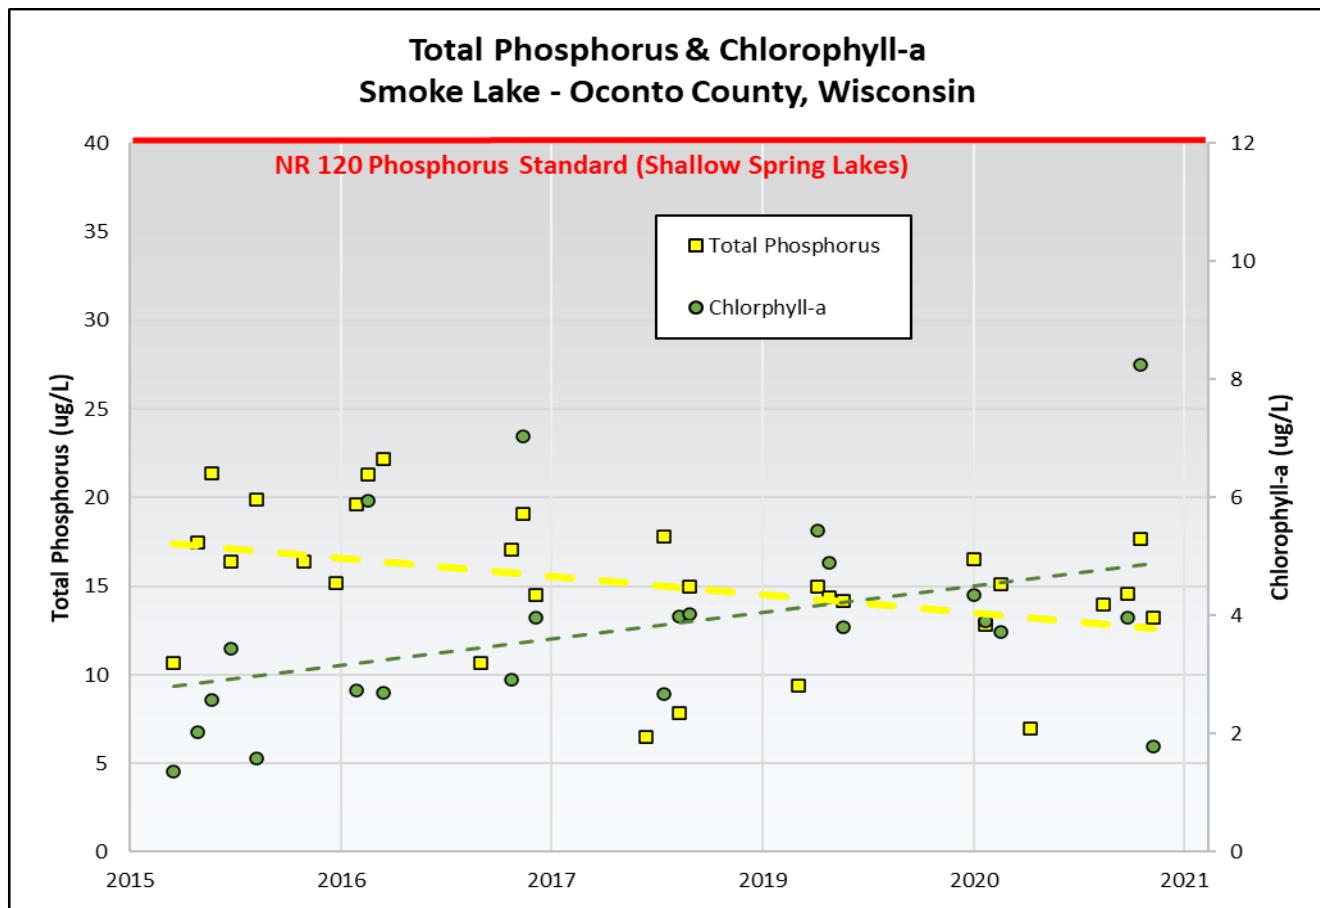
- Total Phosphorus was consistently below the Wisconsin state standard of 40 ug/L for shallow spring lakes during the two-year study. The long-term trend (based on summer samples) suggests a decreasing average concentration.
- Inorganic nitrogen remained below the threshold of 0.3 mg/L when algal blooms increase.
- Chlorophyll-a, an indirect measure of algae, exceeded the threshold of 6 ug/L in one sample. Historic data suggests an increasing trend.

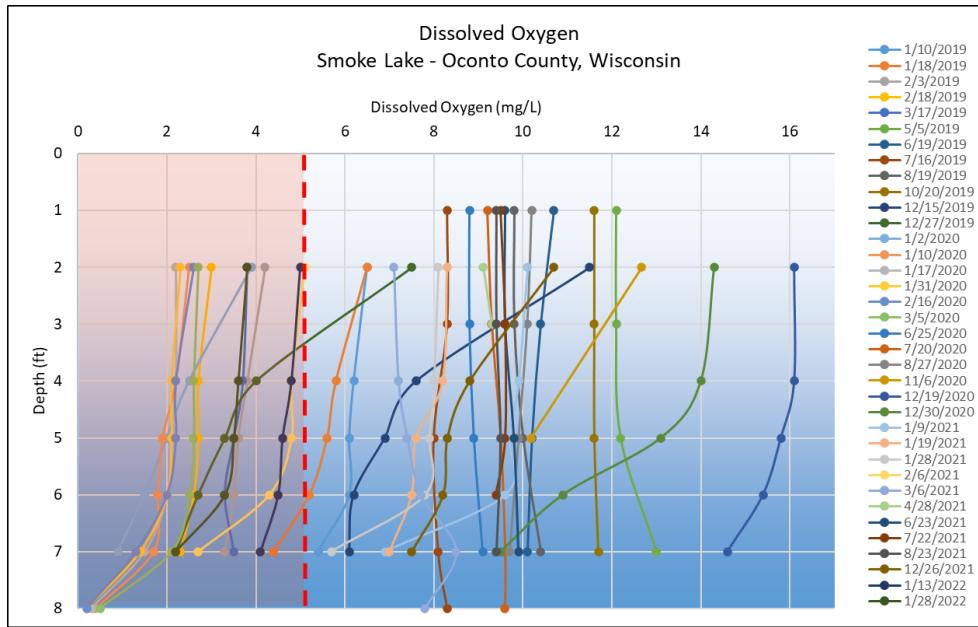
➤ Sufficient oxygen is available in the water column of Smoke Lake most of the year, but is commonly anoxic during late winter.

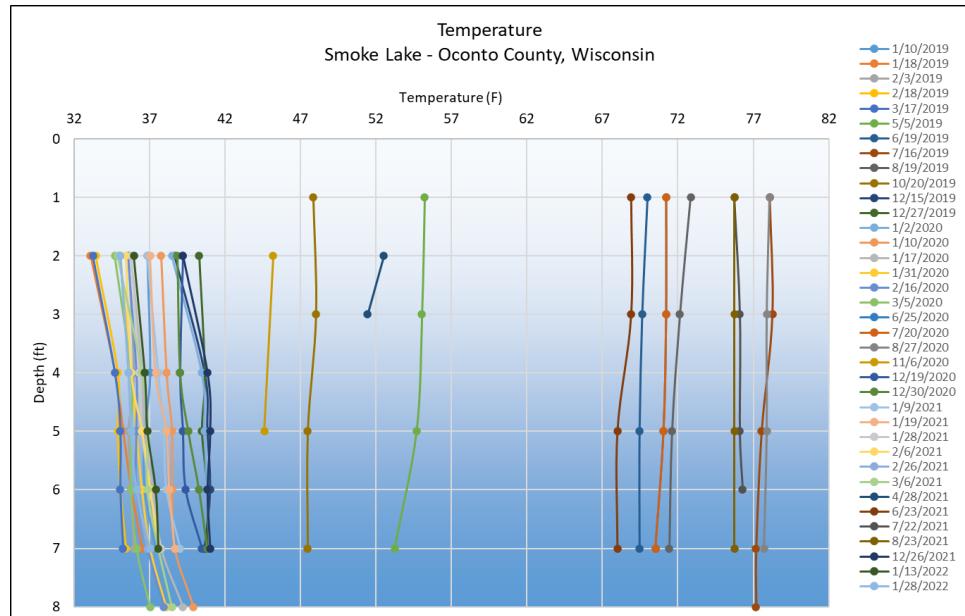
➤ The temperature gradient in Smoke Lake shows a similar temps with depth, typical of a shallow, mixed lake.

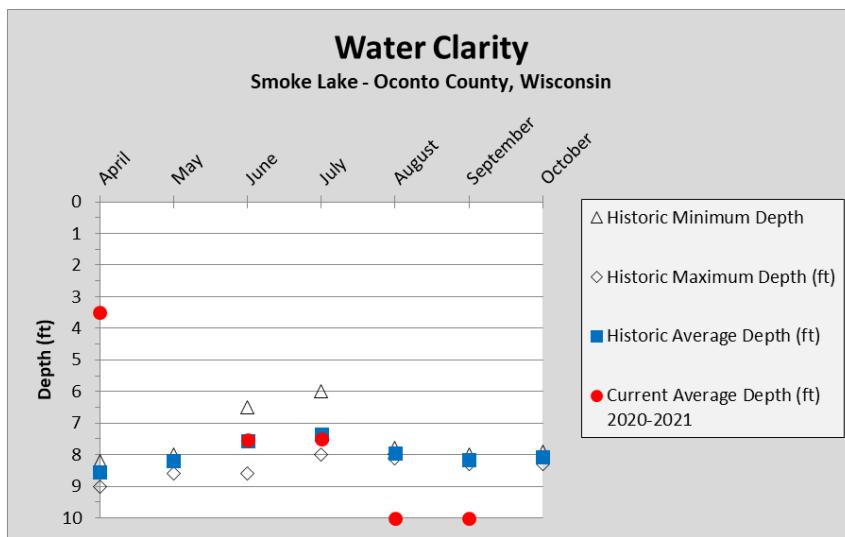
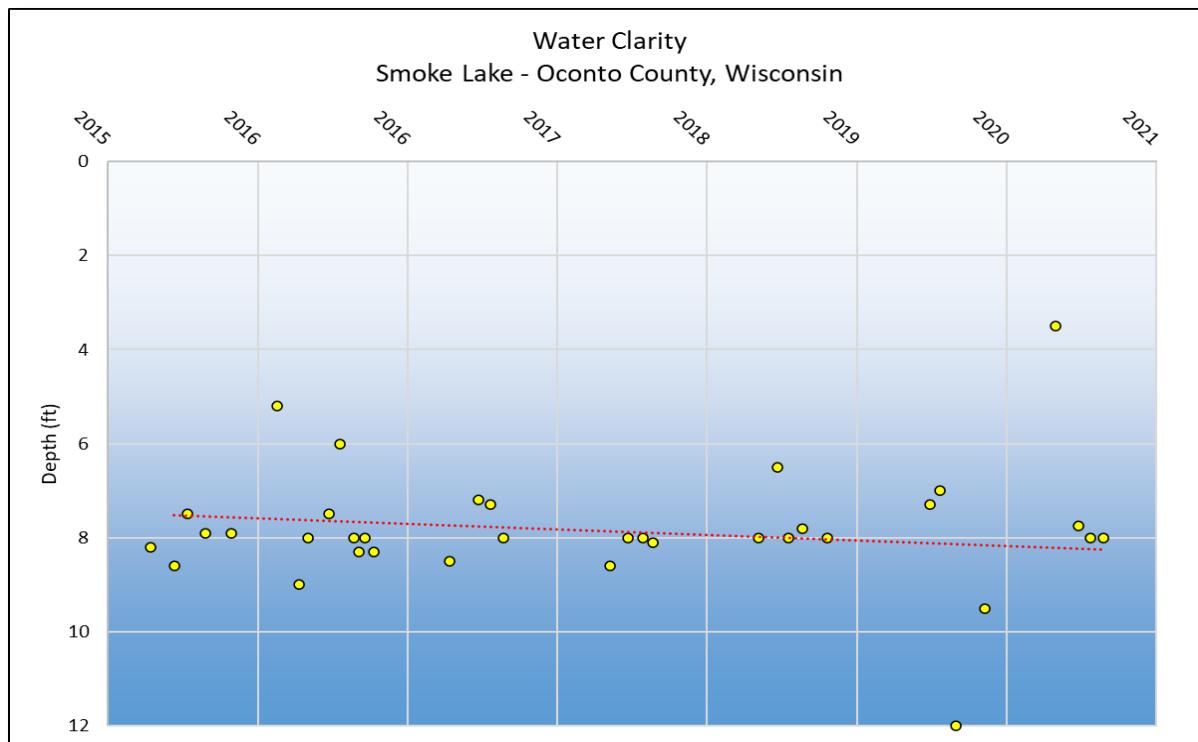
- The graph below shows water clarity measurements taken between May and November.
- During 2020-21, the poorest average water clarity was in June-July and best was in August-September. Historic data suggests an increasing trend.

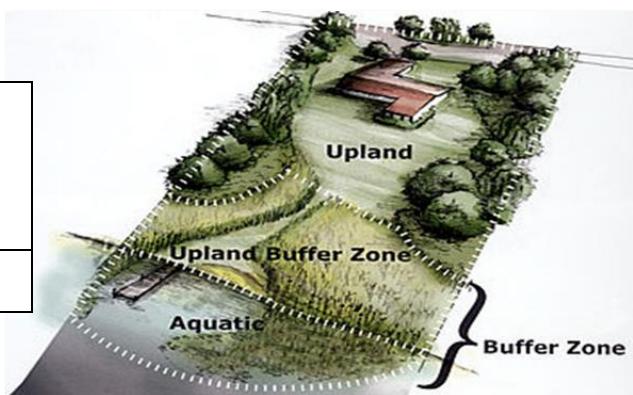
- Shorelands around Smoke Lake were surveyed in July 2020. Most of Smoke Lake's shoreland is healthy, but a few stretches are in need of restoration.

Total lakefront footage	No. Riparian lots	Measured shoreland disturbance (feet)	Measured shoreland disturbance (%)
8,606	35	823	10%

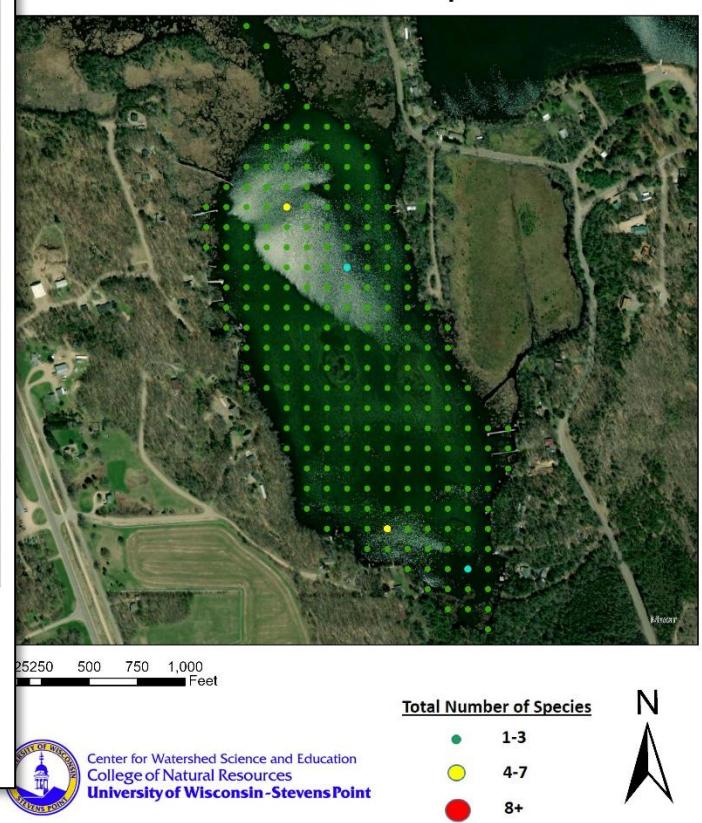
**Smoke Lake Aquatic Plant Survey 2020:
Total Number of Species**

- The aquatic plant community in Smoke Lake is characterized by average diversity of plant species when compared to other lakes in the Oconto County Lakes Project, with a total of 17 species in the 2020 survey.
- During the 2020 aquatic plant survey of Smoke Lake, 70% of visited sites had vegetative growth. The maximum depth of vegetation was 9 feet and the Floristic Quality Assessment (FQI) was 25.5.
- The most frequently encountered plant species were slender naiad (48%), chara (41%) and variable pondweed (28%). All three species are native to Wisconsin.
- No invasive species were observed.

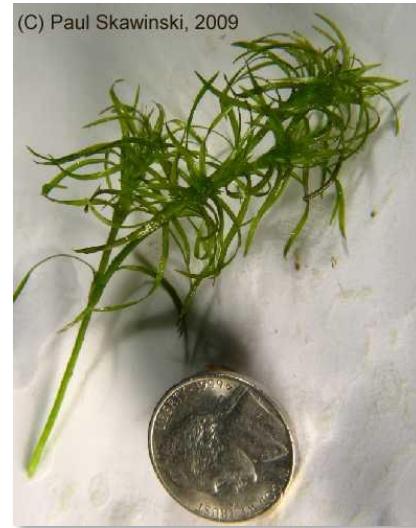
Slender naiad, also called nodding water-nymph, is a primary food source for waterfowl and provides habitat for many invertebrates.

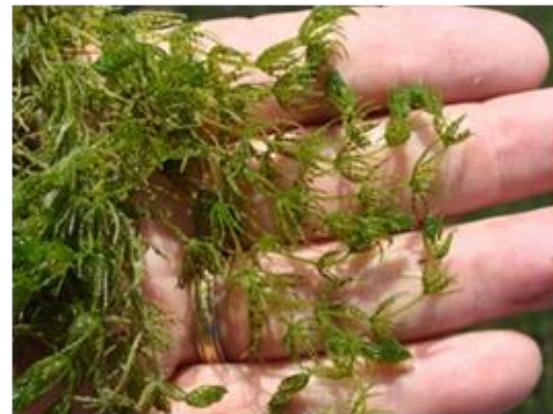
Chara is a type of macro algae that grows attached to muddy lake bottoms and has a musky odor. Muskgrass, as it is known, filters the lake water and is helpful in preventing the establishment of invasive species.

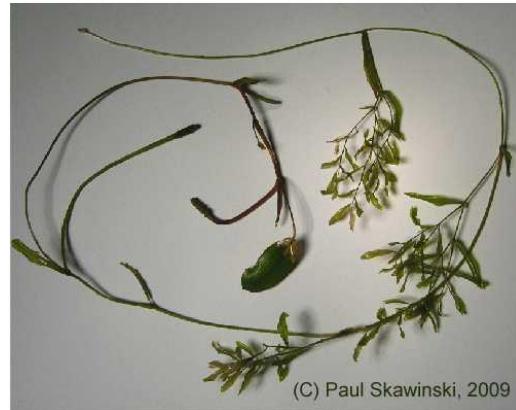
Variable pondweed has both floating and submersed leaves which provide food and habitat for fish.
